PSM10 Installation experience report

PSM 10 - 4kW (FAL10KWh - 4 kW)

Date of completion: 2019-10-01

Customer:
Roger Klasson

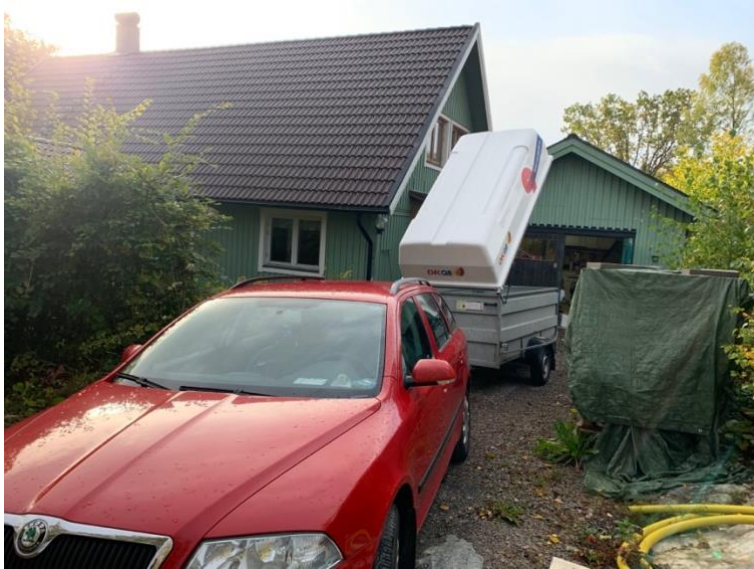
Photo 1. Start to unload the cargo, the battery is to be installed in the small cottage on the right. 12kW PV panel is installed on the bigger roof, on the side facing the sun (not visible from the photo). The customer has also an SMA system under his roof which works in parallel with FA system.

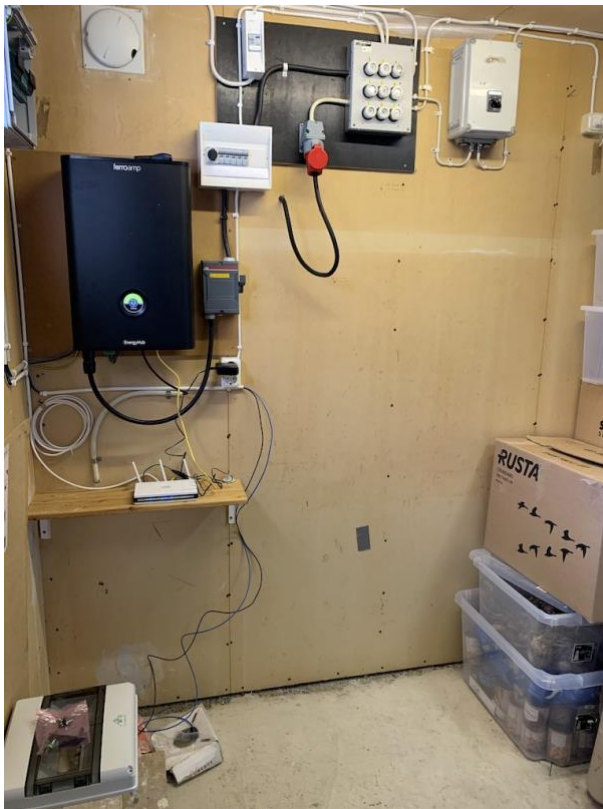
Photo 2. The existing EHub (14kW) has one SSO connected. The emptied space to the right in the picture was prepared for the smaller cabinet. It turned out the space was too small for the taller one that was shipped. It was then decided to install the taller cabinet on the other side of the room.

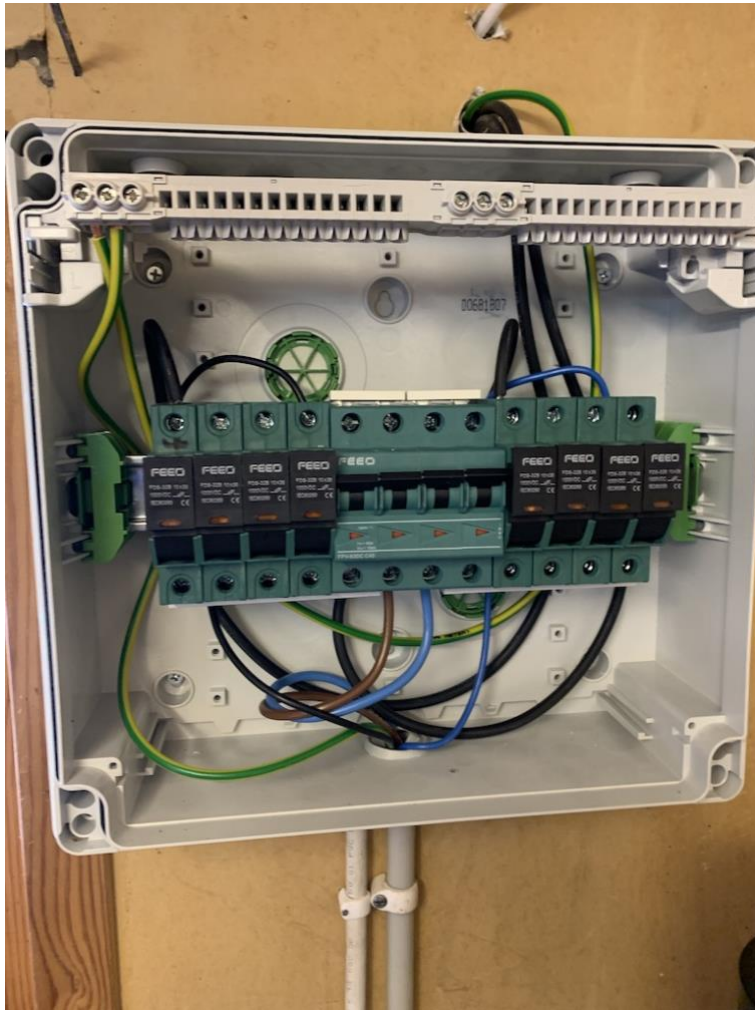
Photo 3. The junction box

The brown and blue cable connected to the MCB are the DC link cable. Divided by the middle line of the MCB, the left-hand side is “DC+” and the right-hand side is “DC-”.

The thinner black and blue cables are the ones prepared for the ESO. The PE cable was forgotten for which the customer has to build one so as to connect to the common PE at the junction box (the bar above the fuse holders).

That said, Liang offered help for much of the installation work, including examining the junction box, part of the mounting, the cable connection etc. **It was decided on site to build a temporary PE cable, as there is no proper grounding cable prepared. Also, the DC link cable had to "fly" from the junction box to the other side of the room (photos below). The temporary PE cable was labeled with yellow tape, just for the purpose to have the system up and running before an electrician can fix everything in a proper way.**

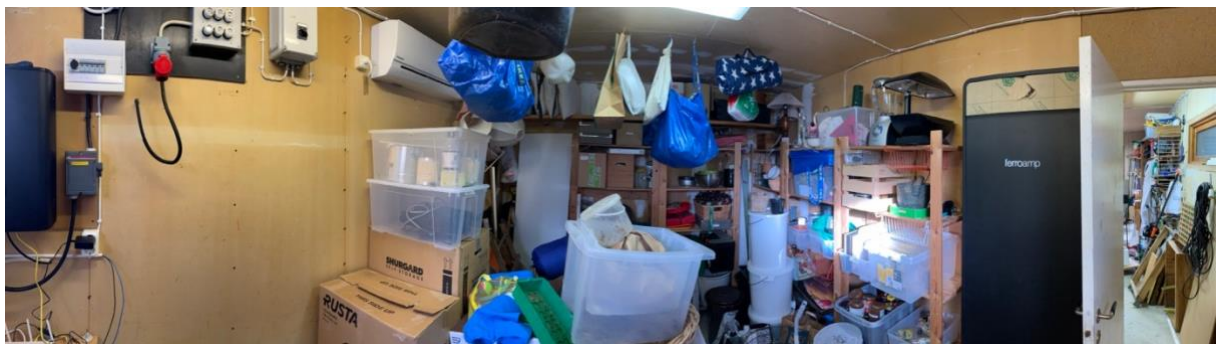
Photo 4. The room

A panorama photo of what inside the room. There is an air conditioner inside.

The customer said he would make sure the room temperature > 8 degree over the winter.

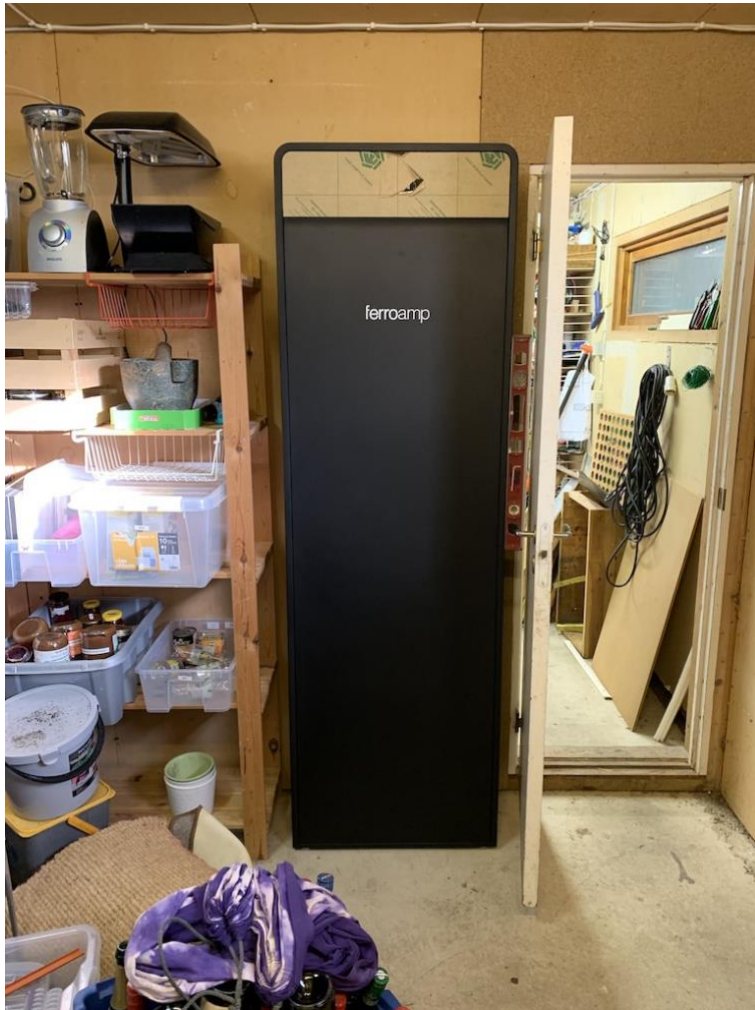
Photo 5. The mounted cabinet

It was only possible to mount the cabinet on the other side of the EHub instead of just next to it. The cabinet was installed exactly the way illustrated in the manual. the battery insertion was done from the righthand side.

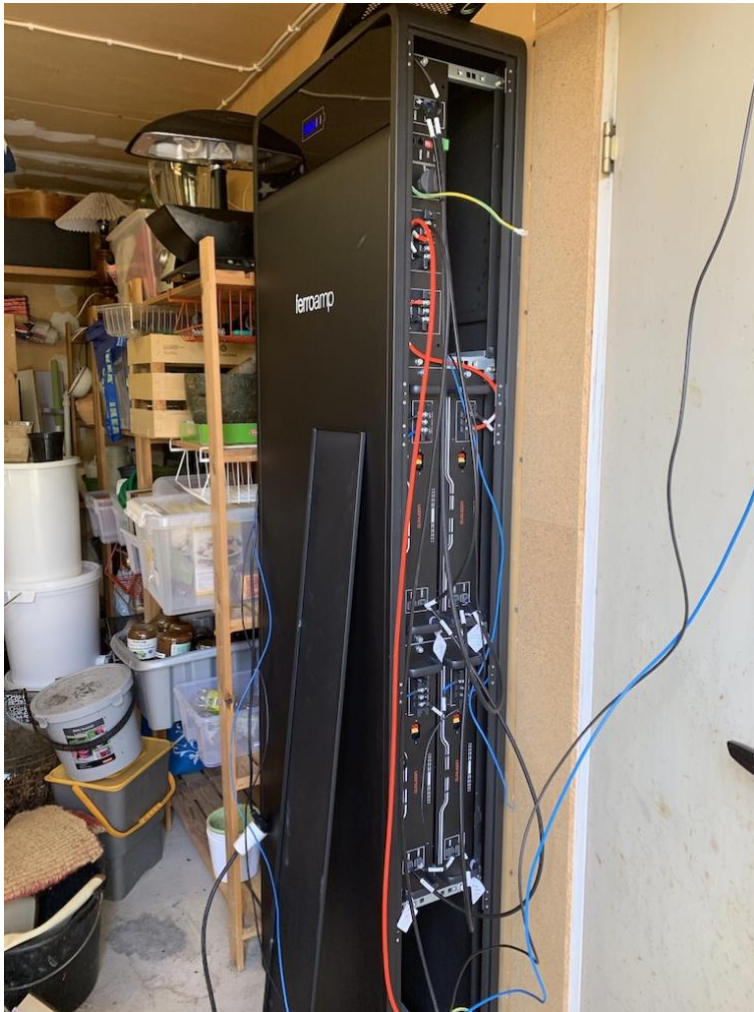
Photo 6. The battery installation

The 10kWh batteries were all inserted into the cabinet while the bottom two slots were left empty. In case of future upgrading, it is easy to upgrade by inserting two extra battery modules from the bottom. Moreover, in the worst case of water damage, the bottom clearance will help preventing the live battery from submerged.

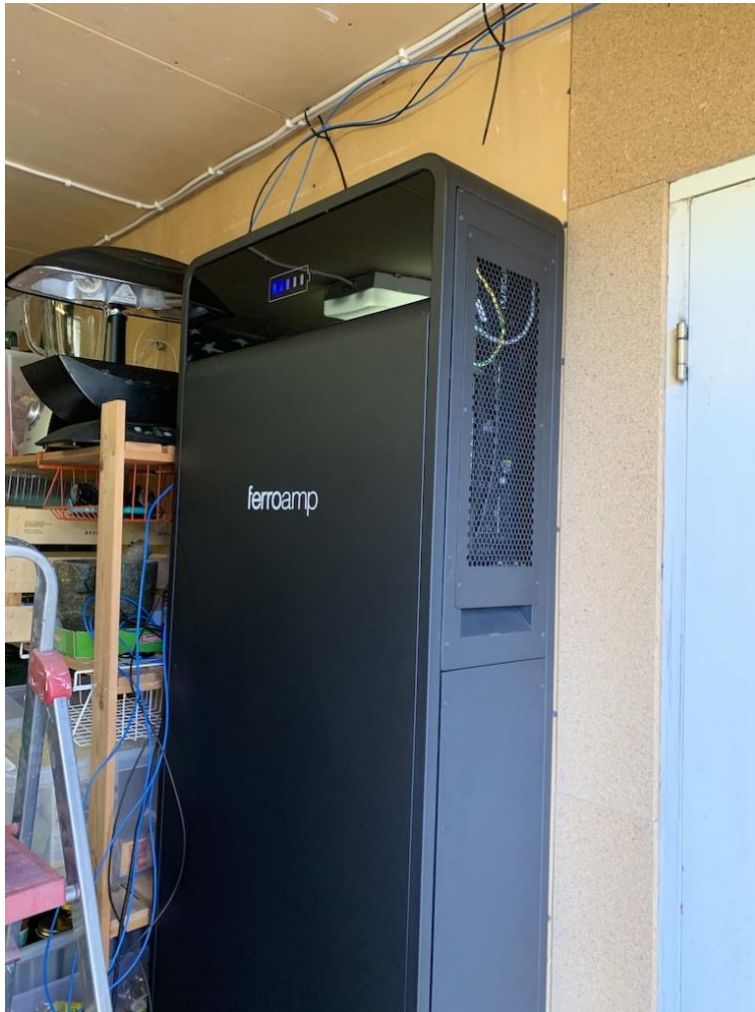
Photo 7. The system up and running

Liang managed to configure the system directly from the ESO.

The battery was recognized from the portal showing correct SOC and rated capacity. By the time Liang leaving the site, the system was set to topping up the battery. The customer was happy to see the system already from the mobile phone.

Liang talked with Anton later in the afternoon about the proper configuration for the customer. The delivery of the whole system was done.

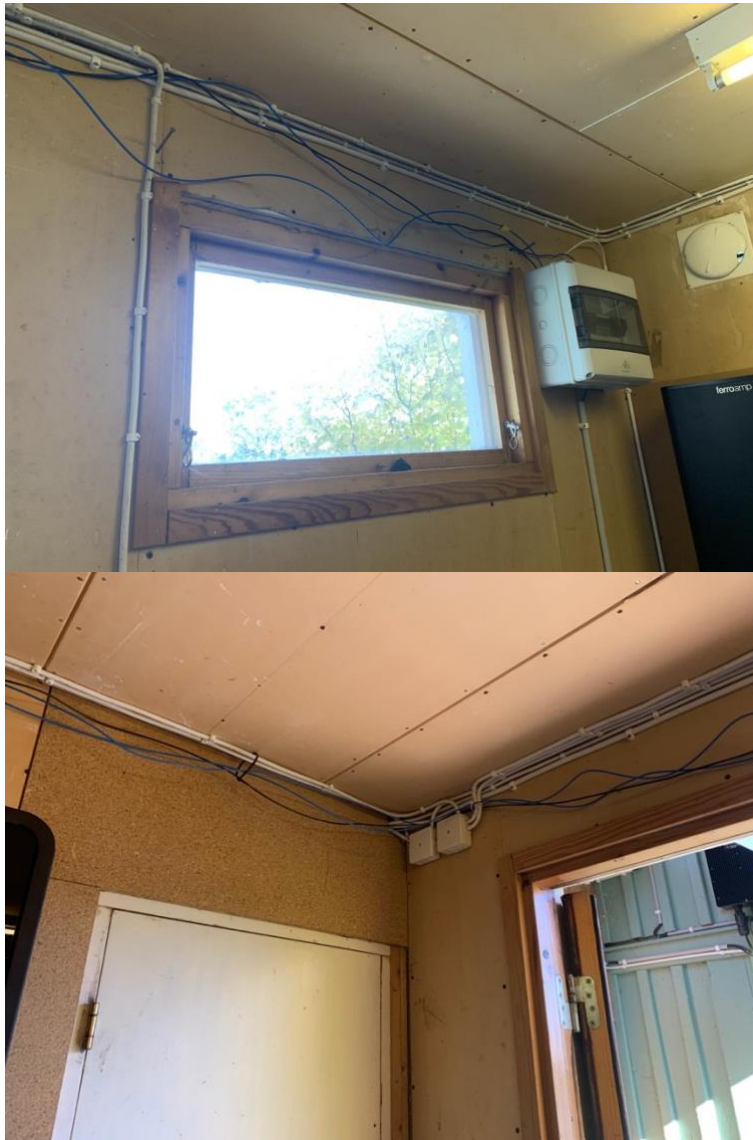
Photo 8-9. The fly cables

As the cabinet was installed on the opposite side of the EHub, “fly cables” were used just to make sure the system was up and running.

In the picture: Black for “DC +”, blue for “DC -”, the other blue with yellow tape is for the PE. This need to be fixed at later stage.

**The customer promised to call in a proper electrician to fix the cable in a proper way.
I suggest that FA service team to call the customer later just to make sure the fix is in place.**

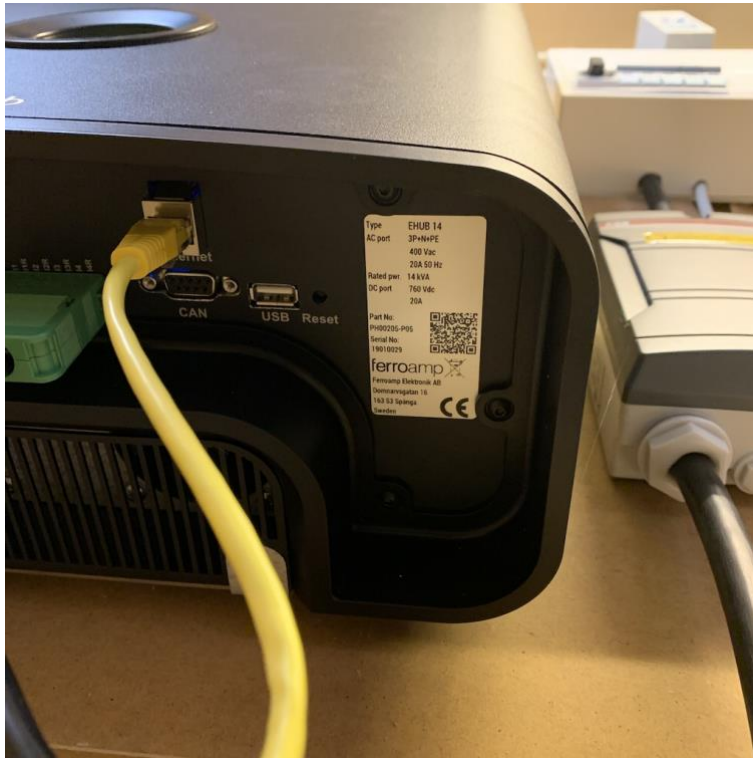
Photo 10. The Ehub

Liang examined the EHub which is in good working condition.

It is worth noting that when opening the MCB where SSO was connected, the LCD panel still shows number indicating PV production instead of displaying “0”.

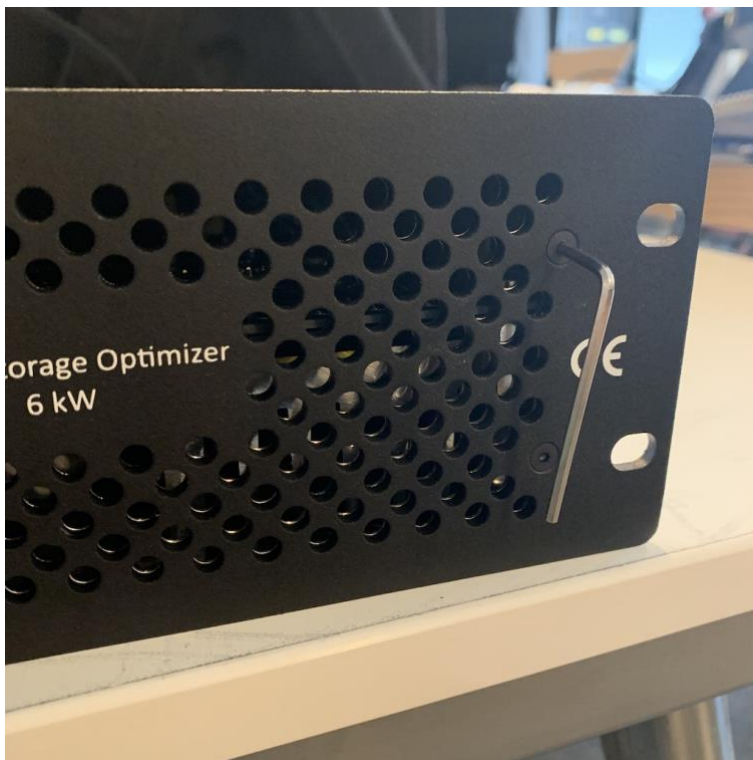
Photo 11. The ESO with front plate

An ideal way for ESO transportation is to ship it with the front plate removed. However, Liang found it not possible to untighten the screw as it was so firmly fastened.

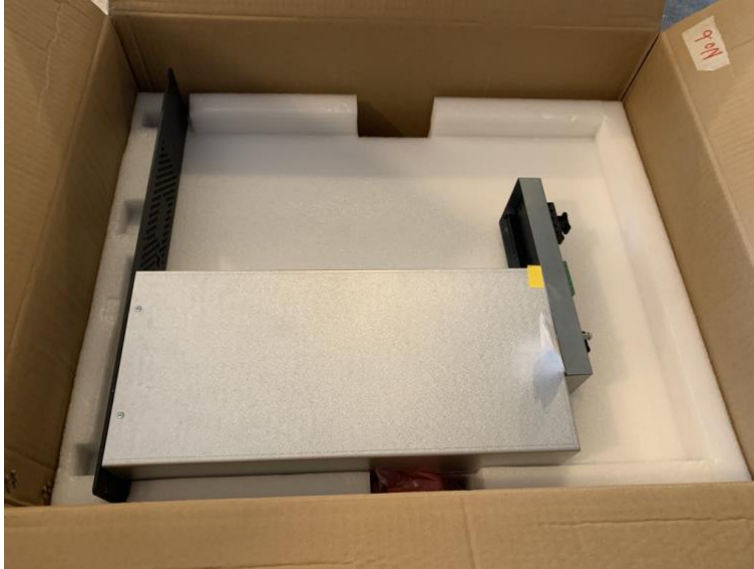
Photo 12. Temporary fix for ESO shipping package

Note that when shipping with only one ESO, the whole assembly is not as sturdy compared to Duo-ESO configuration thus must be handled with care. It is not allowed to lift the assembly by holding only the ESO adopter (only two screws are used between the two).

One SU canton box (the box used for the sample rack at FA showroom) was used to ship the preassembled ESO. The whole assembly fits nicely into the pre-cut protective foam made for the SU battery module.

There can be better packaging solution presumably done by FA.
