# Site Fazenda São Jorge verification 27th November 2024

This document established record for FSVP compliance requirements of our site visit to Coopercabruca facility

- Supplier visited: Coopercabruca
- Supplier 31.948.811/0001-42: 31.948.811/0001-42\_NUMBER
- Site name: Fazenda São Jorge
- Date: 27th November 2024

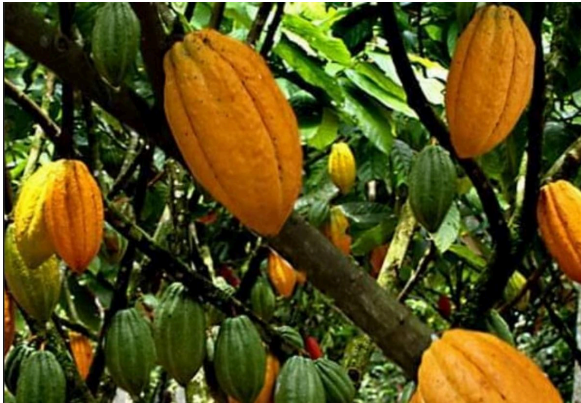
#### **Insect Infestation**

For organic cacao, natural organic insect repellents are used.

When the environment is balance insect infestation is unlikely

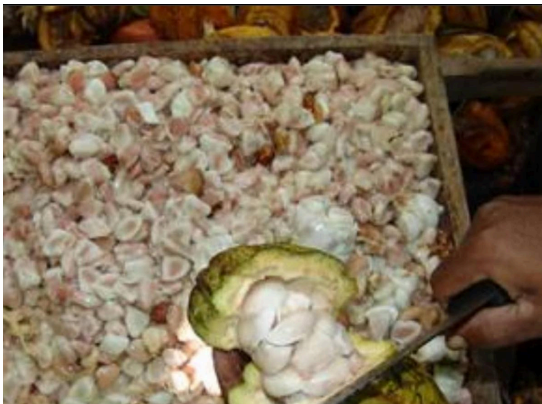
#### **Microbial Contamination (salmonella)**

We only harvest mature and perfect fruit directly from the tree.

We utilize Garra tool to handle the fruit to ensure against broken skin which is a vector for contamination.

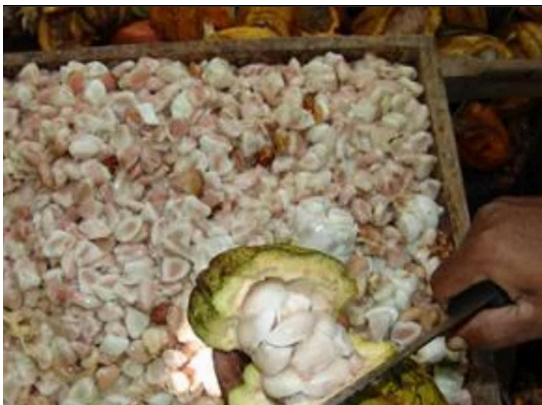
#### **Foreign objects like rocks, dirt, or debris from the field**

When fruits are harvested and broken and the beans are extracted. But the actual removal of this foreign objects are done at the later stage during drying

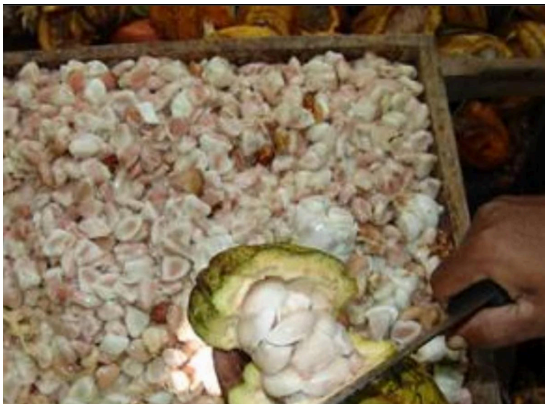
<p><b>Undesirable Fermentation</b></p> <p>There are three traditional organic measures for this</p> <p>Measure 1: Smell test. Ensure there are no traces of putrefy smell</p> <p>Measure 2: Ensure PH is below 6. The batch cannot be too alkaline. 4.8 to 5.8PH is ideal</p> <p>Measure 3: Professional taste test.</p>

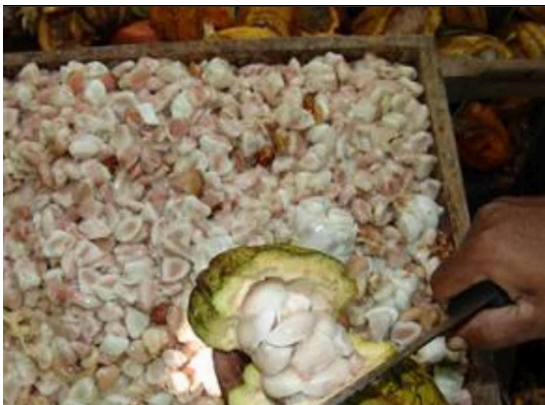
<p><b>Inclusion of non-cacao materials in fermentation containers</b></p> <p>Fermentation is done in a wood box in the house of fermentation.</p> <p>Nothing else is allowed in the house besides the cacao almonds to be fermentation</p>

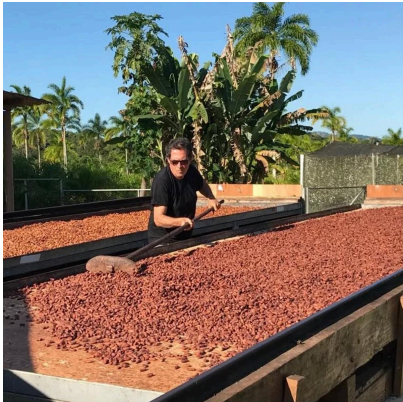
<p><b>Mold growth due to improper drying practices.</b></p> <p>Turnover the beans frequently in the sun which still contain humidity often to ensure against mold.</p> <p>First 2 days: When sample of cacao almonds is squeezed, if there is humidity, there is the liquid dropped</p> <p>Beans will be turned over every 30 minutes in the sun</p> <p>When sample of cacao almonds is hand squeezed, it cracks</p> <p>3rd day: Beans will be turned over every 1 hour in the sun</p> <p>4th to 7th day: 4 to 5 times a day.</p>

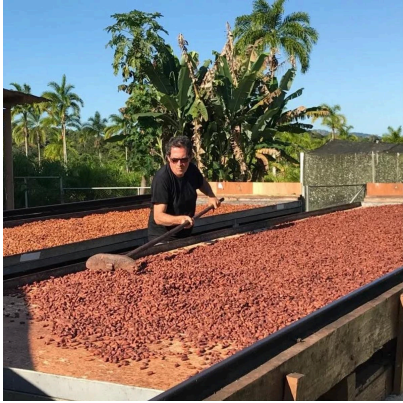
<p><b>Inclusion of foreign objects during drying and sorting process</b></p> <p>Before the dried cacao almonds are collected, they are processed through sieve</p>

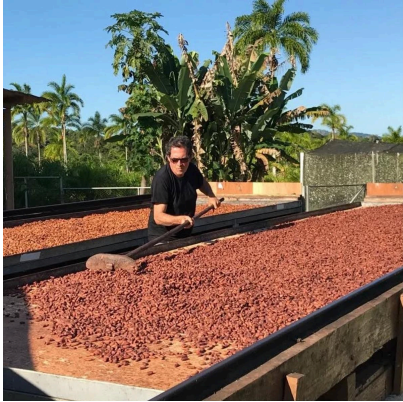
<p><b>Residues from cleaning agents or pesticides</b></p> <p>The facility will be located on the farm which has been organically certified. There will be not pesticide or artificial chemicals on the premise</p>
