# OBSERVATIONS OF TWO SKYLEAD C40 CABLE YARDERS

Patrick D. Forrester

During the summer and fall of 1991 the Forest Engineering Research Institute of Canada (FERIC) observed two Skylead C40 cable yarders, working in the North Okanagan area of British Columbia, for the purpose of determining system costs and productivities. The Skylead is one of a number of cable yarders operating in the Interior of British Columbia to be studied by FERIC.

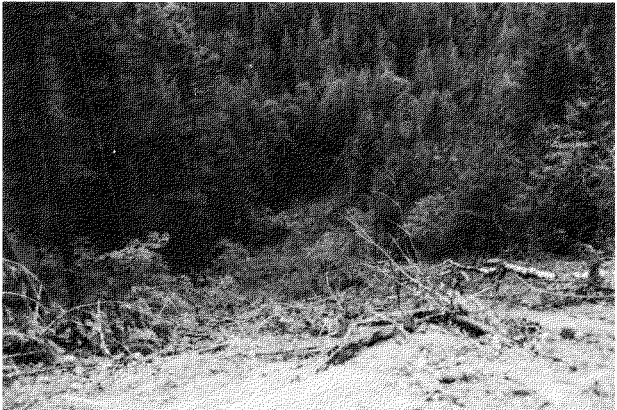
Figure 1. Yarding corridor at Vernon.

ring mostly on the lower slope and flats. Slope distance from the road to the stream averaged 136 m and ranged from 80 to 205 m. Trees were harvested in 20-m wide strips with 40-m wide leave strips to preserve ungulate winter range (Figure 1).

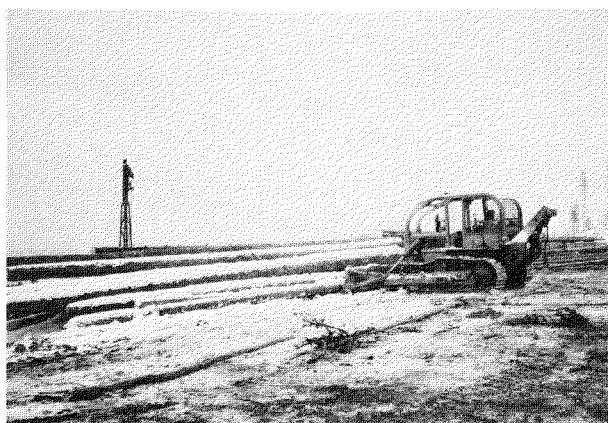
Figure 4. Caterpillar D6 anchor for Skylead yarder, at Lumby.

Changing corridors (Vernon) or roads (Lumby) required the skyline to be lowered, released from the tailhold, and respooled. The carriage was slung and locked on the yarder, the three guylines were released and respooled, and the tower was lowered into a cradle and also locked down. This process was reversed for setup. The landing buckler and skidder operator assisted the yarding crew in pulling the skyline out to the back end. At Lumby, a backspar had to be selected, prepared, and guyed back before the skyline could be raised. When sound guyline stumps were not available the yarder guylines were attached to the blade on a well-anchored tractor (Figure 4).
