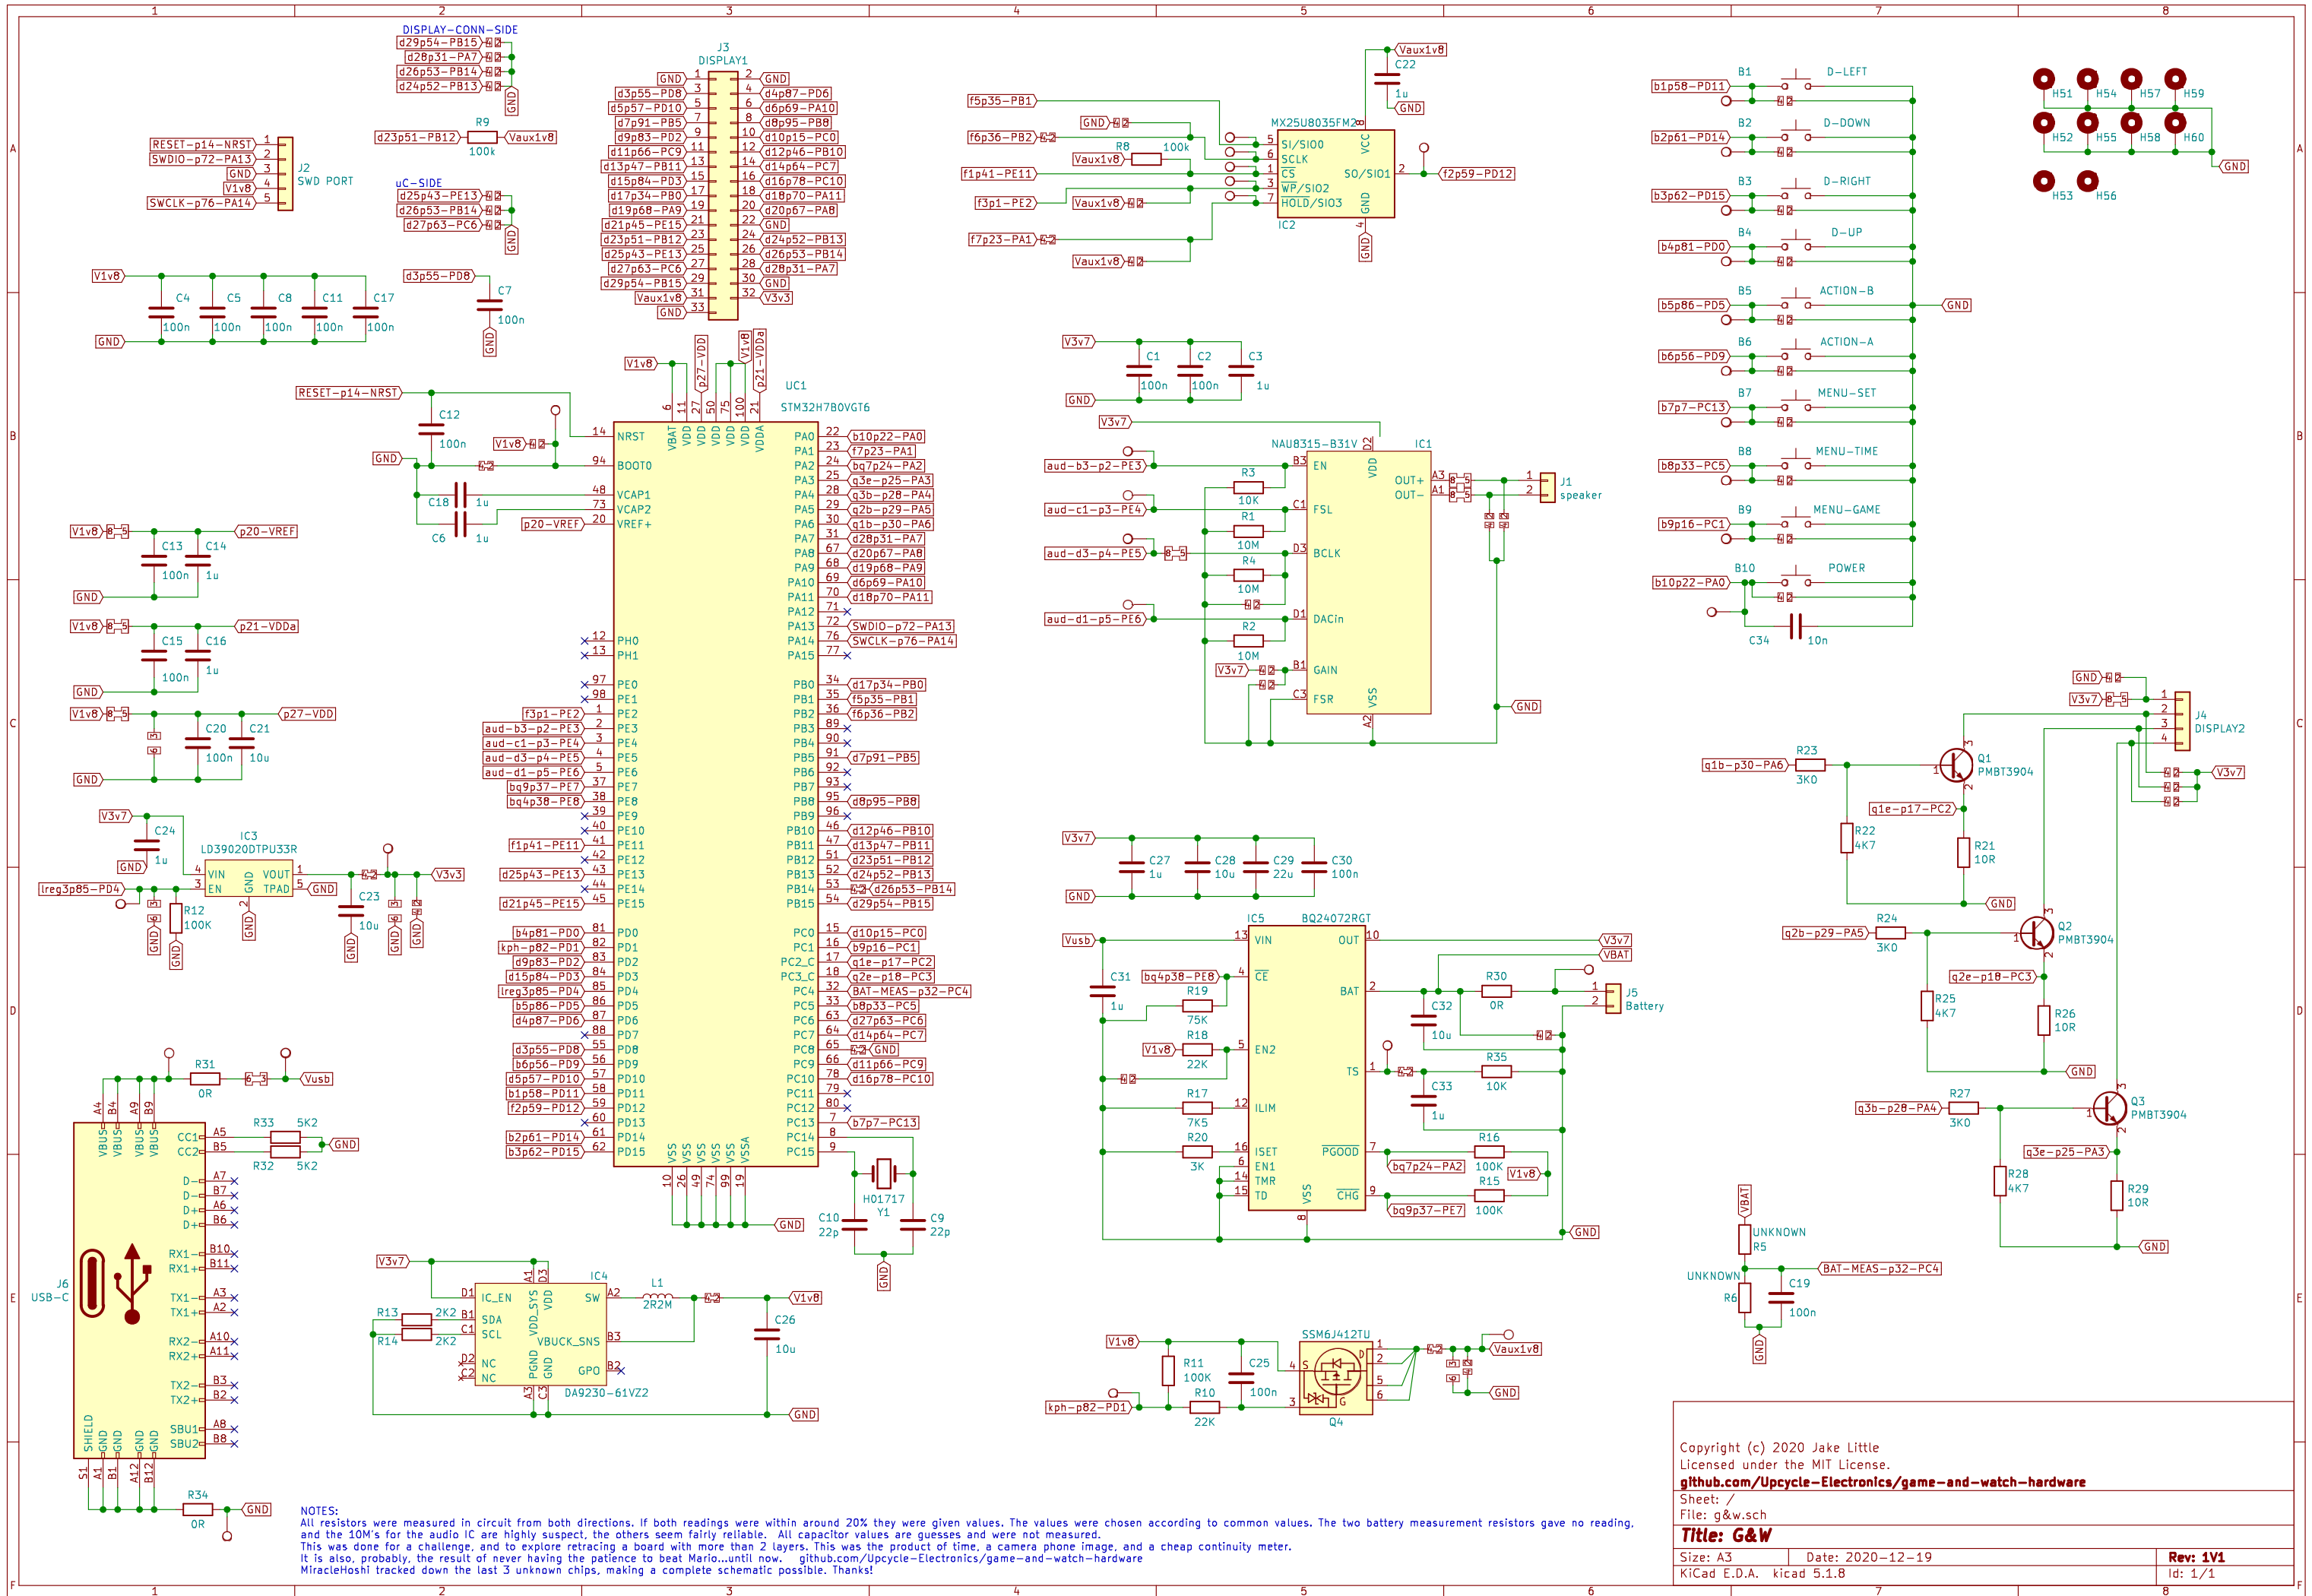
NOTES:
All resistors were measured in circuit from both directions. If both readings were within around 20% they were given values. The values were chosen according to common values. The two battery measurement resistors gave no reading, and the 10M's for the audio IC are highly suspect, the others seem fairly reliable. All capacitor values are guesses and were not measured. This was done for a challenge, and to explore retracing a board with more than 2 layers. This was the product of time, a camera phone image, and a cheap continuity meter. It is also, probably, the result of never having the patience to beat Mario...until now. github.com/Upcycle-Electronics/game-and-watch-hardware
MiracleHoshi tracked down the last 3 unknown chips, making a complete schematic possible. Thanks!
