**ASSESMENT AND MONITORING HORIZONTAL DEFORMATION OF
MFUGALE FLYOVER**

Dissertation

Ardhi University, Dar es Salaam

July, 2023

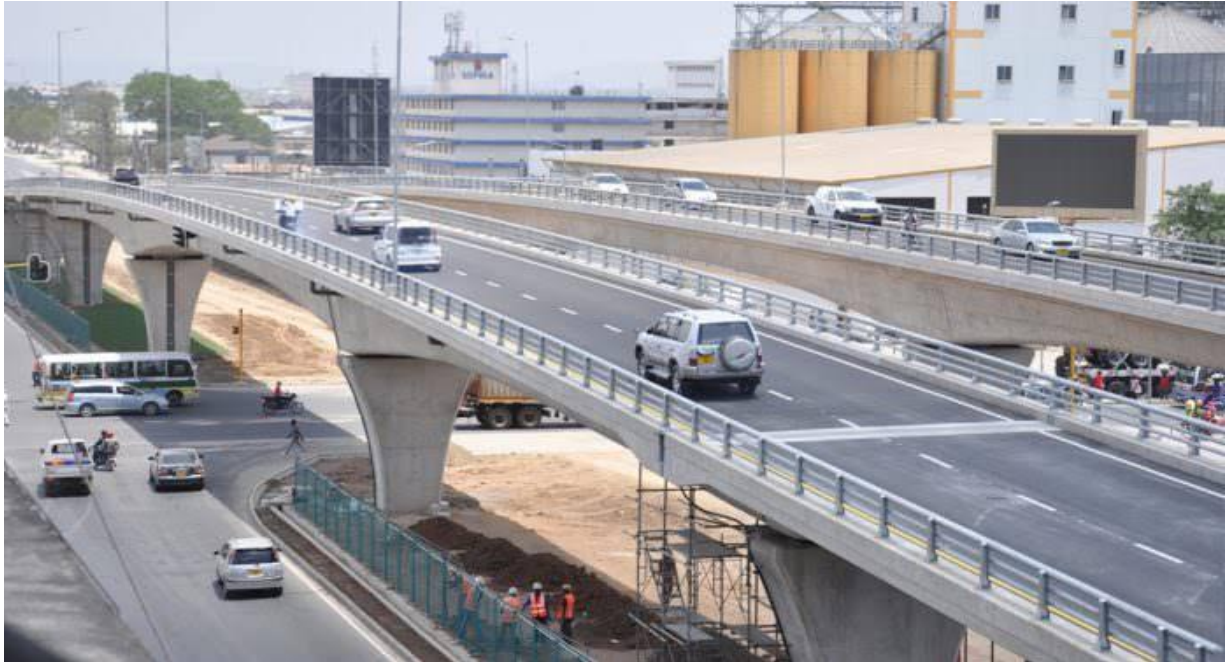
Figure 1.1: Mfugale flyover

The transit time of public buses connecting peripheral areas to the city center has also been significantly reduced. Also, the residents who use the flyover are now spending their time more productively instead of waiting in traffic jams. Due to this merit to the economy this structure is greatly in need to be monitored to protect the national investment. Figure 1.1 shows the Mfugale Flyover.

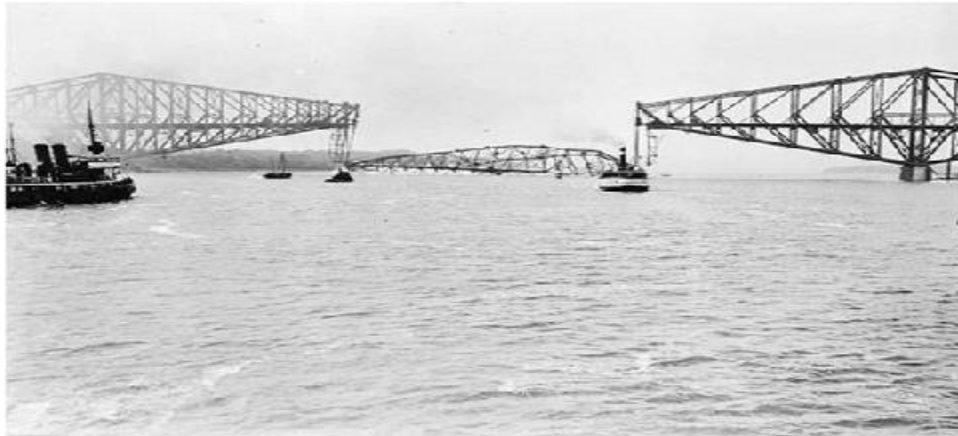
Figure 1.2: Quebec Bridge, Canada

There are many bridges that collapsed in various places in the world and resulted into negative impacts. For example, the Quebec Bridge in Canada collapsed on September 11, 1916 due to a design flaw of the actual weight of the bridge was heavier than its carrying capacity, which caused it to collapse twice, first in 1907 and second time in 1916 resulting into 95 deaths from both tragedies (Pearson & Delatte, 2006). Figure 1.2 shows the Quebec bridge in Canada after it collapsed.

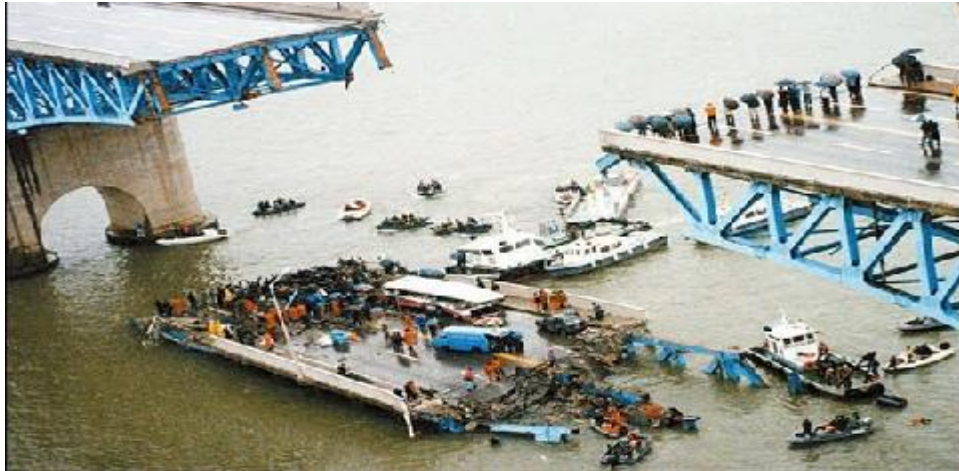
Figure 1.3: Seongsu Bridge, South Korea

On October 21, 1994 the Seongsu Bridge in South Korea collapsed. The structural failure was caused by improper welding of the steel trusses of the suspension structure beneath the concrete slab roadway being among internal properties of the structure. In this case about 32 people died and about 17 people were injured (Kim, 1997). Figure 1.3 shows the Seongsu bridge after it collapsed.

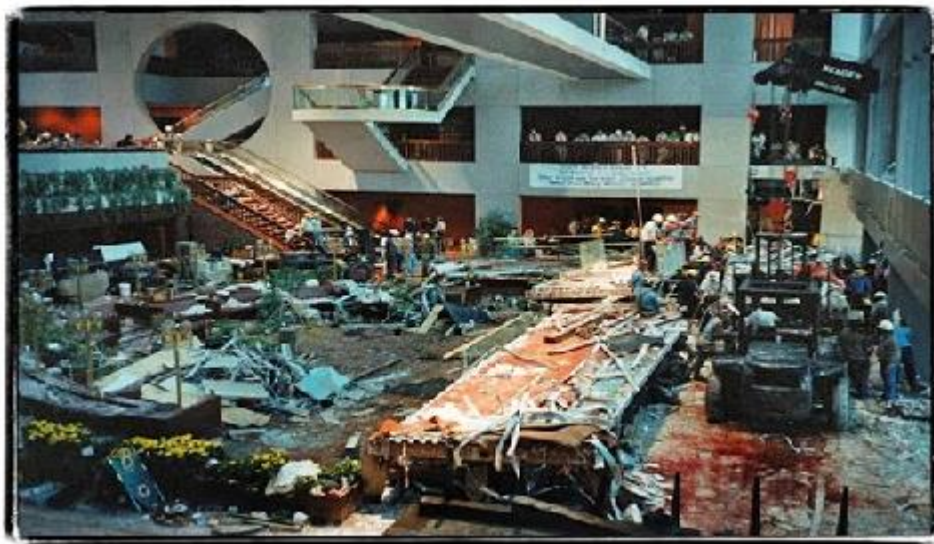
Figure 1.4: Hyatt Regency Skywalks, Kansas City

On July 17, 1981 the Hyatt Regency Skywalks, Kansas City two suspended walkways were crowded with some people who were dancing. Architects theorized after the collapse that vibrations by the dancers might have contributed to the structural breakdown, as did the sheer weight of the crowd, there were 114 deaths (Turner, J.A & Johnson , D.R., 1985). Figure 1.4 shows the Hyatt Skywalks in Kansas City after it collapsed.

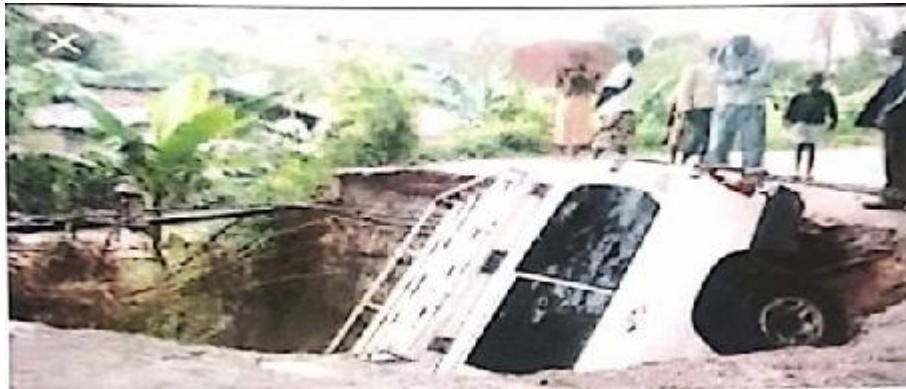
Figure 1.5: Bridge at Mbezi Makonde in Dar es Salaam

There has been different contributor of bridge collapse in Tanzania and the main contributors being tidal phenomena, tectonic phenomena, earthquake, changes of ground water level, landslides, compressible and collapsible soils, swelling and shrinkage of clay soils and other factors being flooding and heavy trucks. For example, in Dar es Salaam along the Bagamoyo road the bridge joining Mbezi and Makonde area collapsed due to heavy rainfall on 26th October, 2017. This resulted into massive destruction of properties in the area although they were no people who died or injured in the incident (Mwalongo, 2012) as shown in Figure 1.5 below.

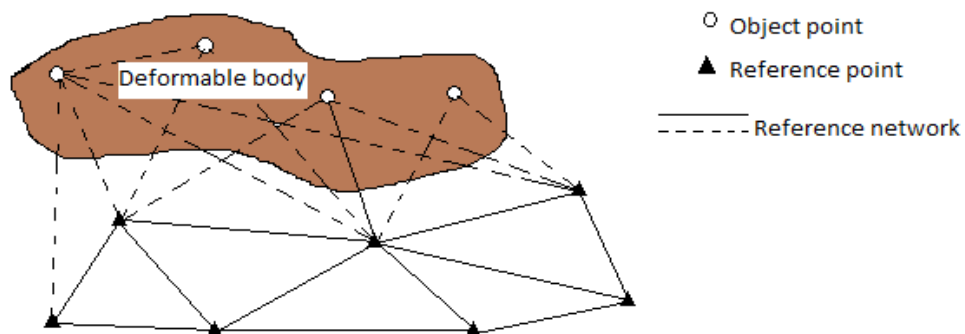
Figure 2.1: Absolute Monitoring Network

This is a monitoring network in which some control points are installed inside the deformable body or object and others are reference installed outside the deformable body as shown in Figure 2.1. The general procedure to monitor deformation of structures and its foundation involves measuring of the spatial displacement of the selected object points (i.e monitoring points) from external reference points that are fixed in positions. Both terrestrial and satellite method are used to measure these geospatial displacements. Subsequent periodic observations are then made relative to these reference points (US Army Corps of Engineers, 2018)

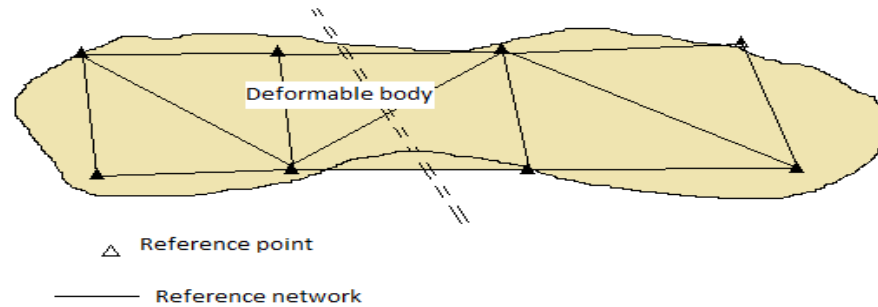
Figure 2.2: Relative monitoring network

In relative networks, all the survey points are assumed to be located on the deformable body, the purpose in this case is to identify the deformation model, i.e., to distinguish, on the basis of repeated geodetic observations, between the deformations caused by the extension and shearing strains, by the relative rigid body displacements, and by the single point displacements. When the reference points are located in the structure, only relative deformation is determined, method used is to freeze the mean deformation for instance, micrometer joint measurements are relative observation (US Army Corps of Engineers, 2018). Figure 2.2 below shows the relative monitoring network.

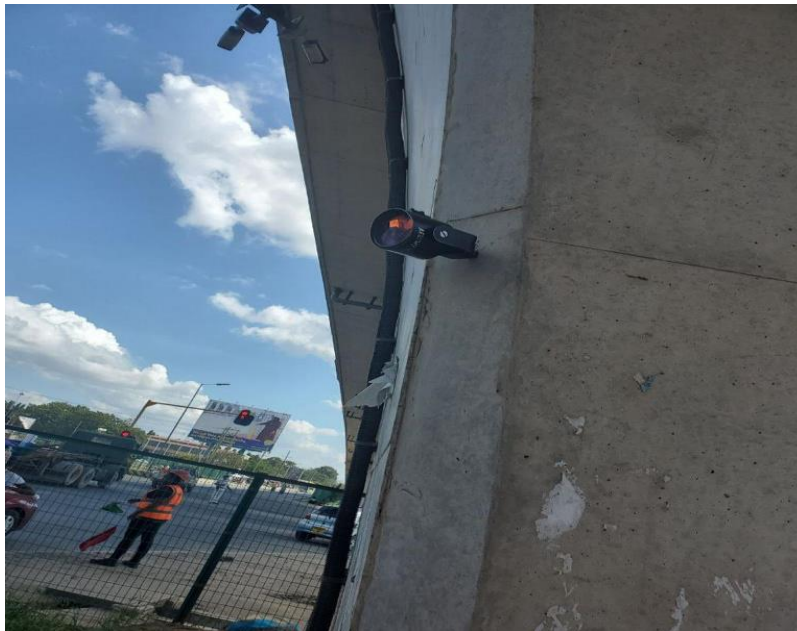
Figure 3.1: Object point installed on the column of the bridge

For the case of site reconnaissance, the study examined the existing control points if they are still in-situ and that they can still be used for the study intended. Furthermore, the site reconnaissance examined the nature of the site and help to plan and schedule field activities at the Mfugale Bridge. Figure 3.1 below shows one of the object points installed on the column of the bridge.

This is the most important aspect of any survey, which must be undertaken before field work commences. It involved both office and field reconnaissance. In the case of office reconnaissance, data from previous study for deformation of Mfugale Flyover were obtained from previous studies. Adjusted coordinates were obtained which includes 2D positions of the monitoring points TZR1, TZR2, TZR3 and TZR4 as the reference points located away from the bridge and the object points TR1, TR2, TR3, TR4, TR5, TR6, TR7 and TR8 located on the columns of the bridge.

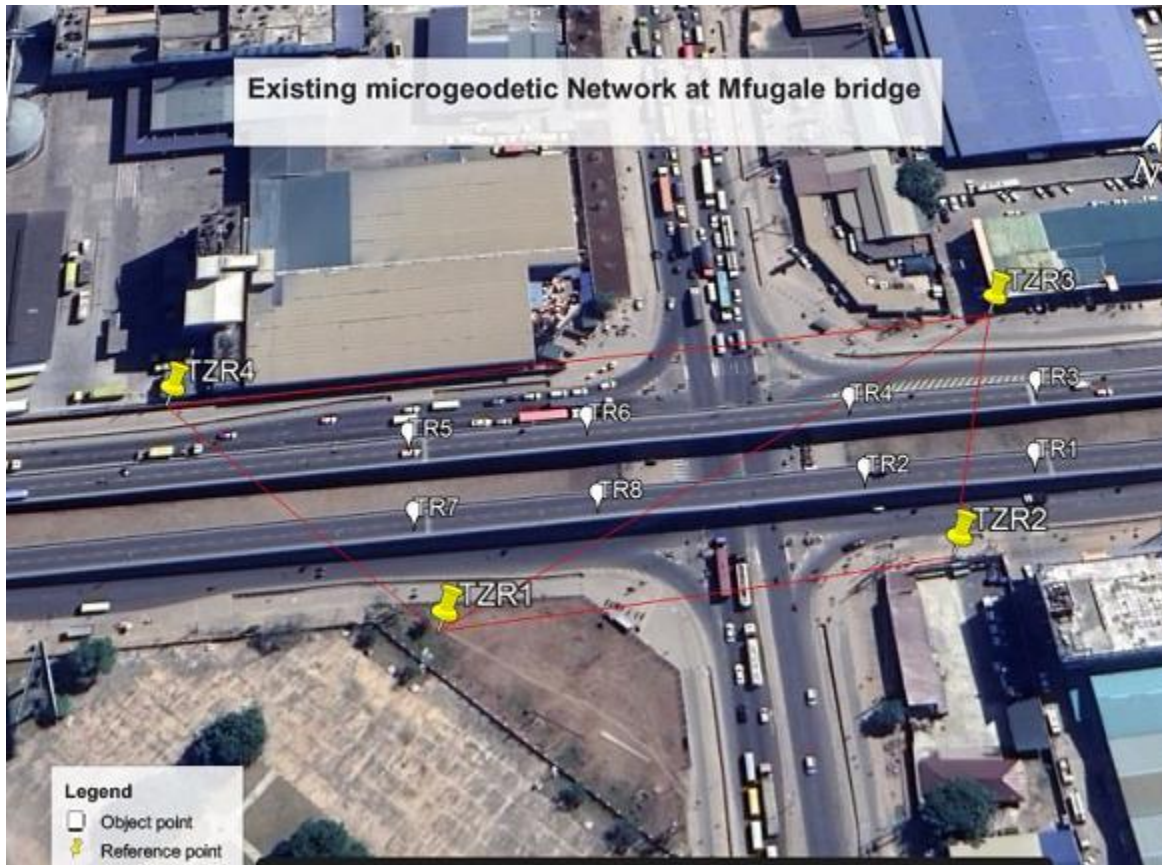
Figure 3.2: Existing micro-geodetic network at Mfugale Bridge

This study applied absolute network at Mfugale bridge due to its scale and capability of identifying the object points and reference points. The observation was based on the network which was designed from the previous study such that one reference point is inter-visible to at least four object points. This network consists of four reference station and eight object points as shown in Figure 3.2 below.

During reconnaissance, the coordinates of the reference points as well as the object points were obtained from the previous study. This study re-observed these object points TR1, TR2, TR3, TR4, TR5, TR6, TR7 and TR8 while basing on the reference points TZR1, TZR2, TZR3 and TZR4. Table 3.5 shows the third epoch tacheometry data for measured object points.

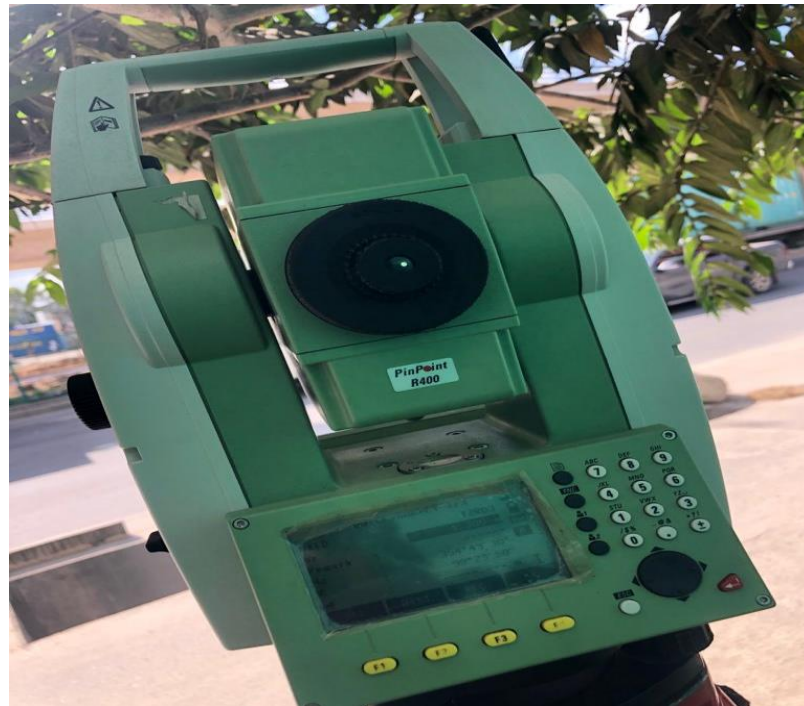
Figure 3.3: Leica Total Station TS 09

In this study the instruments used include Leica total station TS09 (Figure 3.3), steel tape, tripod stands, reflectors and kin pole stands. The main instrument used was the total station. It is an instrument that combines the angle measurements that could be obtained with a traditional theodolite with electronic distance measurement. Taping distance, with all its associated problems, has been rendered for all baseline measurement. Distance can now be measured easily, quickly and with greater accuracy, regardless of terrain conditions.

From the instrument specification,

Therefore, the expected standard deviation in determining 3D position using total station TS09, is 2mm.

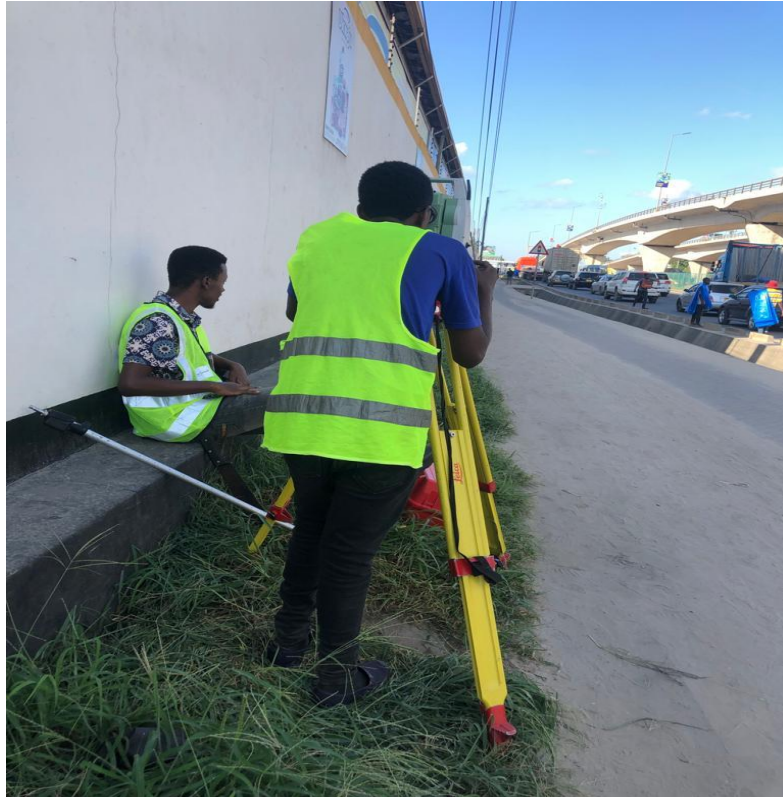
Figure 3.4: Tacheometry observation at the bridge column

- Initially a total station is set at TZR2 oriented to TZR3 and performed a datum check, then two points on the bridge which are TR1 and TR2 were coordinated.
- Then the total station was again set at TZR3 oriented to TZR2 and performed a datum check, then two points on the bridge which are TR3 and TR4 were also coordinated.
- Also, the total station was set at TZR4 oriented TZR1 and datum check was performed, then two points on the bridge which are TR4 and TR6 were also coordinated.
- Lastly the total station was set at TZR1 oriented TZR4 and performed a datum check, then two points on bridge TR7 and TR8 were coordinated.
- In all setups it was assured that all circular bubbles were well leveled both circular bubble in the target and circular bubble in the total station machine.

- All points on the bridge were designed to hold Leica prisms.
