Inspection Date:
Saturday, August 16, 2025

Report Number:
081625AD1

18559 Denise Dale Ln, Houston, TX 77084

PROPERTY INSPECTION REPORT FORM

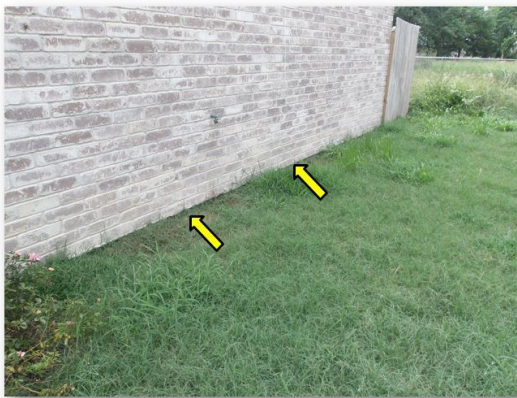
Soil level too high, in contact with siding and/or at/above brick weep holes at one or more locations around the house/garage. Promotes wood rot and is considered a conducive condition to termite activity.

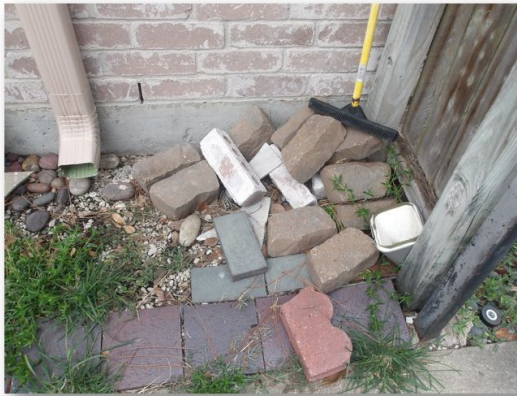
Bricks, stone, wood, debris, etc. should not be stored near the house or garage, can hide evidence of wood-destroying insect activity, recommend relocating away from the house/garage.

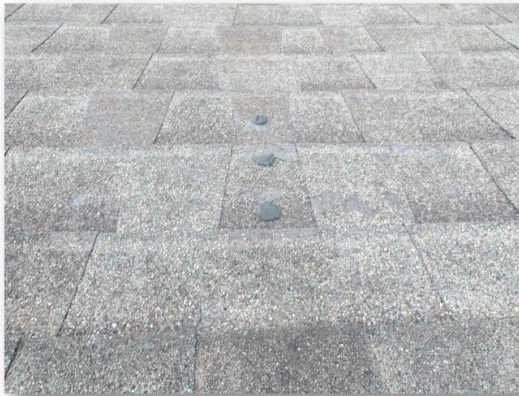
Older roof. Observed curled ends, and/or excessive granular loss of shingles.

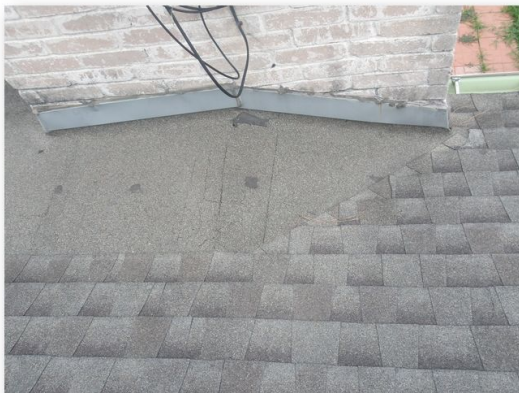
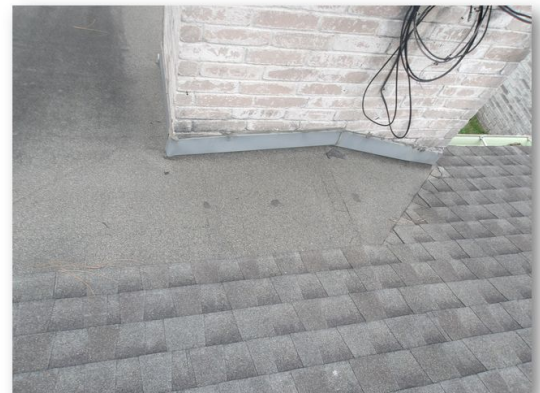
The roof changes from shingles to a rolled roofing material near the chimney, which is common for low-slope areas. These transitions are more prone to leaks and should be monitored. Some sealant is present at the chimney flashing, which may only be a temporary fix. Recommend monitoring during the heavy rain.

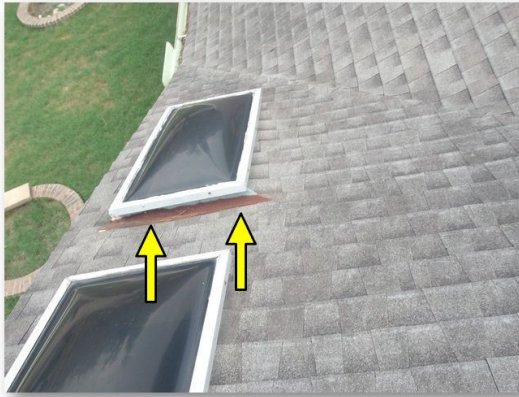
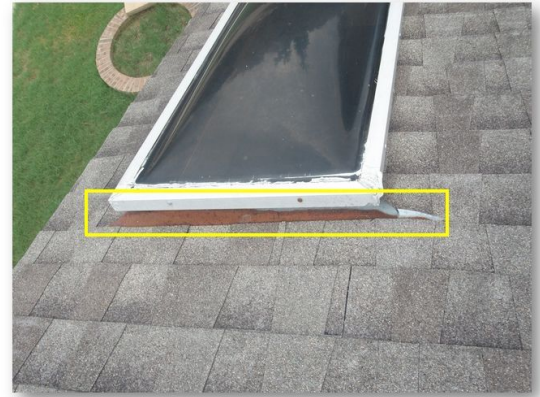
Rusted flashing observed around the skylights.

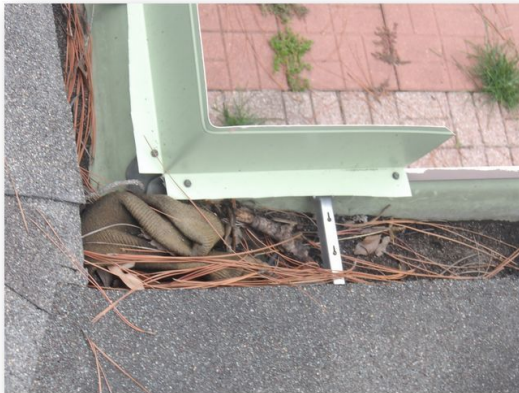
Full of debris; cleaning recommended.

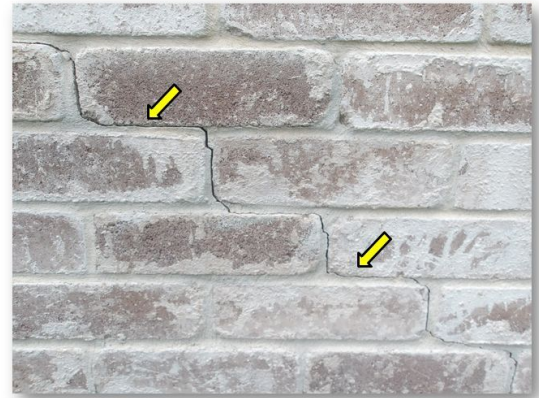
Caulking missing and/or deficient around windows / vertical trim / joints in siding. May allow wind driven rain entry.

Observed cracks in exterior wall structure at time of inspection. Cracks occur from expansion and contraction of building materials, brick ties that have come loose from rust, settlement of foundation, defects in brick veneer or foundation cracking. Hairline cracks or a common occurrence usually seen in mortar joints. Cracks that appear through brick veneer walls that are 1/8" in width could be a sign that the foundation movement is beyond normal settlement.

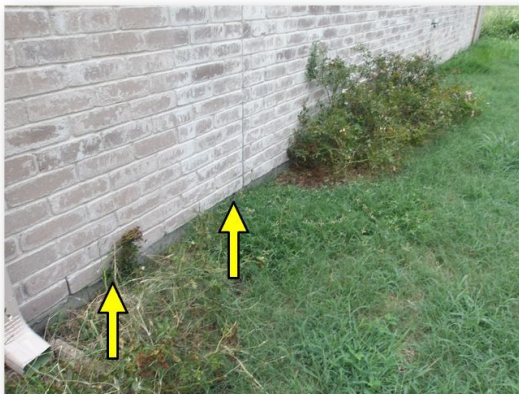
Foundation brick ledge does not meet flush with brick veneer around all areas of the house, some areas where foundation extends past brick veneer and some areas where brick veneer extends past foundation.

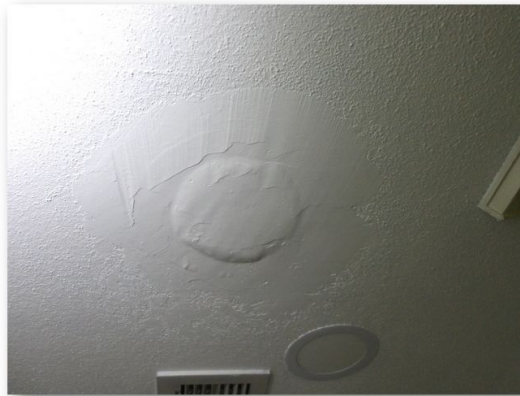
Observed cracks and/or repaired cracks in sheetrock observed in ceiling at one or more areas of house.

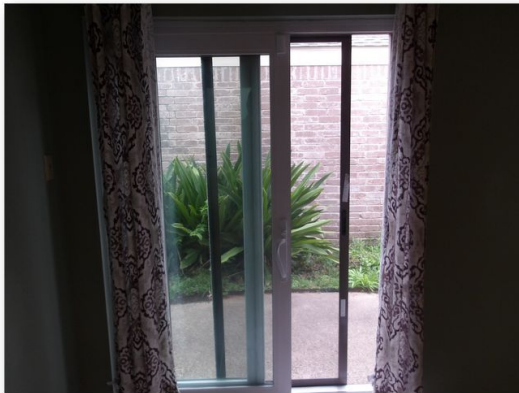
Sliding door was very difficult to operate; Master bedroom back door.

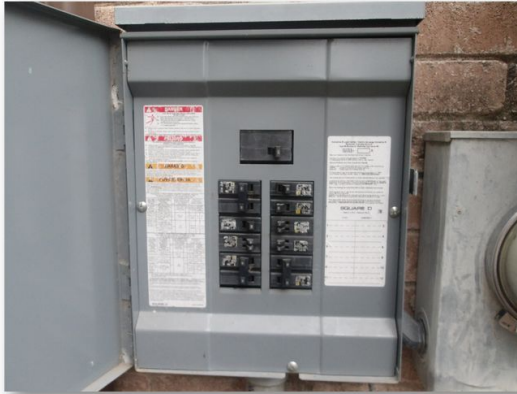
125 AMPs ELECTRICAL SERVICE PANEL LOCATED AT BACK EXTERIOR.

One or more breaker(s) were off at the time of inspection. Possible related to the solar panel electrical box. Inspector does not turn on breakers found in off position due to potential short/electrical problem, recommend inquiring seller regarding information regarding any/all breaker(s) found in the off position.

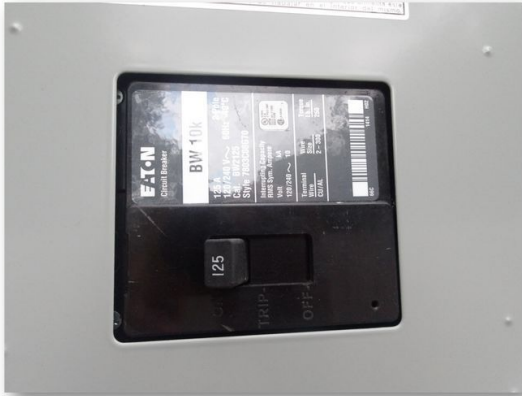
125 AMPs ELECTRICAL SOLAR PANEL LOCATED AT BACK EXTERIOR.

Unable to fully do inspection due to the partially of this panel came from solar system.
Recommend to have qualified professional check.

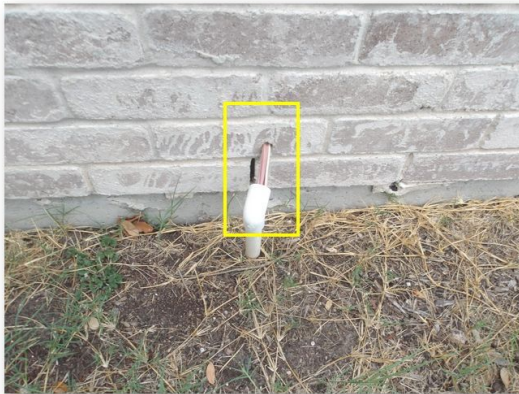
The electrical line supplying sprinkler system outside is not fully enclosed in a protective conduit.

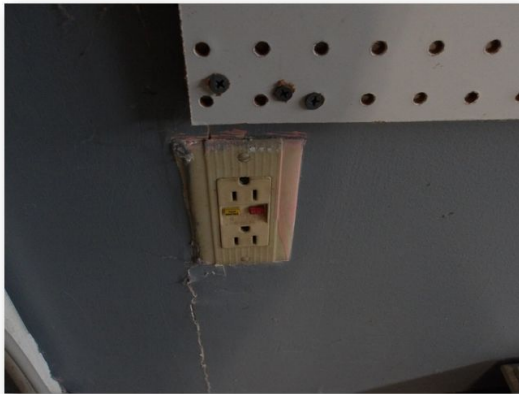
☞ All exterior outlets whether in use or not are required to have in use weather proof cover per September 1st 2014 NEC Code Change.

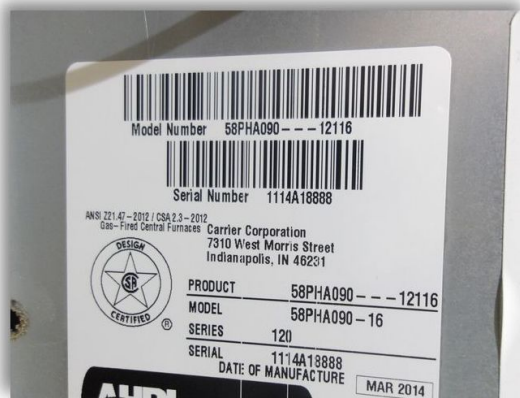
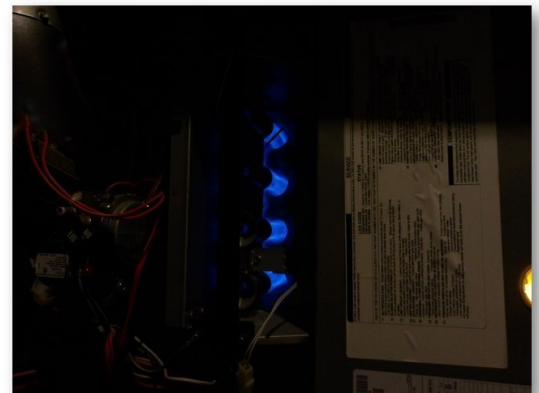
HEATING UNIT:

Age: 2014

No significant deficiencies or anomalies observed at the time of inspection.

Typical life expectancy: between 15 - 25 years as reported by Nachi [Click here for more information](#)

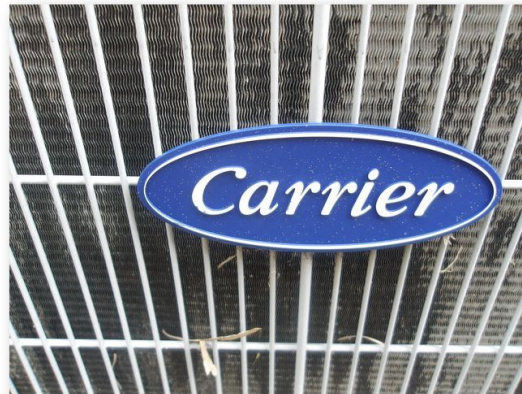
Coils are dirty, needs cleaning. Dirty coils reduce airflow through the system and create high head pressures at the compressor, thereby unduly stressing and reducing the life span of system components.

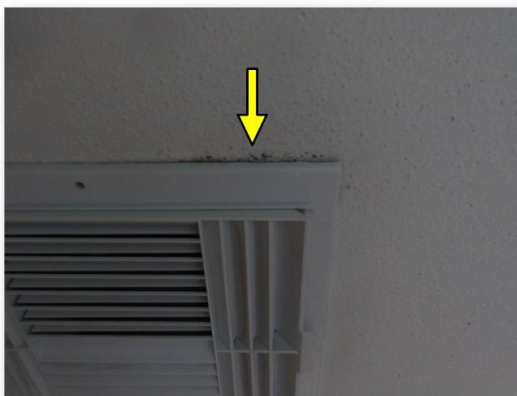
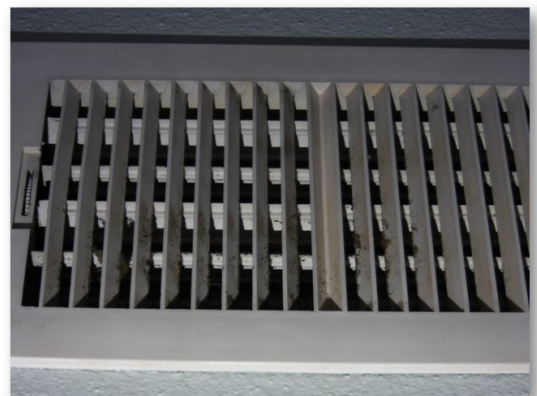
The HVAC ductwork appears to be older duct work. During the inspection, some registers showed visible dirt and possible microbial growth, indicating a buildup of debris within the system. While no major damage was noted, aging ductwork can develop air leaks, insulation breakdown, and reduced efficiency over time. Recommended to have the ductwork professionally cleaned to address the observed debris and potential microbial contaminants. In addition, a licensed HVAC contractor should evaluate the overall condition of the duct system to determine if any sealing, repairs, or full replacement is needed to improve air quality and system performance.

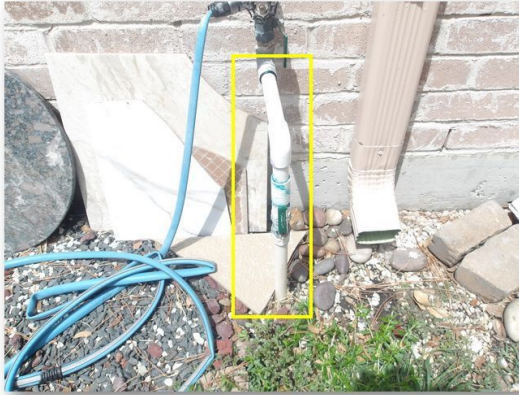
Recommend insulating exterior water line(s) to prevent freeze damage.

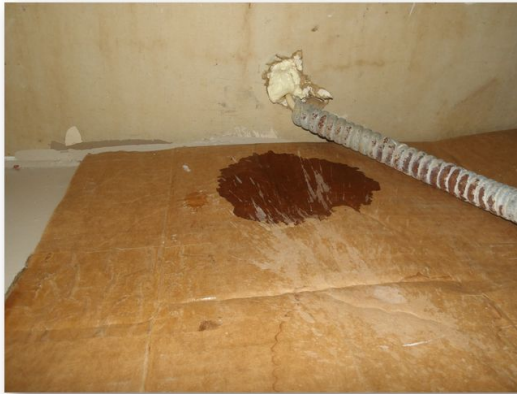
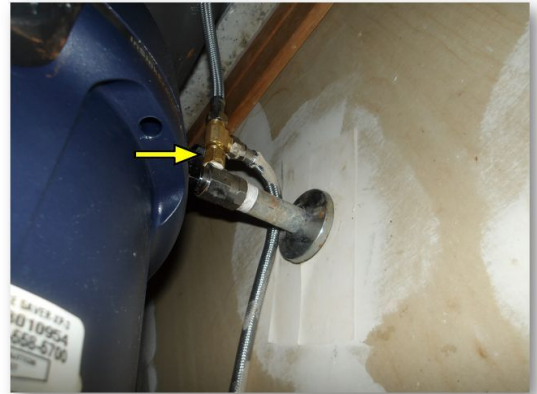
Water leak from shut-off valve below sink; including, but not limited to the kitchen sink.

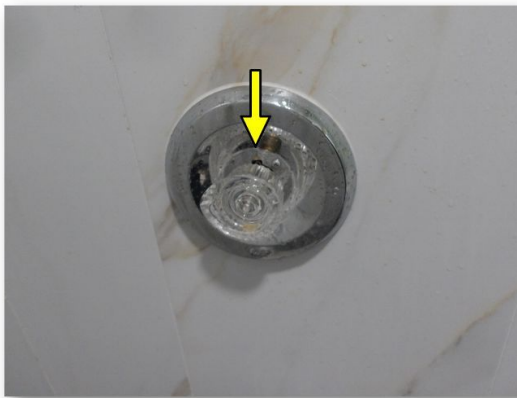
Faucet stop broken, [turns 360°]; needs repair/replacement; both shower faucet.

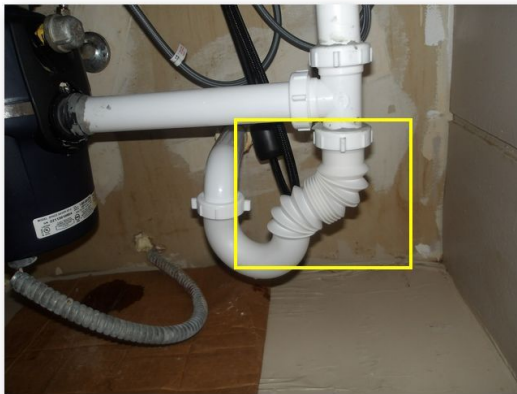
Amateurish plumbing observed; including, but not limited to the below kitchen sink.

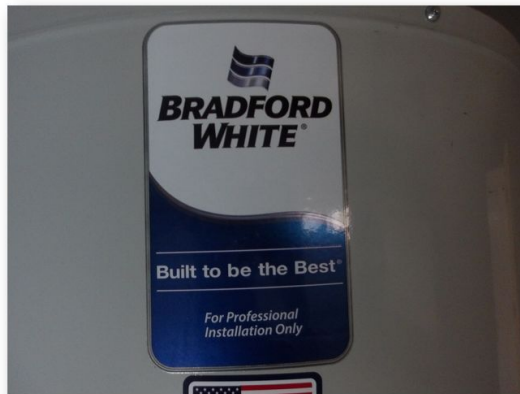
Located on the house/garage slab without the benefit of a drain pan and rain line. Should water heater leak interior flooring/wall can be damaged.

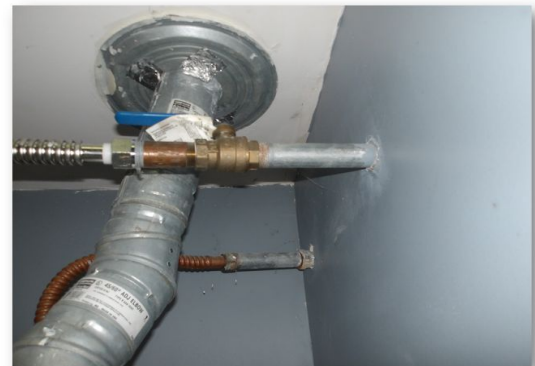
Gas and hot/cold water lines are not properly bonded near the water heater. This does not comply with the most recent electrical code.

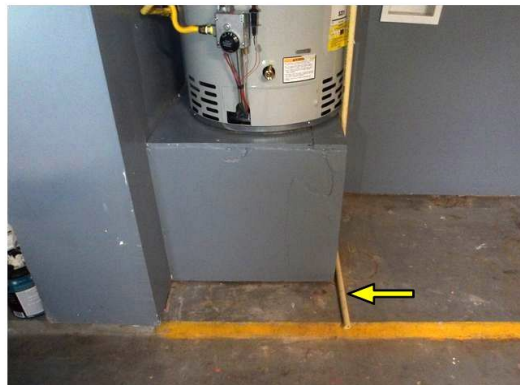
The drain line is improperly routed. Should not discharge into the garage. When the valve is tripped can be difficult to reach out and/or could be very hot water.

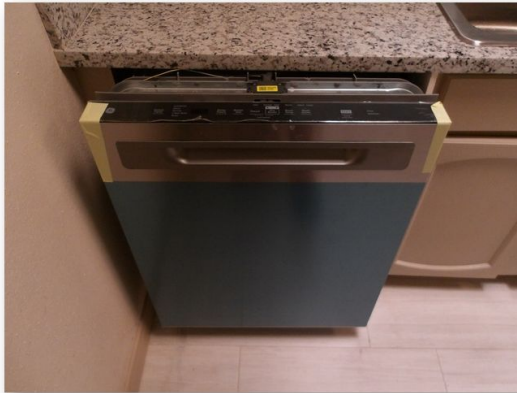
Did not connected, unit was not fully installed. No power as well as no insulation between cabinet and at the top of the unit.

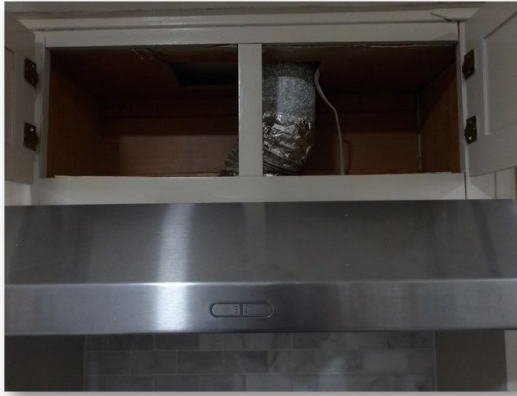
The unit was not operational, not performing its intended function, in need of repair/replacement.

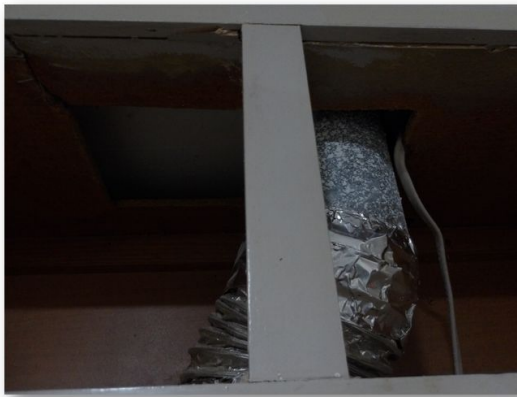
Improper vent duct material used; Current industry standards requires smooth interior single-wall duct constructed of galvanized steel, stainless steel or copper. The duct serving the hood shall have a smooth interior surface. Per IRC 1503.1.

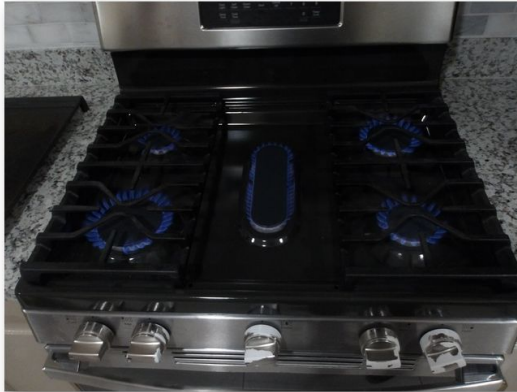
No significant deficiencies or anomalies observed at the time of inspection.

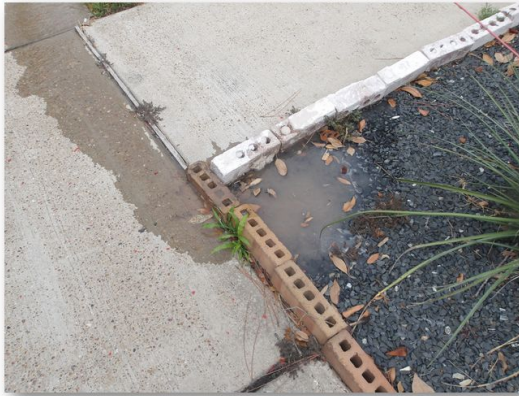
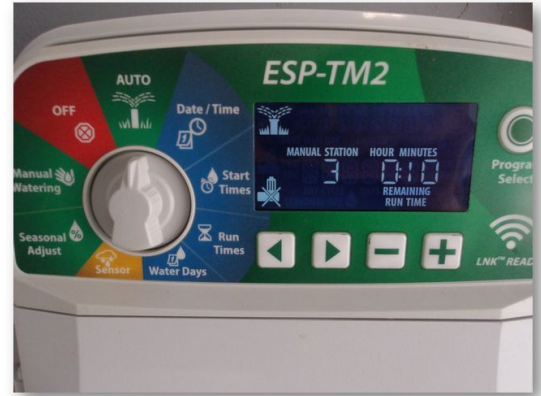
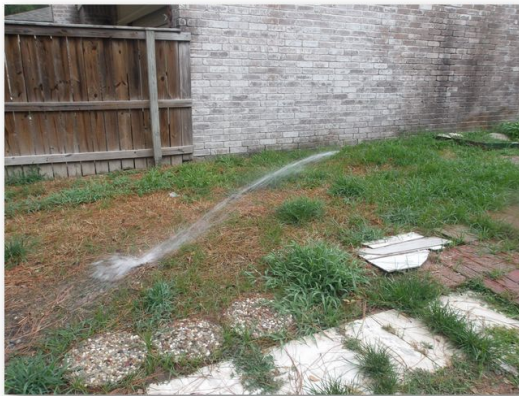
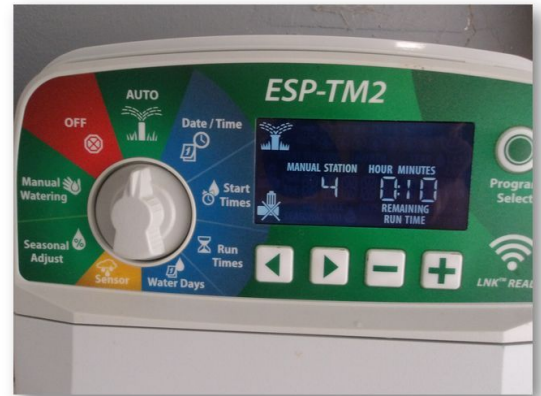
Damaged water line, water gusher in the yard; Station(s) #3 & #4
