**Report Number:**  
20250829-0119122 Pink Grapefruit St

**19122 Pink Grapefruit St, Manvel, TX 77578**

# PROPERTY INSPECTION REPORT FORM

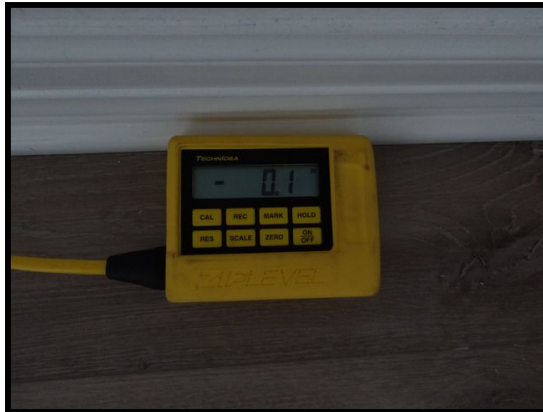
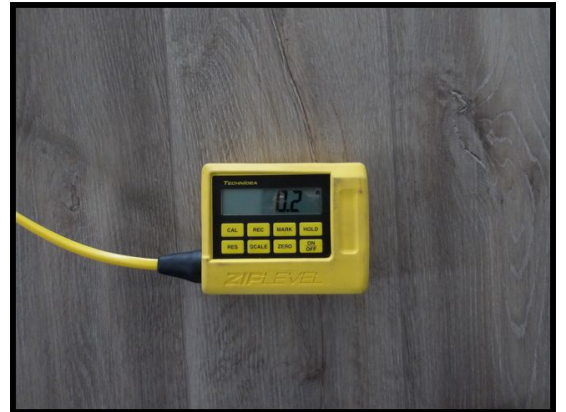
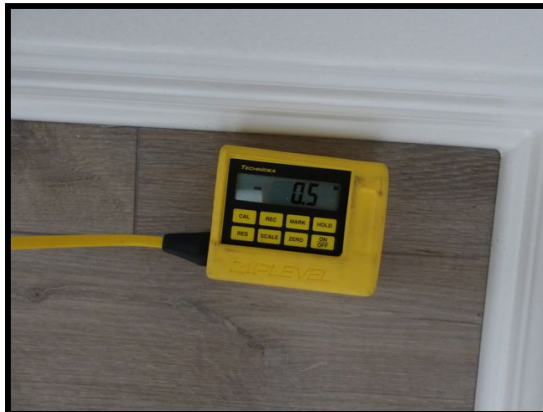
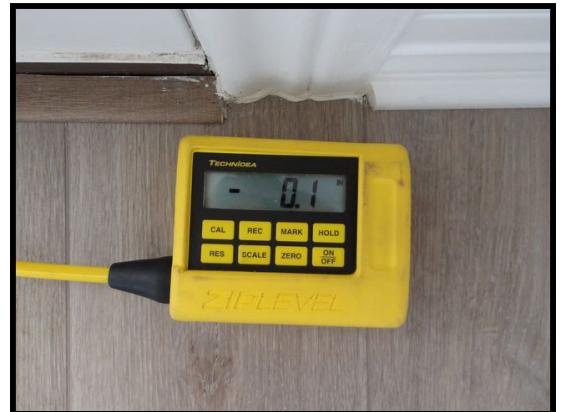
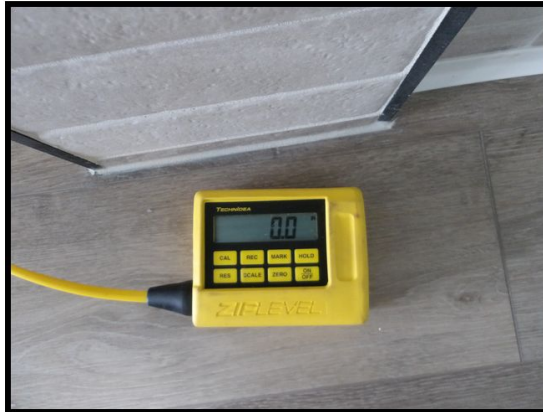
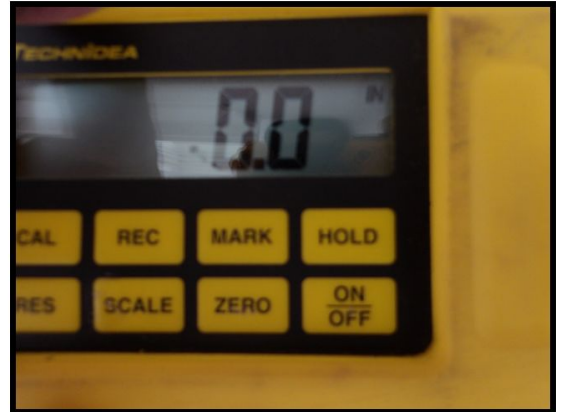
*Performing its intended function. No evidence suggesting significant foundation movement at the time of inspection.*

A foundation elevation survey was conducted during the inspection. The table below represents data gathered using a Zip Level and adjusting for floor covering height differences.

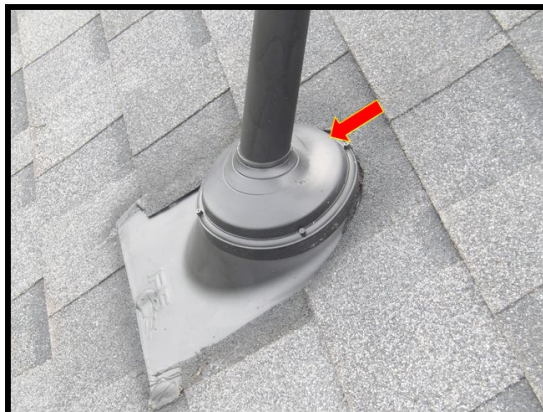
**ROOF PENETRATIONS / EVIDENCE OF ACTIVE ROOF PENETRATION:**

Rubber gasket of one or more drain waste vents was observed to have an inverted rubber gasket, this condition allows rainwater to accumulate and penetrate.

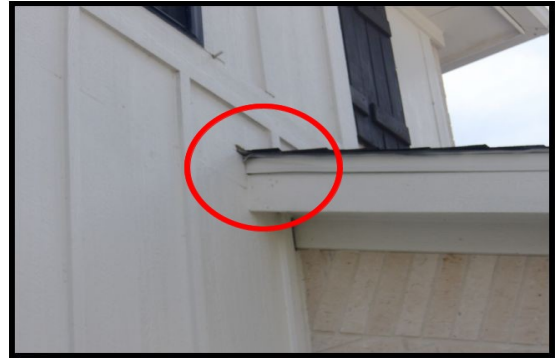
#### VISIBLE FLASHING:

Did not observe "kick out" flashing where the roof terminates along a vertical wall. Kick out flashing encourages rainwater running down the roof to be diverted / "kicked out" away from a vertical wall and reduce water running down a vertical wall.

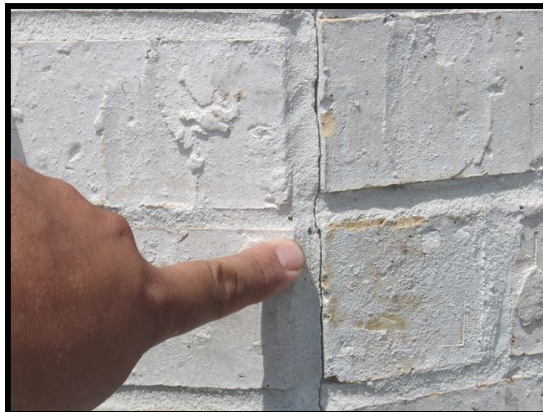
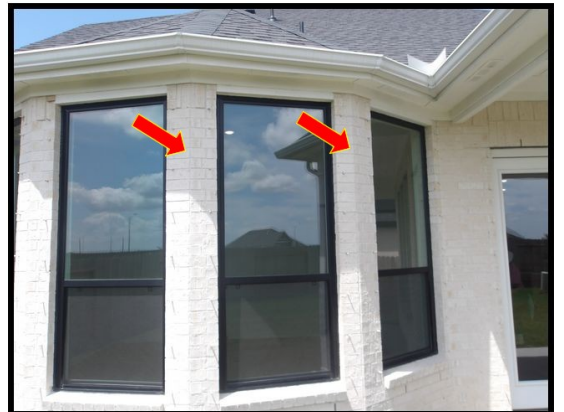
Caulking/grout missing and/or deficient around windows / vertical trim / joints in siding.  
May allow wind driven rain entry.

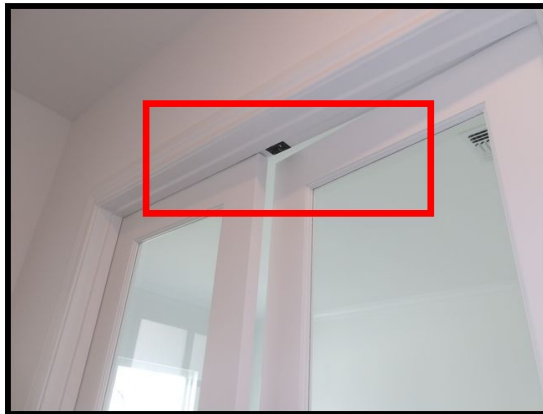
**INTERIOR:**

One or more latching balls on top of door observed to be damaged/ missing / defective; office.

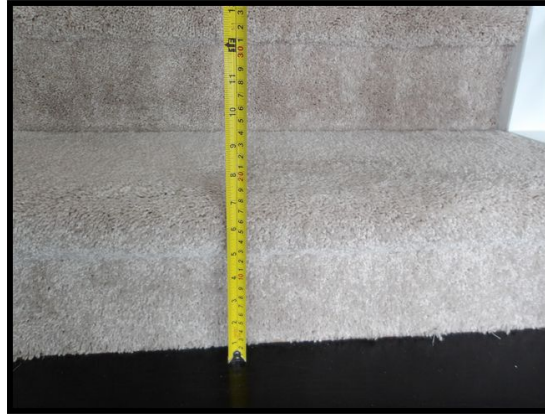
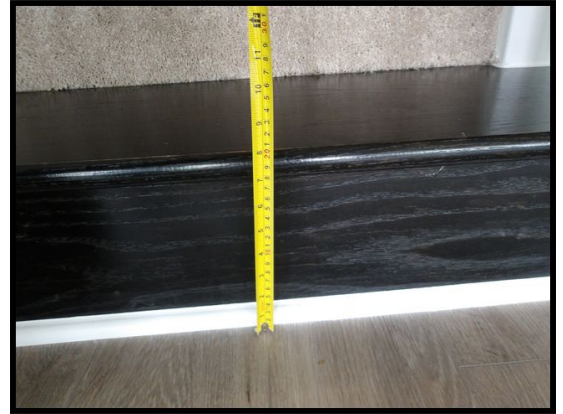
INTERIOR:

The stairway has a tripping hazard as the risers are not consistent in height throughout the entire flight of stairs. The first step of the stairways to the second.

According to IRC R311.7.5.1, 'The greatest riser height within any flight of stairs shall not exceed the smallest by more than 3/8 inch.'

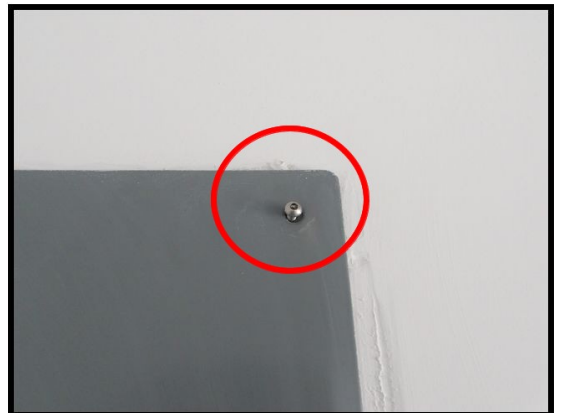
150 AMPs ELECTRICAL SUB PANEL LOCATED AT GARAGE INTERIOR.

The service panel dead-front is not secured in place, missing proper screw at one or two spots.

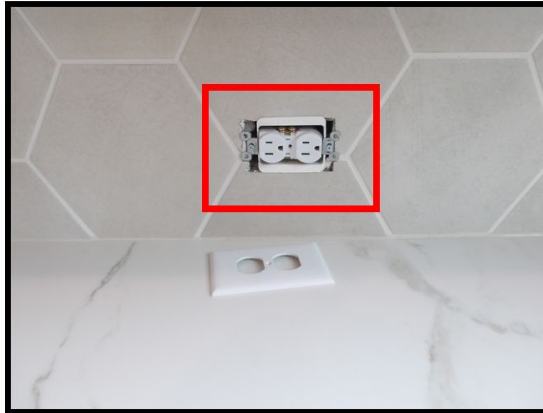
OUTLETS:

Cover missing and/or not secure in place. (Kitchen)

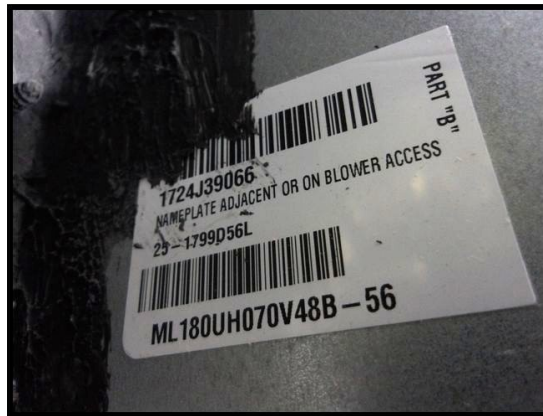
HEATING UNIT:

Age: 2024

No significant deficiencies or anomalies observed at the time of inspection.

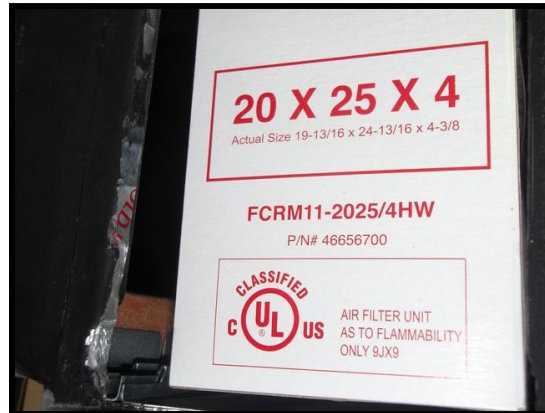
*Media air filter(s) located in the attic that requires changing/cleaning every 6 months, recommend checking guide for proper maintenance information.*

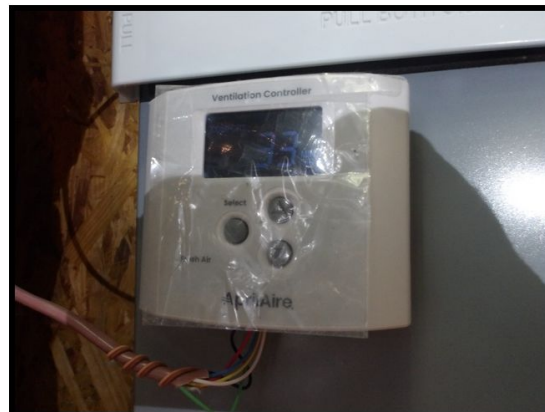
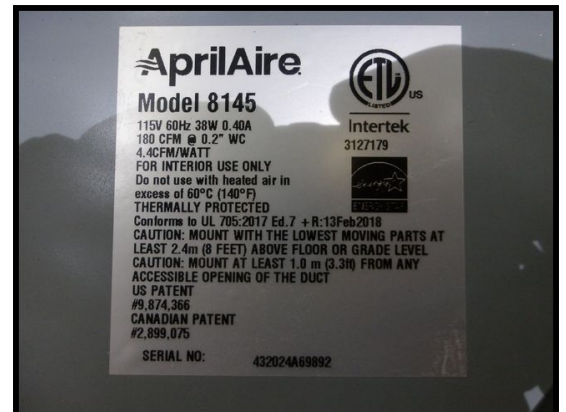
*An Aprilaire 8145 fresh air ventilation system was present. The unit appeared to be properly mounted and connected. The filter should be inspected and replaced regularly as part of routine maintenance. Recommend ongoing servicing in accordance with manufacturer guidelines.*

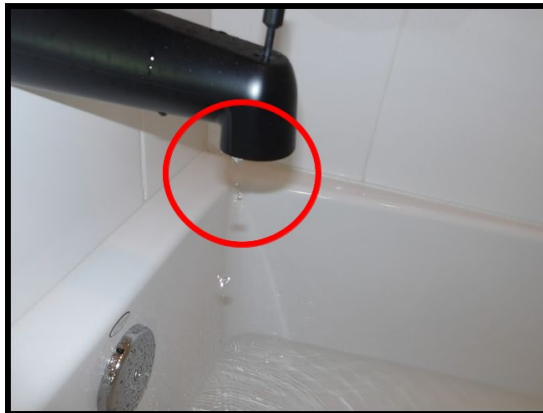
**SHOWER(S):**

The shower diverter valve is not fully functional, does not direct all water to shower head during operation, (Guest room bath)

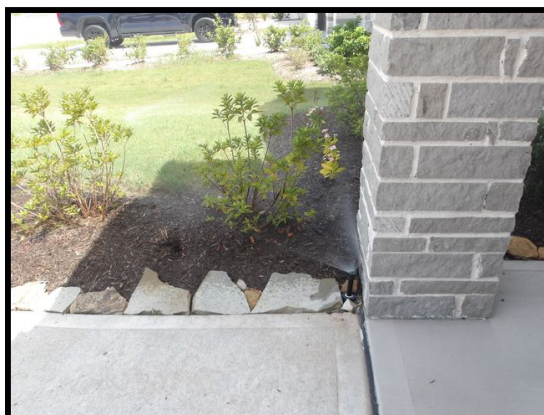
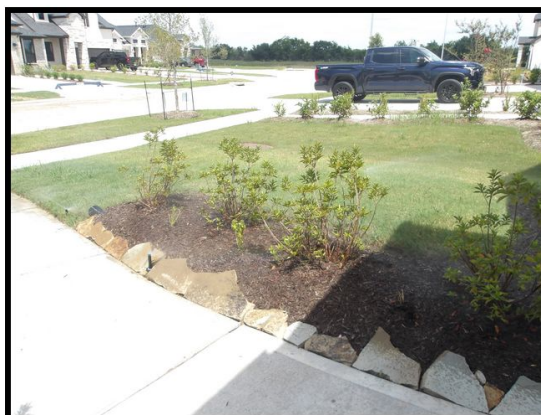
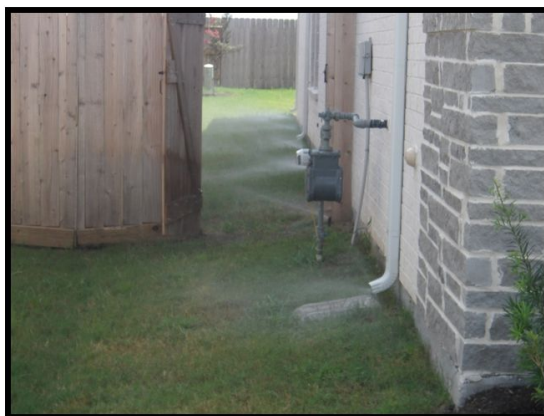
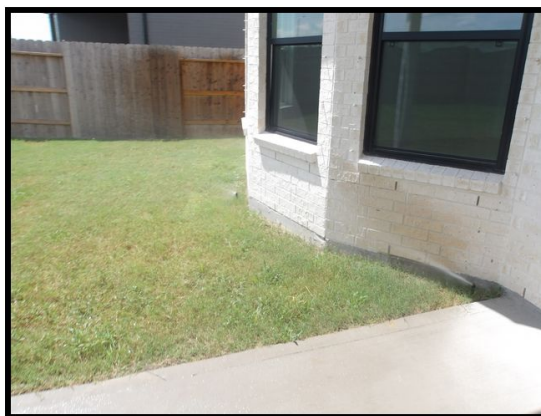
Irrigation system did not provide water to stations 2 and 5, and coverage at the rear portion of the backyard was inadequate.

Control box needs to be secure tot he wall in the garage.

Other station working properly at the time of inspection.
