MUNICIPAL ASSET CONDITION ASSESSMENT IN CHATHAM-KENT

A GIS CASE STUDY

GEOS 540: APPLIED GIS DIRECTED FIELD STUDIES

Assignment 2: Case Study (15 Pages)

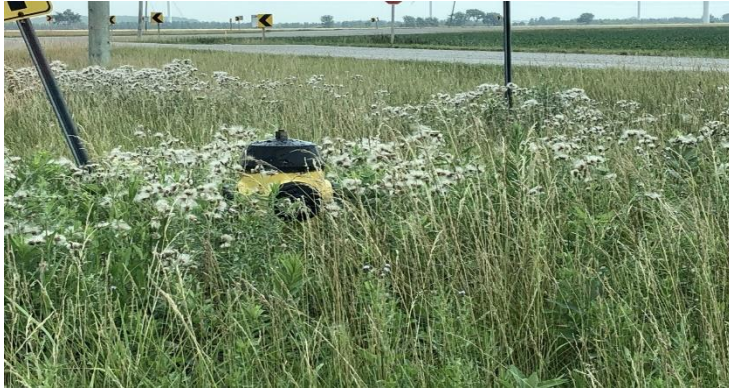
Public assets such as fire hydrants and bus shelters/stops are very important, especially during emergencies. A fire hydrant that is hidden, for example, can affect its functionality when needed.

Figure 1: Hidden Fire Hydrant

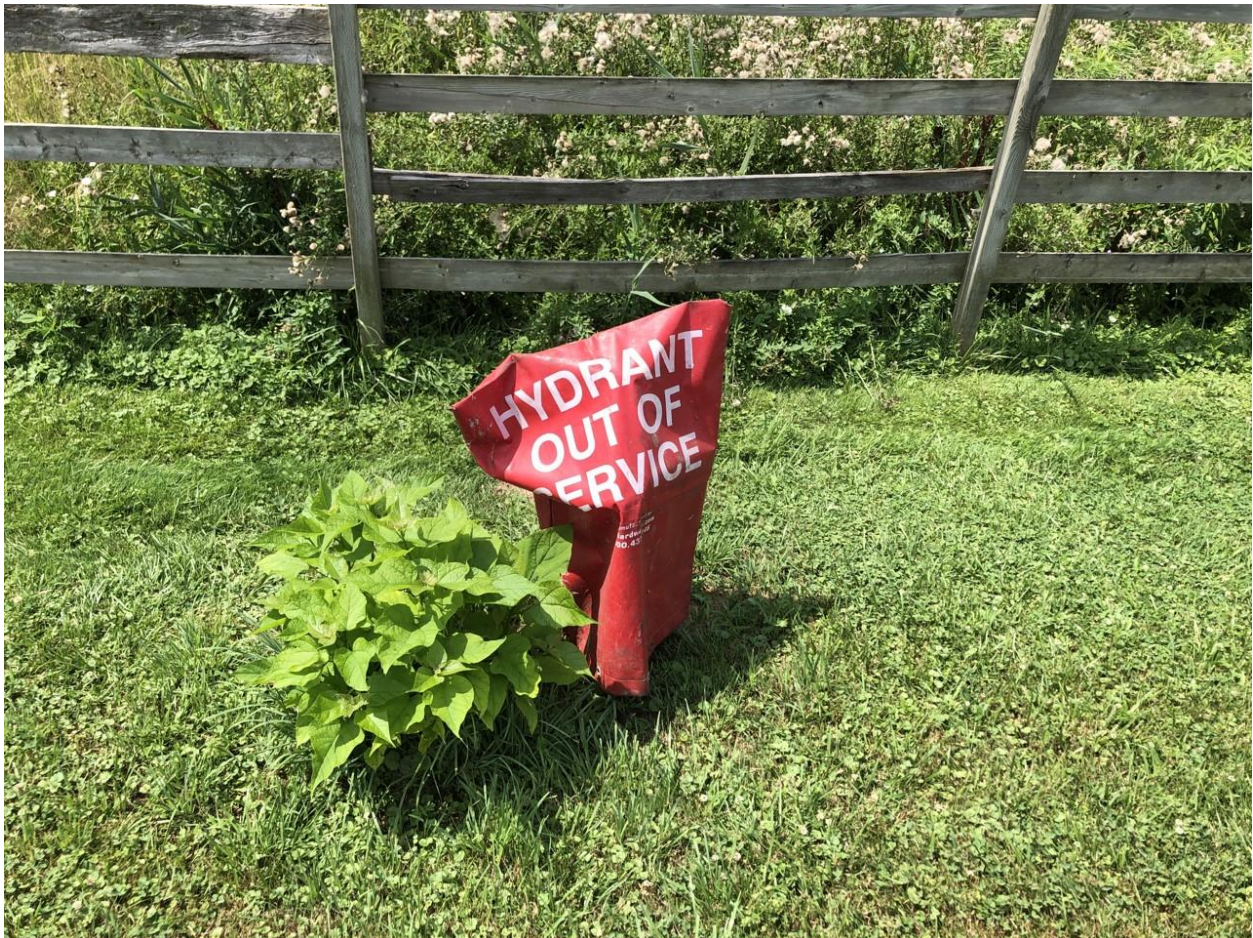
Figure 2: A Fire Hydrant Out of Service

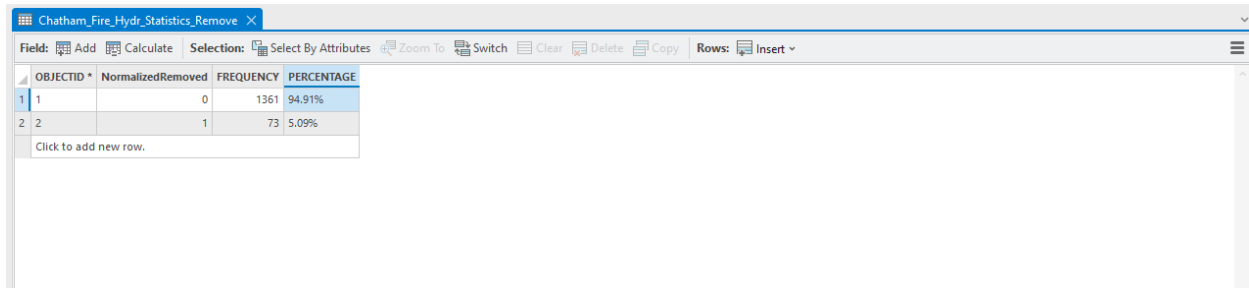
Out of 1434 verified fire hydrants, 5.09% have been removed, while the remaining 94.91% are still present.

OBJECTID *	NormalizedRemoved	FREQUENCY	PERCENTAGE
1	1	0	1361	94.91%
2	2	1	73	5.09%

Figure 4; Summary statistics table showing percentage of removed fire hydrants
