HG60-00021-00 verification new HSN report

FOXCONN VN Team.

May.10th , 2023

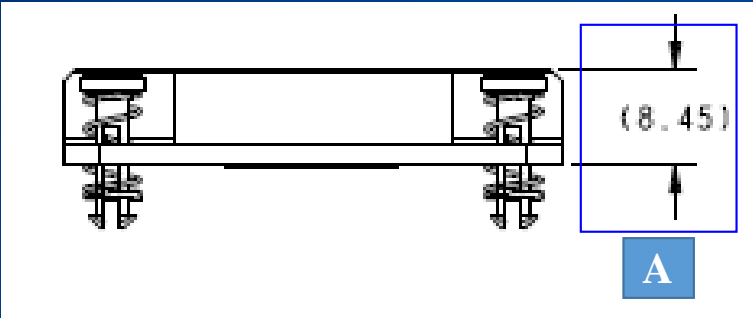
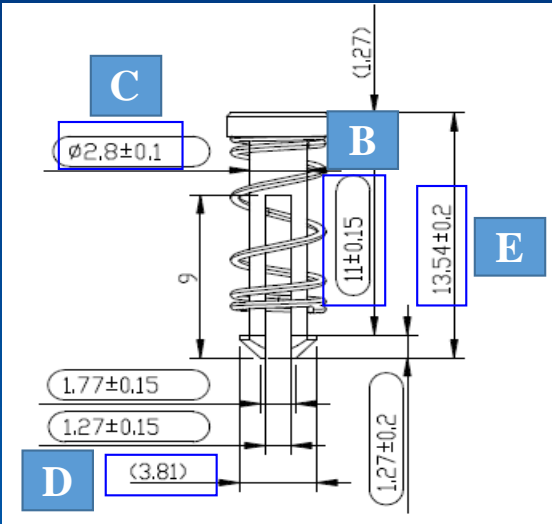
Unit: mm

Item	Drawing	Min spec	Max spec	#1	#2	#3	#4	#5	#6	#7	#8	#9	#10
A	8.45±0.1	8.35	8.55	8.40	8.38	8.38	8.37	8.38	8.38	8.39	8.40	8.37	8.40
B	11 ± 0.15	10.85	11.15	10.92	10.89	10.91	10.90	10.89	10.92	10.89	10.89	10.89	10.92
C	2.8±0.1	2.70	2.90	2.78	2.81	2.77	2.78	2.79	2.77	2.76	2.77	2.78	2.79
D	3.81 ± 0.1	3.71	3.91	3.75	3.78	3.82	3.80	3.79	3.80	3.81	3.76	3.77	3.79
E	13.54±0.2	13.34	13.74	13.65	13.60	13.57	13.59	13.61	13.64	13.59	13.58	13.58	13.56

- **Conclusion :** We checked the dimension of new HSN in spec.

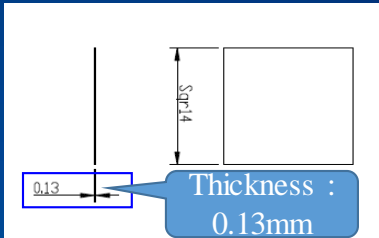
Copper

Thickness : 0.13mm

➤ Conclusion: - Appearance checked

1. Change design of push pin : - The material change from plastic to copper. The dimension as the same.
2. Change material of TIM : - The material change from T588 to T725. The new Tim have protect sheet cover & need remove before assembly .
3. Change design TOP side : - The fins old heatsink more than new heatsink.
4. Change design BOT side : - **The old HSN have copper and the new HSN haven't copper.**

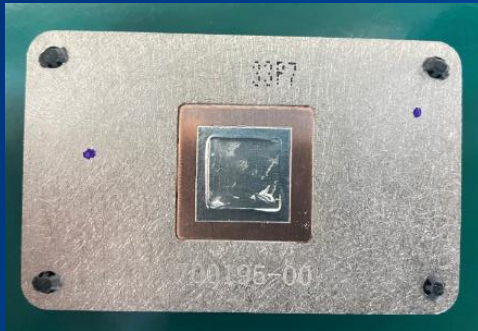
Disassembly HSN check TIM contact with BGA good

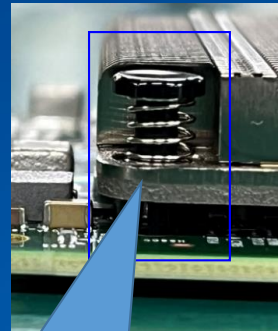
Check push pin don't shift after assembly

Assembly OK

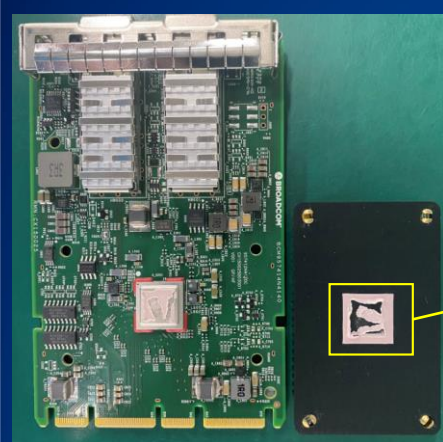
Disassembly HSN check TIM
contact with BGA good

1. The structure of new HSN was change ,but the dimension are the same . So Can assembly as normal old HSN ,no detect any issue.
2. The Tim contact with BGA good.
3. The new Tim material will peel of after remove, So can't recycle HSN if need rework.

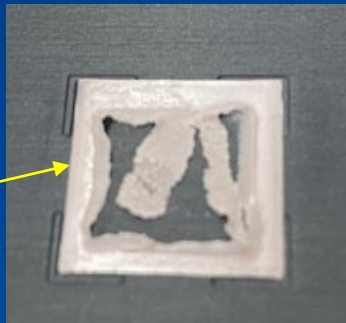
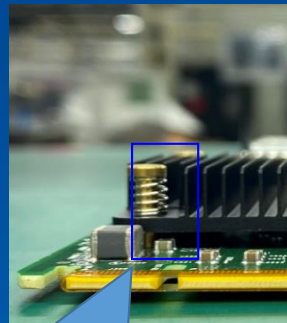
Check push pin don't
shift after assembly

Assembly OK
