A wedge deflector (shown at the end of the building) was used to mitigate wraparound effects in one test.

the tests and to assess the buildings' structural response. The hydrocodes CTH, a Sandia National Laboratories code, and AUTODYN, a commercial code, provided the basis for modeling.

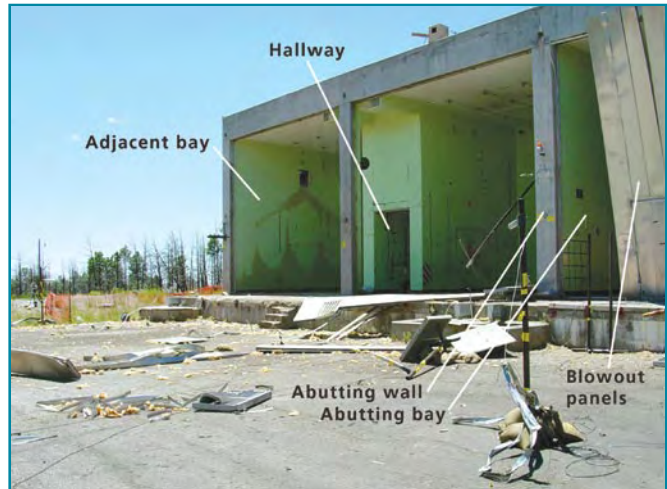
After a 25-lb test shot, blowout panels are on the ground and blowout panels in the abutting bay are damaged.
