An Infrared Thermography-Based CNN System for Cultural Asset Conservation and Flooring Material Identification

Abstract—Thermographic imaging has gained significant use in recent years, particularly during the epidemic, including its application in architecture for damage detection on archaeological monuments through high-temperature analysis. The non-invasive nature of Thermographic imaging, along with its ability to visualize temperature levels, allows for problem identification while preserving the building's structure. The integration of artificial intelligence further enhances its potential applications. This study aims to propose an automated inspection system using a convolutional neural network (CNN) for analyzing materials in high-temperature floor blocks. A team of academicians with more than seven years of expertise in monument preservation gathered the imaging data for this investigation. They were in charge of collecting thermal imaging photos of floors at significant monuments and aiding in the identification of overheating data and floor tile types. Analyzing materials at elevated temperatures for restoration purposes offers several benefits: efficient identificatio

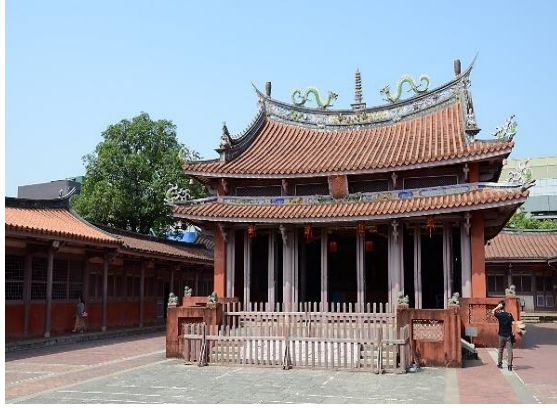
Fig.1. Da cheng Hall and surrounding spaces of the Tainan Confucius Temple. (a) Da cheng Hall. (b) Plane configuration. The core areas encompass Da Cheng Hall (code A), East Wing (code B), West Wing (code C), Ritual Implements Storeroom (code D), Musical Instrument Storeroom (code E), Yi Cheng school (code F), Chong Sheng Shrine (code G), the library housing book collections (code H), and Pan pond (code I).

This temple, established in 1665, boasts the distinction of being Taiwan's inaugural and oldest Confucius temple. Figure 1(a) provides a visual representation of the actual scene at the Tainan Confucius Temple. During its inception, it held a unique role as the sole institution in Taiwan dedicated to the education of children, earning it the prestigious title of the "Premier Academy of Taiwan." The Tainan Confucius Temple has maintained its significance across different political eras due to its distinctive historical and cultural value. It stands as one of Taiwan's rare and exceptionally preserved architectural treasures, carrying profound historical importance, and is

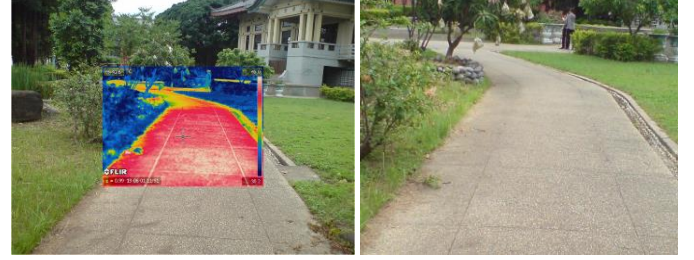
Fig.4. (a) Center Point Alignment. (b) Cutting results.

To ensure a seamless alignment between the vulnerable regions identified in the Thermographic image and their corresponding areas in the original image, achieving identical dimensions for both images is crucial. This necessitates centering the images and removing any excess portions, as demonstrated in Figure 4. In the initial step, as shown in Figure 4 (a), the centers of the Thermographic image and the original image are aligned. This alignment establishes a common reference point for subsequent analysis and marking of the vulnerable areas. By centering the images, precise mapping and seamless integration of the Thermographic image's findings into the original image are ensured. Once the centers are aligned, both images undergo a cropping process, as depicted in Figure 4 (b). This procedure guarantees that both images share the

same dimensions and eliminates any redundant areas. The resultant images can then be seamlessly merged, providing a smooth and accurate representation of the vulnerable regions within the context of the original image. By employing this cropping technique, the research aims to enhance visual consistency and precision in marking the vulnerable parts of the Thermographic image onto their corresponding locations in the original image. This approach aids in the assessment and evaluation of the site's condition, contributing to a more comprehensive understanding of the subject matter.

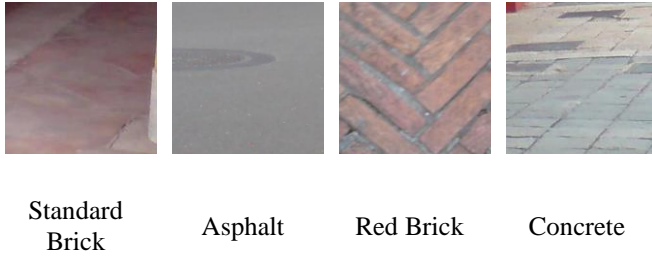
Fig.9. Schematic diagram of four target materials.

Subsequently, the CNN for material recognition was tailored to meet specific functional criteria, with a particular focus on four materials: standard bricks, asphalt, red bricks, and concrete. These materials were systematically categorized and structured into dedicated training sets, illustrated in Figure 9. Ultimately, a comprehensive dataset comprising 1685 material images was employed during the training phase of the material recognition model. This dataset underwent division into a training set, encompassing 1178 images, and a validation set, incorporating 507 images, as outlined in Table 3.

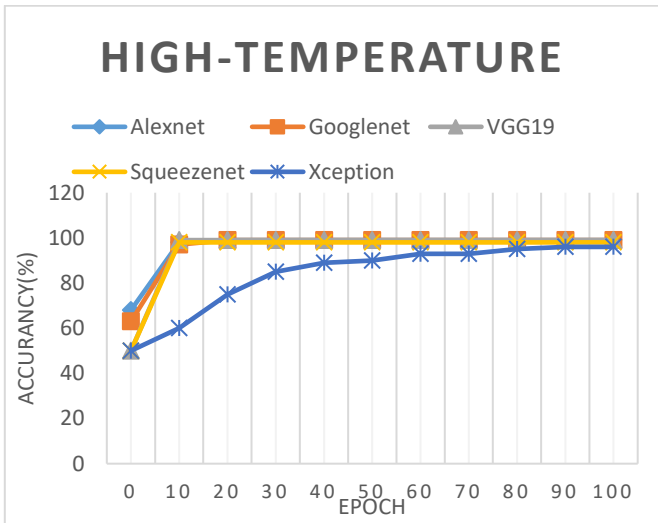
Fig.16. Model training folding chart for High-Temperatures
