**Pedestrian Crosswalk Safety:
Evaluating In-Pavement, Flashing Warning Lights**

FINAL REPORT
April 2002

Submitted by
Peter Boyce, Ph.D. and John Van Derlofske, Ph.D.
Lighting Research Center
Rensselaer Polytechnic Institute

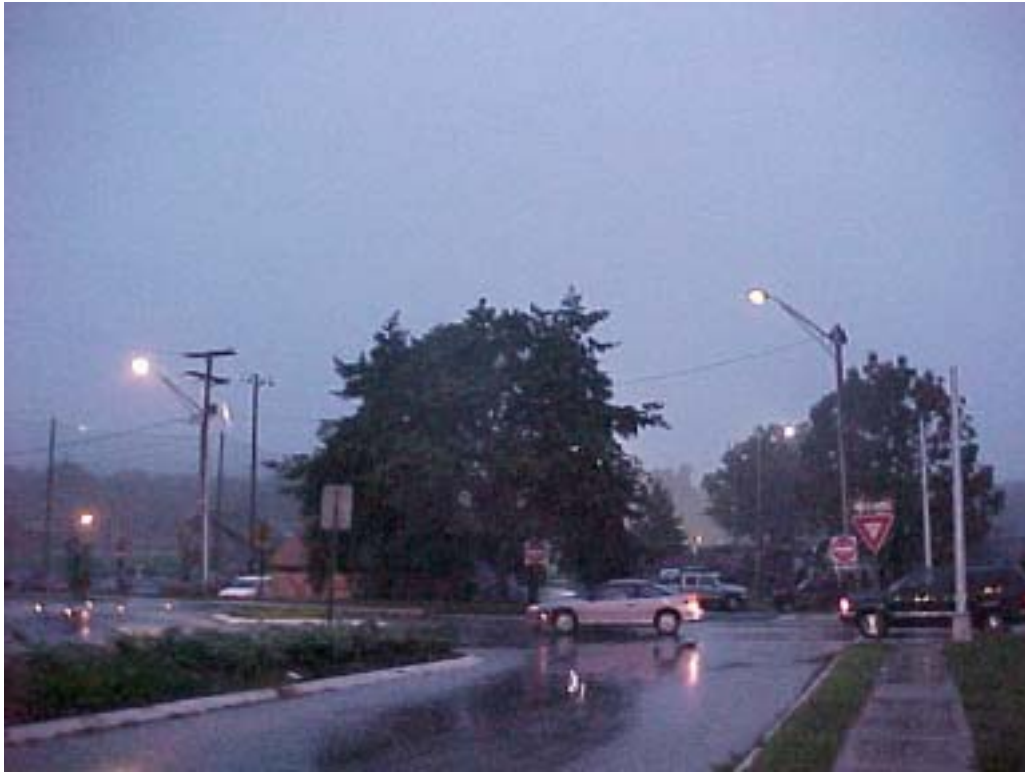
Figure 3. The cobrahead luminaires used to light the evaluation site at night.

Throughout the series of evaluations the lighting of the junction of Franklin Road and Savage Road has been provided by two drop-lens cobrahead luminaires, each one containing a 250 W high-pressure sodium discharge lamp (Figure 3). Each luminaire is

mounted on an extension arm fixed to a wooden utility pole. The two poles are located close to the two crosswalks.

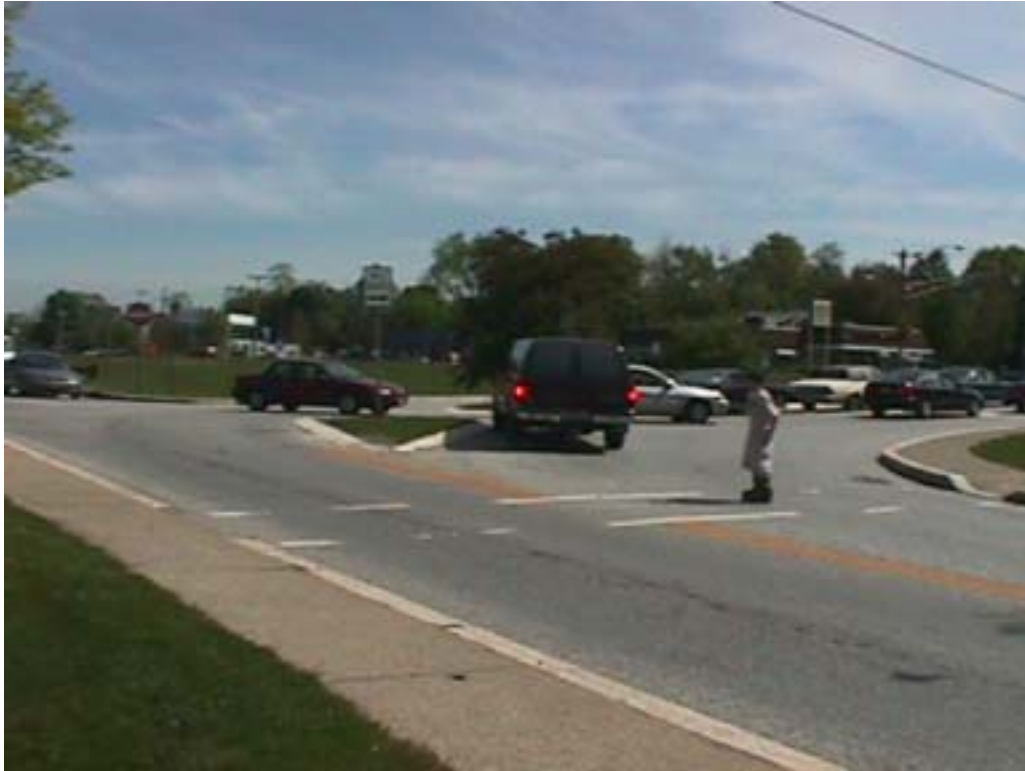
Figure 4. Crosswalk 2 at the time of the first evaluation.

The first evaluation was made on Saturday, 12th June 1999. At this time, there was only one marked crosswalk at the site, that being crosswalk 2 on the northwest side of the junction of Franklin Road and Savage Road. This crosswalk was linked to a sidewalk on the northwest side of Franklin Road. There was no sidewalk on the southeast side of Franklin Road so there was no marked crosswalk 1 at this point. Figure 4 shows the marking of crosswalk 2 from the sidewalk on Savage Road on the day of the evaluation. It is clear that the original marking of crosswalk 2 consisted of two parallel lines across the road, although by the time of the evaluation, the lines had been badly eroded by traffic.

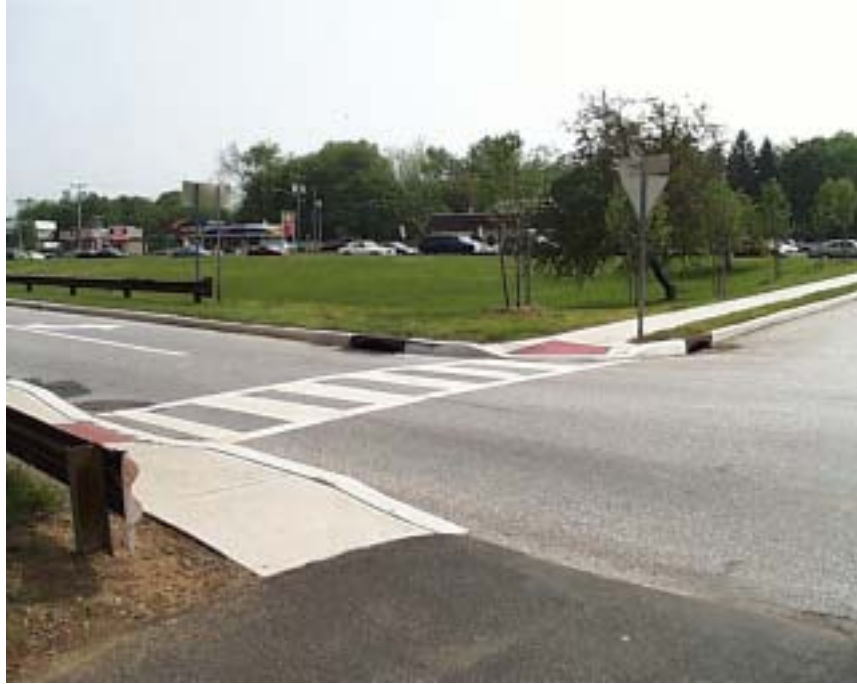
Figure 5. Crosswalk 1 at the time of the second evaluation.

The second evaluation took place on Saturday, 13th May 2000. By this time, a sidewalk had been constructed on the southeastern side of Franklin Road and a new crosswalk across Savage Road (crosswalk 1), complete with ADA ramps, had been finished. Both crosswalks had been newly striped in a grating pattern. Specifically, the striping consisted of alternate 2-ft-wide bars of white paint and 2-ft-wide pieces of asphalt, arranged to form a grating pattern, the upper and lower boundaries of the grating being closed by a continuous white paint line of 9" thickness. The overall width of both crosswalks was 7 ft. Figure 5 shows a view of crosswalk 1 at this stage and Figure 6 does the same for crosswalk 2.

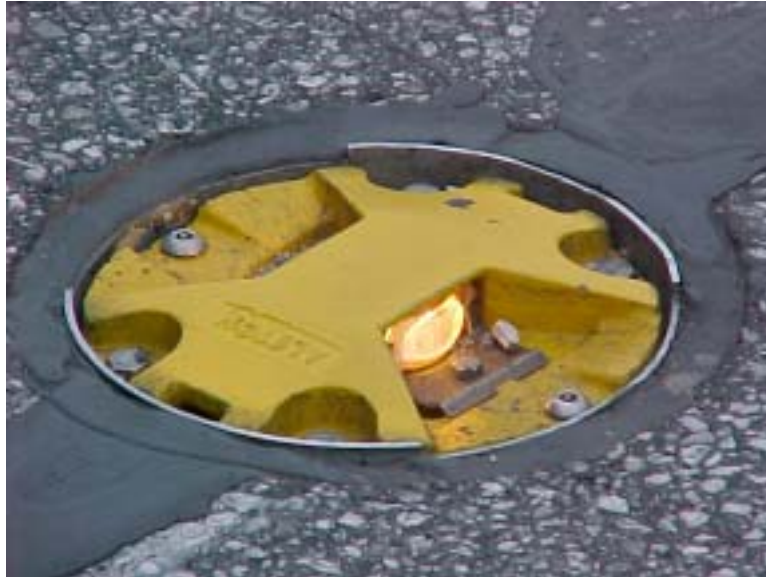
Figure 7. One of the in-pavement flashing warning lights, installed.

pavement flashing warning lights (Model ZA230) were purchased from Traffic Safety Corporation of Sacramento, California and installed by the New Jersey Department of Transportation. Figure 7 shows a close-up of one of the in-pavement flashing warning light units as installed.

The unit was originally designed for use on airport runways. Consequently, it is of rugged construction and designed to be set low enough in the pavement (projecting less than 0.50 inches above grade) that it will not be damaged by snowploughs. The light source used in the unit is a 45 W tungsten halogen lamp. The light output of the unit is predominantly in two directions, through apertures set at 180° to each other. The unit is installed so that these directions are along the main axis of the road. In Denville, only the direction towards approaching traffic emits light (the other direction is sealed). The light distribution from the unit is determined by the clear lens in the aperture of the unit. The effect of the lens is to direct a high luminous intensity beam along the road in the direction of approaching drivers. The color of the flashing warning lights was white. Four ZA 230 units were installed on crosswalk 1 and six units on crosswalk 2, as shown in Figure 8. Figures 9 and 10 show the installations at crosswalks 1 and 2 respectively.

As originally installed, the in-pavement flashing warning light installation consisted of ten in-pavement light units. During the one year of operation New Jersey Department of Transportation has had to carry out maintenance on five of these units. Two of the units had to be replaced after suffering damage from a snowplow. Another three suffered electrical failure of some sort, probably a failure of the filament of the halogen lamp in the unit, caused by vibration produced by the high traffic flows over the units. This cause of failure has to be an assumption because the maintenance procedure is to extract the failed unit from the pavement, replace it with a spare unit, send the failed unit back to the manufacturer in California, who makes any necessary repair and returns the unit to NJDOT where it becomes a spare unit. Nonetheless, the fact that five out of the ten units initially installed have required maintenance during the first year suggests that the units are not suitable for use where they will be exposed to high traffic flows.

A close examination of the units after one year in the pavement showed a large reduction in light output from new. There were two reasons for this reduction. The first was the presence of small debris in the incline leading to the lens of each unit. The second, and more important, cause was the deposit of a black film, probably rubber, over a large part of the lens through which light is emitted in each unit. Both these causes of decline in light output were easily removed using a brush and glass cleaner respectively.

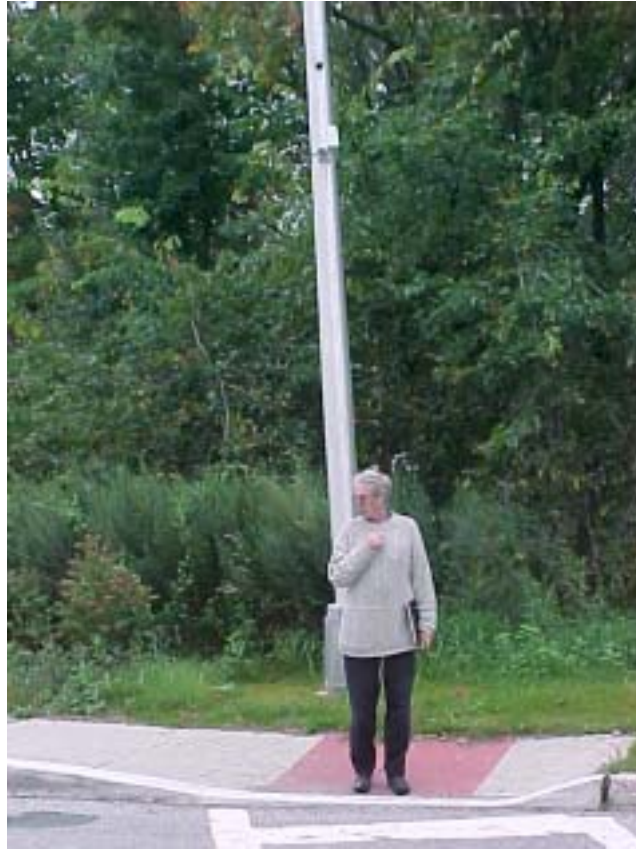
Figure 11. One of the four microwave detectors used to activate the in-pavement flashing warning lights. The detector is in the small box on the pole behind and above the pedestrian.

The activation of the in-pavement flashing warning light units was by four microwave detectors (Model AD1400) also purchased from Traffic Safety Corporation. One of these detectors was mounted on a pole at either end of both crosswalks. Figure 11 shows the location of one of the AD1400 detectors relative to the pedestrian. These devices detect the presence of a pedestrian in the detection area. The pedestrian has to be in the detection area for a minimum time before the flashing warning lights are activated. This time delay from detection to activation is necessary so that pedestrians passing through the detection area but continuing along the sidewalk do not trigger the flashing warning lights. The sensitivity of the detector, the detection area and the delay time are all adjustable on site.

The pole-mounted activating system has adjustments of coverage area, sensitivity and time delay. These adjustments are used to ensure that the in-pavement flashing warning lights are only operated when a pedestrian is waiting to cross and are not activated by a pedestrian walking along the sidewalk past the crosswalk, nor by passing traffic. At the time of Evaluation 3, i.e., one week after commissioning, it was observed that the in-pavement units were sometimes activated when there was no pedestrian present. Examination of the activation of the in-pavement flashing warning lights for several hours during Evaluation 5 revealed the pattern of activation shown in Table 9.

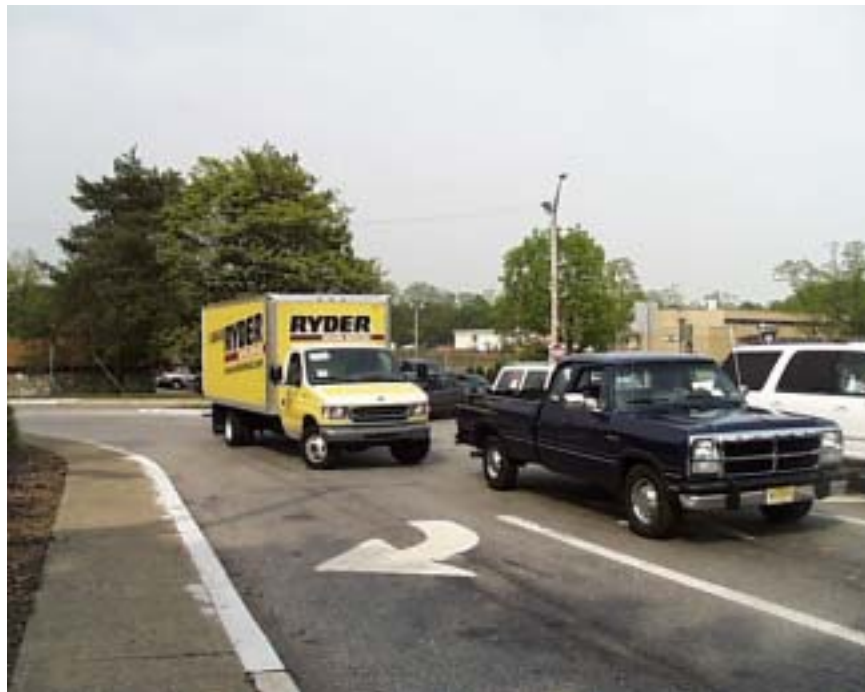
Figure 13. Blockage of some directions of travel in the area of the crosswalk by traffic backing up from the traffic signals at US Route 46 and Franklin Road.

While making the evaluations on site, the authors had an opportunity to observe drivers' behaviors. Two aspects of that behavior are of relevance here. The first is that traffic backing up from the traffic signals on US Route 46 sometimes produced partial blockages of different lanes between the two crosswalks. The most common blockages occurred for directions 2 and 3 because of vehicles coming from directions 2 and 4 (Figure 13). Occasionally, this situation was exacerbated by a vehicle coming out of Gardner Field and blocking direction 1. The importance of such blocking for the use of the crosswalks is that the vehicles obscure the drivers' view of the crosswalk and the pedestrians' view of the traffic. This means it is sometimes not possible for a driver traveling in direction 1 to see if a pedestrian is waiting to cross from one side of the two crosswalks, or even if a pedestrian has already started to cross, until the pedestrian emerges from behind a vehicle. Striping does not do anything to help in this situation but the in-pavement flashing warning lights would, if drivers were confident that their operation meant a pedestrian was using the crosswalk.
