Pedestrian Safety and Mobility Aids for Crossings at Bus Stops

FINAL REPORT
September 2003

Project 2001-22
Pedestrian Safety and Mobility Aids for Bus Stops

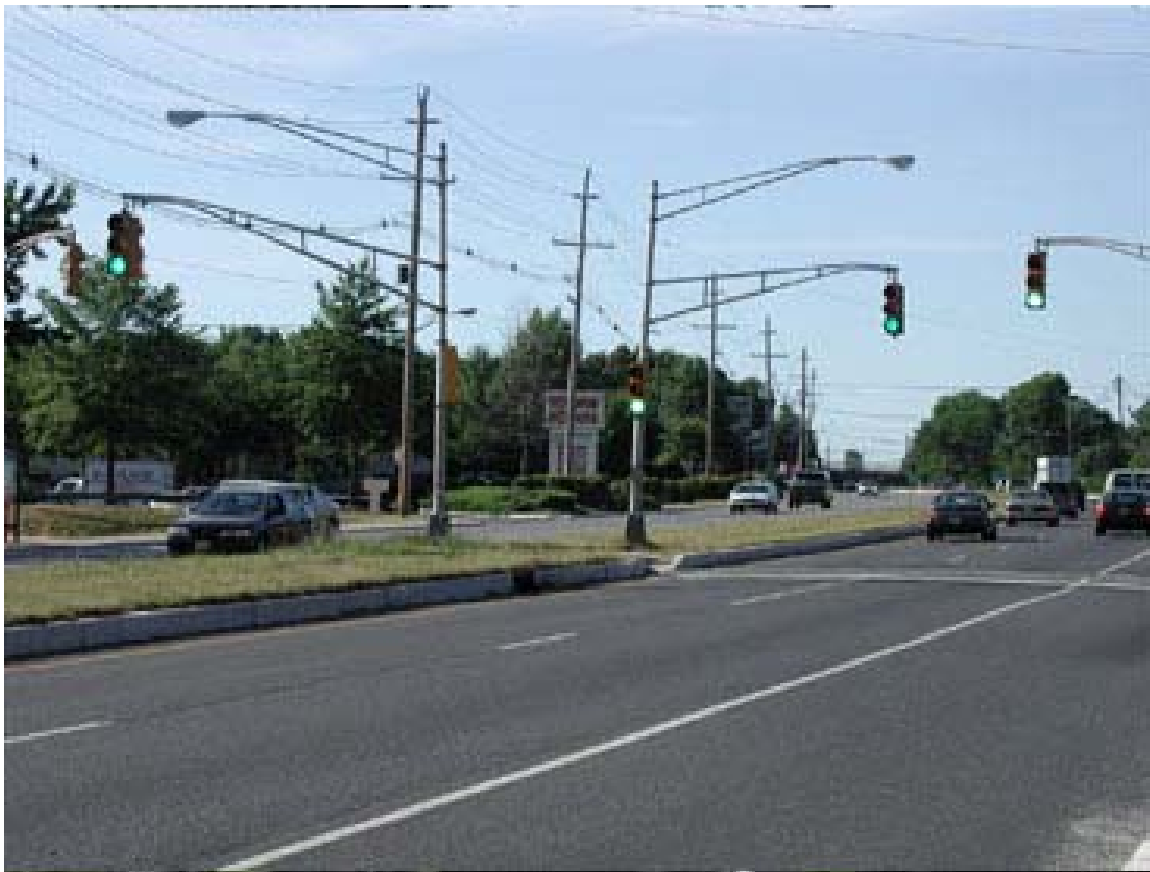
Figure 1. US Route 9. Two lanes with shoulder in each direction divided by grass median.

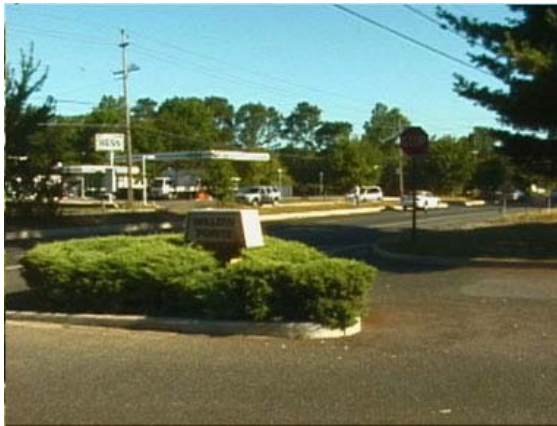
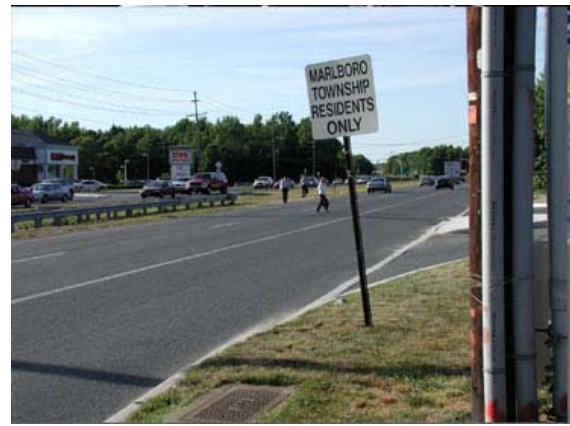
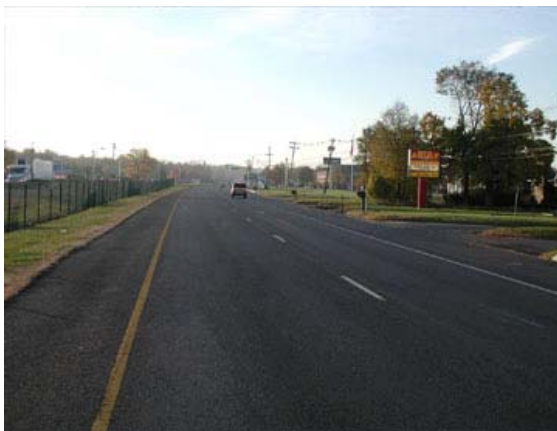
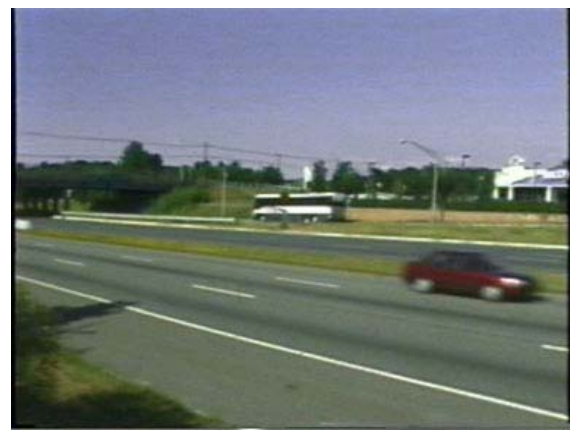
Figure 3. Potential study locations.

Additional field investigations were conducted to determine pedestrian use of each bus stop location (See figure 3). We also studied each location for unique or unconventional crossing behavior. Locations where safety enhancements are already being proposed and/or implemented were eliminated from consideration. Based on the results of our field investigations, Strickland Road and Texas Road were selected as the final study locations.

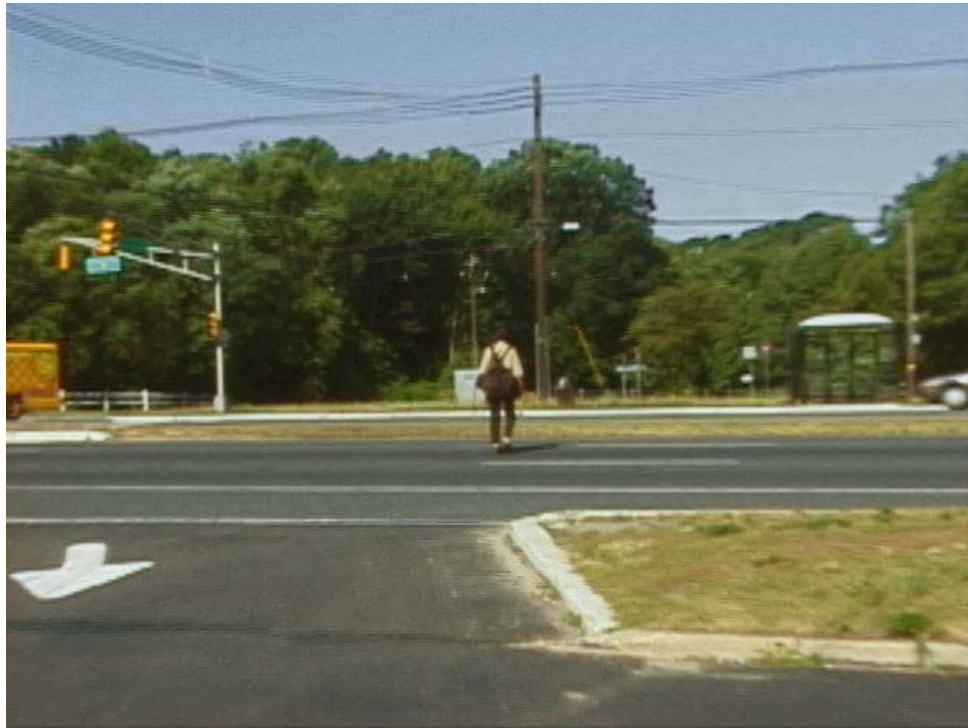
Figure 4. Intersection at Fairway Lane in Old Bridge.

As a follow-up to our field investigations, we also reviewed pedestrian related collisions that occurred along US Route 9 in Monmouth and Middlesex Counties over the past three-year period. The Collision Diagram and Accident Summary are contained in appendix A. We found that a number of serious pedestrian related accidents occurred at the intersection at Fairway Lane in Old Bridge Township (See figure 4). Hence this location was added to our list of study sites only for conducting driver evaluation for measures to enhance pedestrian safety and mobility. Due to the observed lack of use and probable survey participation, the team decided not to administer the survey/questionnaire at Fairway Lane. However, an evaluation from the driver's perspective was conducted for this location.

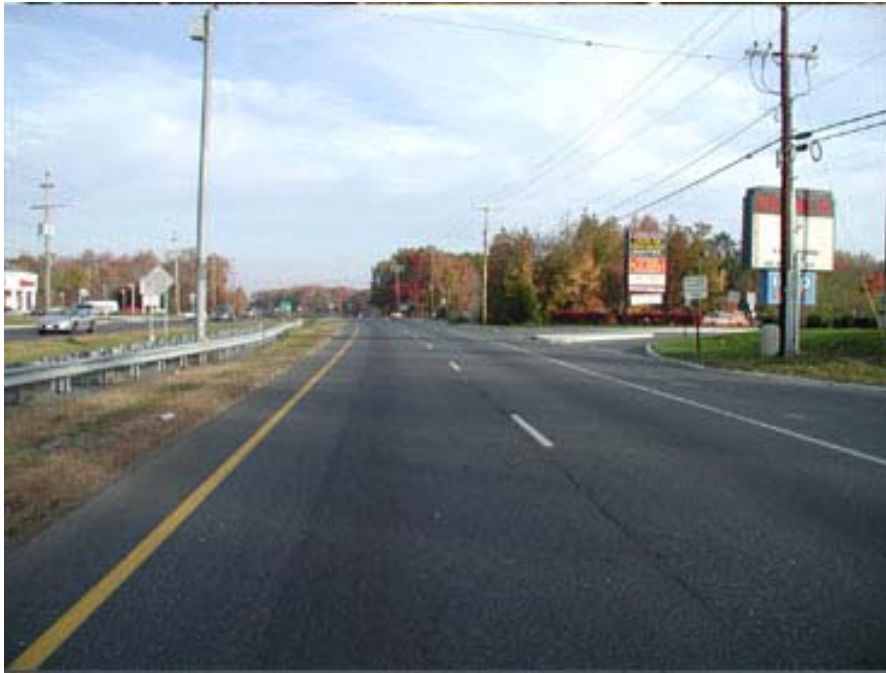
Figure 6. Texas Road location

Bus stops are located within close proximity of the Texas Road and US Route 9 intersection (see figures 6 and 7). On the northbound side of US Route 9, an existing shopping center parking area serves as a park and ride lot. A bus shelter is provided approximately 500 feet south of Texas Road and a bus pull off is provided on the northbound US Route 9 shoulder. For the southbound direction, the bus pulls off the traveled way onto the existing shoulder approximately 200 feet south of Texas Road. No shelter is provided for this direction. The northbound direction experiences the heaviest use during the morning hours.

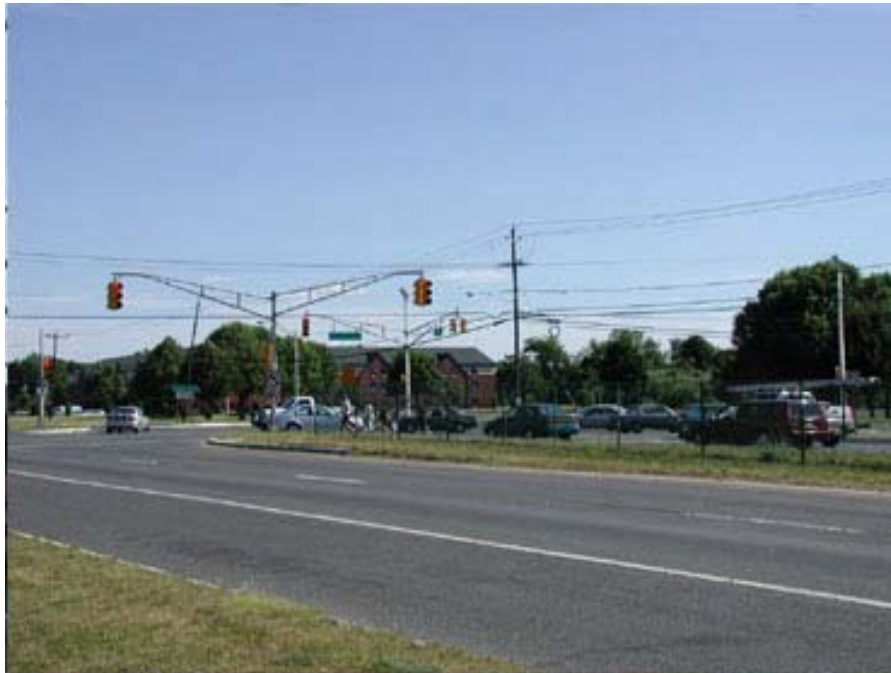
Figure 9. Strickland Road Location

The Strickland Road location has a large park and ride facility with several bus shelters and a large bus pull off area which can accommodate several attending buses at once. These facilities are located on the northbound US Route 9 side. A single bus shelter is provided in the southbound US Route 9 direction and the existing shoulder provides the bus pull off area. (See figures 9 and 10)
