Exo Terra Monsoon RS400: Misting Frequency Flaw Analysis and Resolution

BY: SCOTT RISING

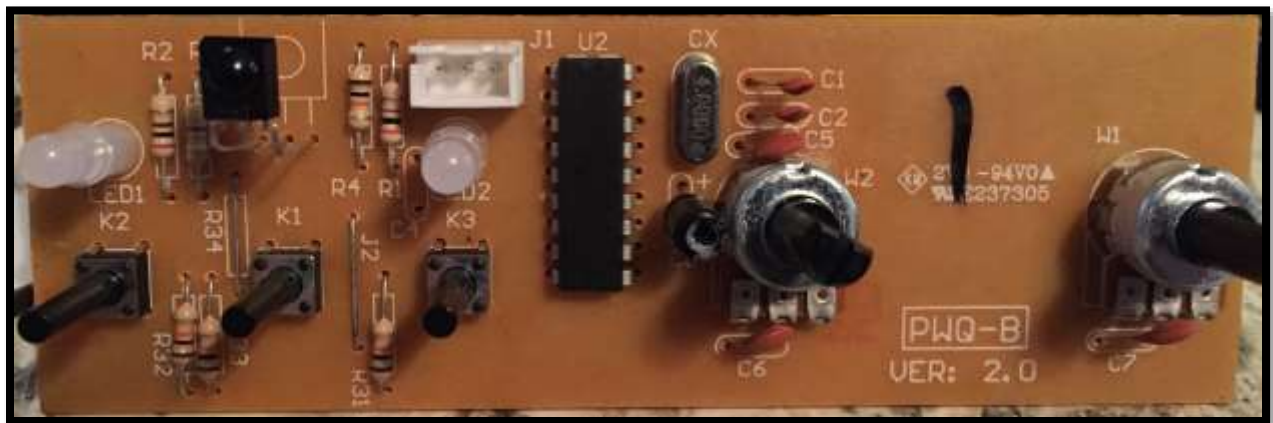
The electrical/electronic hardware external to the Monsoon RS400 consists of a power supply, which accepts 120VAC and converts it to 12VAC, where it connects to the top of the mister unit. Internally, the mister unit consists of a small power supply and pump driver board, which then connects to the main logic board. The main logic board appears to be driven by a PIC microcontroller. Since the microcontroller has no markings on it, it wasn't immediately identifiable; however, pin placement matches several products in the PIC16F18xx microcontroller family. This board also has three momentary-contact buttons, two LEDs, two potentiometers, and an IR-receiver. The board is fed with 5VDC power, and one of the output pins on the microcontroller drives a relay on the pump driver board, which then turns the pump on and off.

The microcontroller and potentiometers appear to be properly de-coupled using capacitors. Images of both sides of the logic board are shown below.

Figure 1: RS400 Main Logic Board, Top

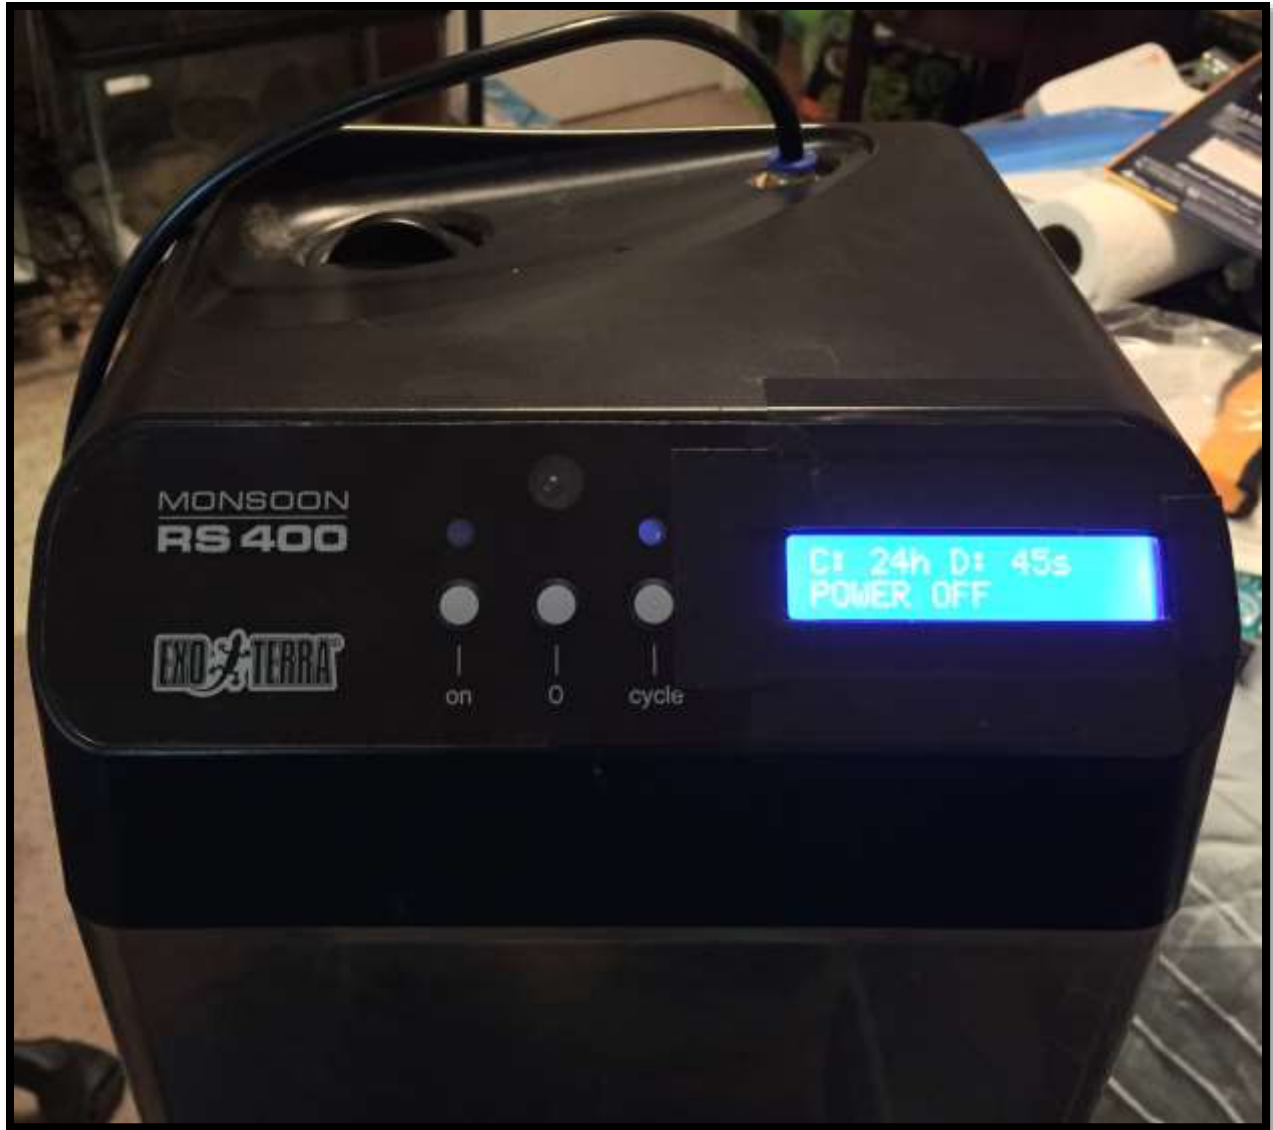
Figure 4: RS400 Digital Upgrade

Since the PIC in the Monsoon RS400 cannot easily be identified, it's difficult to attempt replacing the firmware that's loaded on the microcontroller. In order to salvage this particular unit, I wanted to replace the PIC with an Arduino. Unfortunately, the pin configuration of an ATmega 328 does not match the pin configuration of the PIC. Therefore, I removed the PIC and replaced it with two female header sockets, onto which I plugged a small board containing an Arduino Nano and a few components. I also cut the original PCB in half, removing the potentiometers and crystal oscillator in order to make room for a 16x2 character LCD.

The firmware on the Arduino precisely controls the water pump, and allows the user to change the following settings using the three momentary-contact push buttons: cycle time, duration time, LED brightness, LCD backlight brightness, and LCD contrast. All mister functions continue to operate as originally designed, including the IR receiver. (3)
