# Seismic fragility analysis of deteriorated bridge structures employing a UAV inspection-based updated digital twin

Sungsik Yoon<sup>1</sup> · Sangmok Lee<sup>2</sup> · Seungkyung Kye<sup>3</sup> · In-Ho Kim<sup>4</sup> · Hyung-Jo Jung<sup>3</sup> · Billie F. Spencer Jr<sup>5</sup>

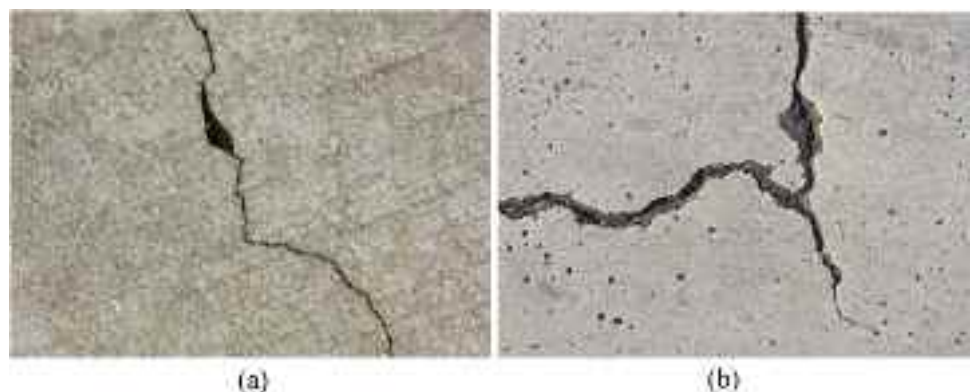
**Fig. 2** Example of **a** one-way crack and **b** two-way crack

In case of crack damage (Table 1), one-way crack and two-way crack (network crack) are distinguished to evaluate the damage as shown in Fig. 2. First, in case of one-way crack damage, for crack rate greater than 2% or less than 10% or for crack width between 0.3 and 0.5 mm, the bridge structure is classified as grade C. For crack width between 0.1 and 0.3 mm, the damage grade of the structure is grade B, and for crack width less than 0.1 mm, it is classified as grade A. On the other hand, in case of a two-way crack, if the crack width is greater than 0.3 mm, the damage grade is categorized as grade C. For crack width between 0.1 and

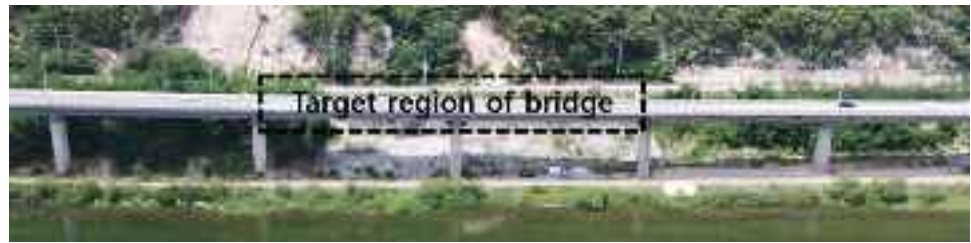
**Fig. 3** Target region of bridge for UAV inspection

For experimental demonstration, the target bridge and the UAV system are explained in this section. The target bridge structure is the Deungsun bridge located in South Korea with a span length of 2,000 m and width of 11 m, and the total number of spans is 40 with 50 m maximum span length. The bridge was constructed around the 1980s, which is classified as a deteriorated bridge as it was built more than 40 years ago, and thus the earthquake-resistance design was not adopted. The superstructure of the bridge is composed of pre-stressed concrete (PSC) box type, and the target region of the bridge has two-segmented spans with three piers. Figure 3 shows the Deungsun bridge, and the black dashed rectangle shows the target region for UAV inspection.

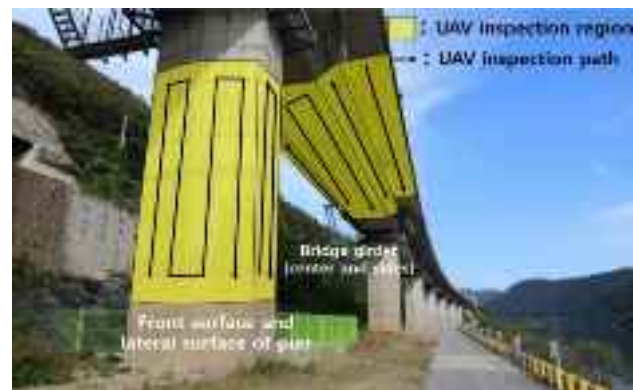
**Fig. 5** UAV inspection region and flight path for updated digital twin

2.5 m between the UAV system and the target region. Figure 5 represents the UAV inspection region and flight path for an updated digital twin. To avoid the missing area in the inspection region, the acquired images are set to 70% overlapping area (rate) between each image. For flight path determination, the width and length of a bridge pier and a bridge girder were considered. In case of the front surface of the pier, the UAV system moves upward and downward two times to acquire the images of an entire region and one time for the lateral surface of the pier and bridge girder. Figure 6

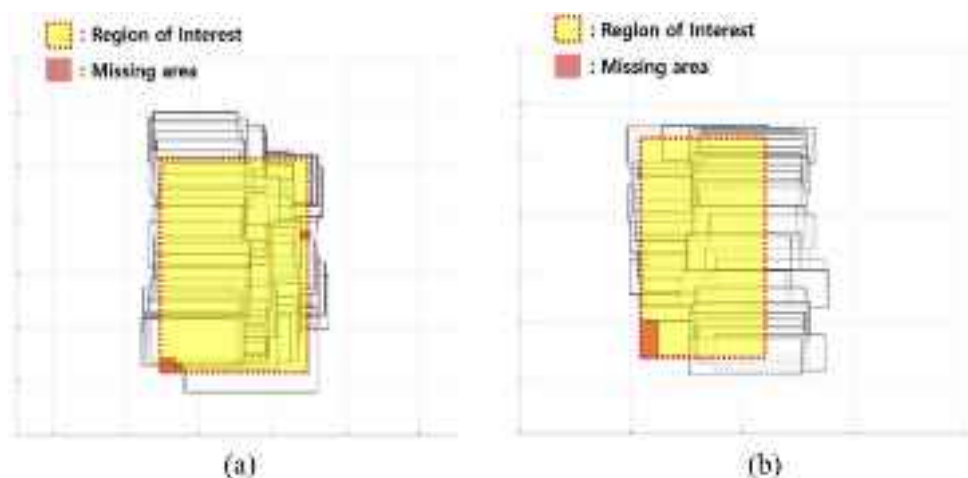
**Fig. 6** Missing area detection in ROI **a** front surface of pier **b** lateral surface of pier

shows the results of detection of missing area in bridge pier. Most of the regions were covered by each FOV, however, some parts of the edge were not detected. In this study, the missing area was minor and did not have significant effect on damage grade evaluation for damage detection purpose. These results showed that no additional UAV surveys are required to acquire the images of the missing area.

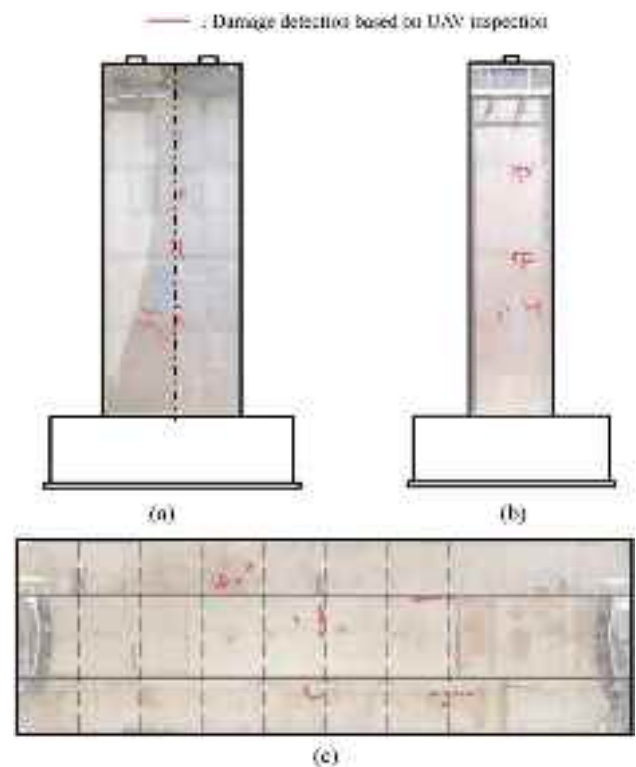
**Fig. 7** Results of UAV inspection **a** front surface of bridge pier **b** lateral surface of bridge pier **c** bridge girder

Figure 7 represents the results of UAV inspection on the front and lateral surface of the bridge pier and bridge girder. Although the mask R-CNN was trained and classified with 6 types of damage (crack, efflorescence, breakage, water leak, material segregation, and rebar exposure), the detected damage was only crack damage as seen in Fig. 7. The trained mask R-CNN model showed that the results of detection is 76.15% in recall with the standard intersection over union (IoU) of 50% and the precision was over than 95% for crack damage. For rebar exposure, the precision and recall was 100% and 71.4% respectively. In case of the breakage (including material segregation) the precision and recall was 100% and 88.8%, and the precision and recall was 100% and 100% for efflorescence damage. For accuracy of location, width, and length of the detected crack damages, the detected damage was compared with human visual inspection (Kim et al. 2022), and the comparison showed good agreement between both detection results. Using the detected crack damage, the bridge condition assessment was conducted according to the procedures described in Sect. 2.1.2 (MOLIT 2019, 2020). Table 4 shows the results of the bridge condition assessment, which is represented in terms of damage grade, damage index, and corresponding reduction in stiffness. The damage index was utilized to update the digital twin by reducing the stiffness of each component.

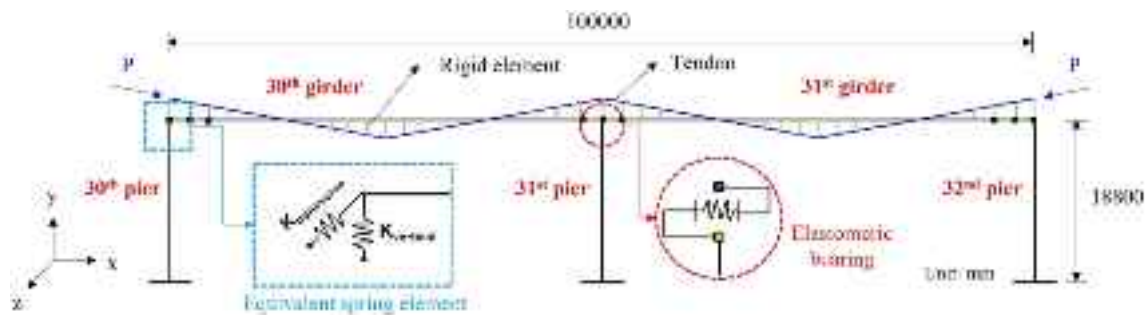
**Fig. 9** Simplified three-dimensional model of the target bridge

An FE model of the target bridge was constructed using Zeus-NL, which is an advanced FE analysis software package specializing in nonlinear dynamic analysis (Elnashai et al. 2010). The numerical modeling was performed based on a structural drawing of the target bridge. Figure 9 shows

the simplified three-dimensional representation of the target bridge. In this study, an eccentric beam model was employed to conduct iterative nonlinear time-history analysis efficiently (Chan and Chan 1999). In the eccentric beam model, beam and truss elements are used to represent the structural behavior of slabs, girders, and PSC tendons by simplifying the complex behavior of full composite structures using rigid link elements. Previous studies validated the eccentric beam model by performing numerical modeling of slab on girder bridges (Chan and Chan 1999), composite steel girder bridges (Chung and Sotelino 2005), and PSC girder bridges (Chung et al. 2005), which was compared with experimental demonstration. The PSC box girder and RC pier are modeled by a three-dimensional cubic element with a concrete rectangular box section and an RC rectangular section, respectively, provided in Zeus-NL. PSC tendon was rigidly connected to the box girder, and pre-tension load to the tendon was applied to represent pre-stressing of the box girder. A joint element was employed to describe the relationship of the pier and girder, and an equivalent spring element was utilized to model the boundary conditions at each side

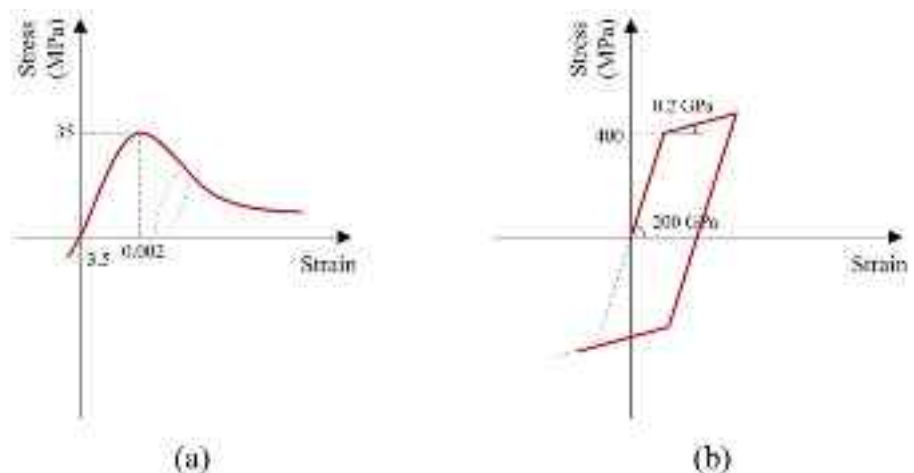
**Fig. 10** Stress–strain curves of **a** concrete and **b** reinforcing steel

(Wilson and Tan 1990). In piers, vertical reinforcing steel bars were modeled to be 29 mm in diameter with 150 mm intervals. The concrete and reinforcing steel were modeled by a uniaxial constant confinement concrete model and a bilinear elasto-plastic model with kinematic strain-hardening model, respectively (Elnashai et al. 2010). Figure 10 shows stress–strain curves of each material, and the strength of concrete is 35 MPa and the one of steel is 400 MPa. The application of such models to consider nonlinear behavior of concrete and steel can be found in previous studies (Moon et al. 2018 and Lee et al. 2021). For the numerical modeling of the deteriorated bridge, the damage index was used as a percent reduction in elastic modulus, which is experimentally demonstrated by previous research (Yoon et al. 2022). For the material property of each bridge region, the reduced elastic modulus was applied to take into account the results of the deteriorated bridge in Table 4.

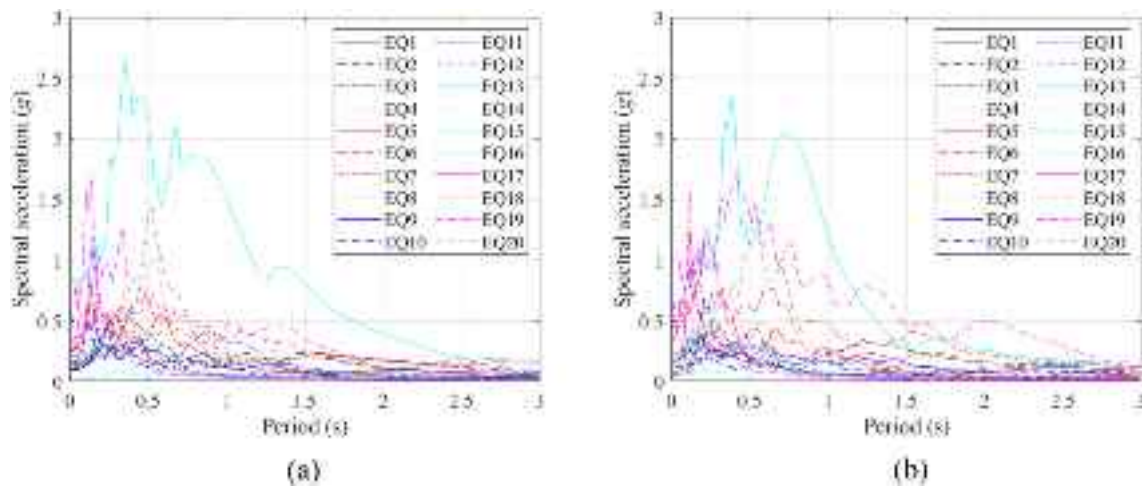
**Fig. 12** Acceleration response spectra with 5% damping for the selected input ground motions in **a** longitudinal and **b** lateral directions

Using the deteriorated bridge FE model developed in this study, nonlinear time-history analysis was performed in this section. In the analysis, twenty input ground motions were utilized to consider the uncertainty of earthquake ground motions, and both horizontal components of each input ground motion were applied simultaneously. The ground motion of vertical direction is much smaller than that of the longitudinal and later directions, and thus, vertical acceleration was not considered in seismic analysis. Table 6 represents the selected input ground motions, and Fig. 12 shows acceleration response spectra with 5% damping for the selected input ground motions in both longitudinal and later directions. PGA was selected as IM,

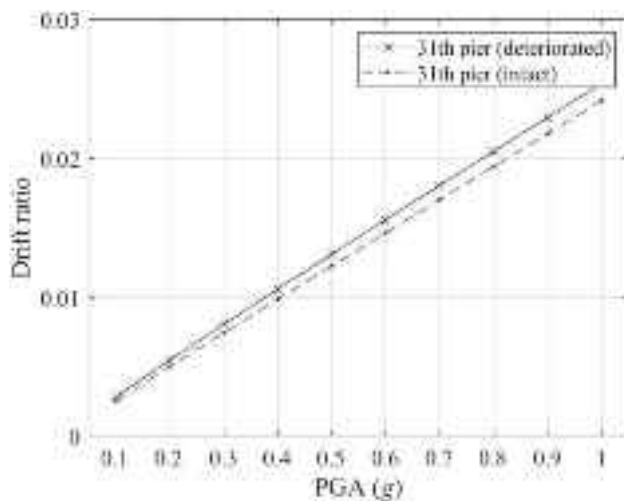
**Fig. 14** Comparison results of the 31st pier PSDMs**Table 9** Drift limits for each damage state (Dutta and Mander 1998)

When comparing the seismic demand for the deteriorated and intact bridges, seismic demand for the deteriorated bridge was larger than that of the intact bridge. In Fig. 14, comparison results of PSDMs for the 31st pier are presented. As shown in the figure, it was identified that the deteriorated pier requires relatively large seismic demand than the intact pier at all PGA levels considered

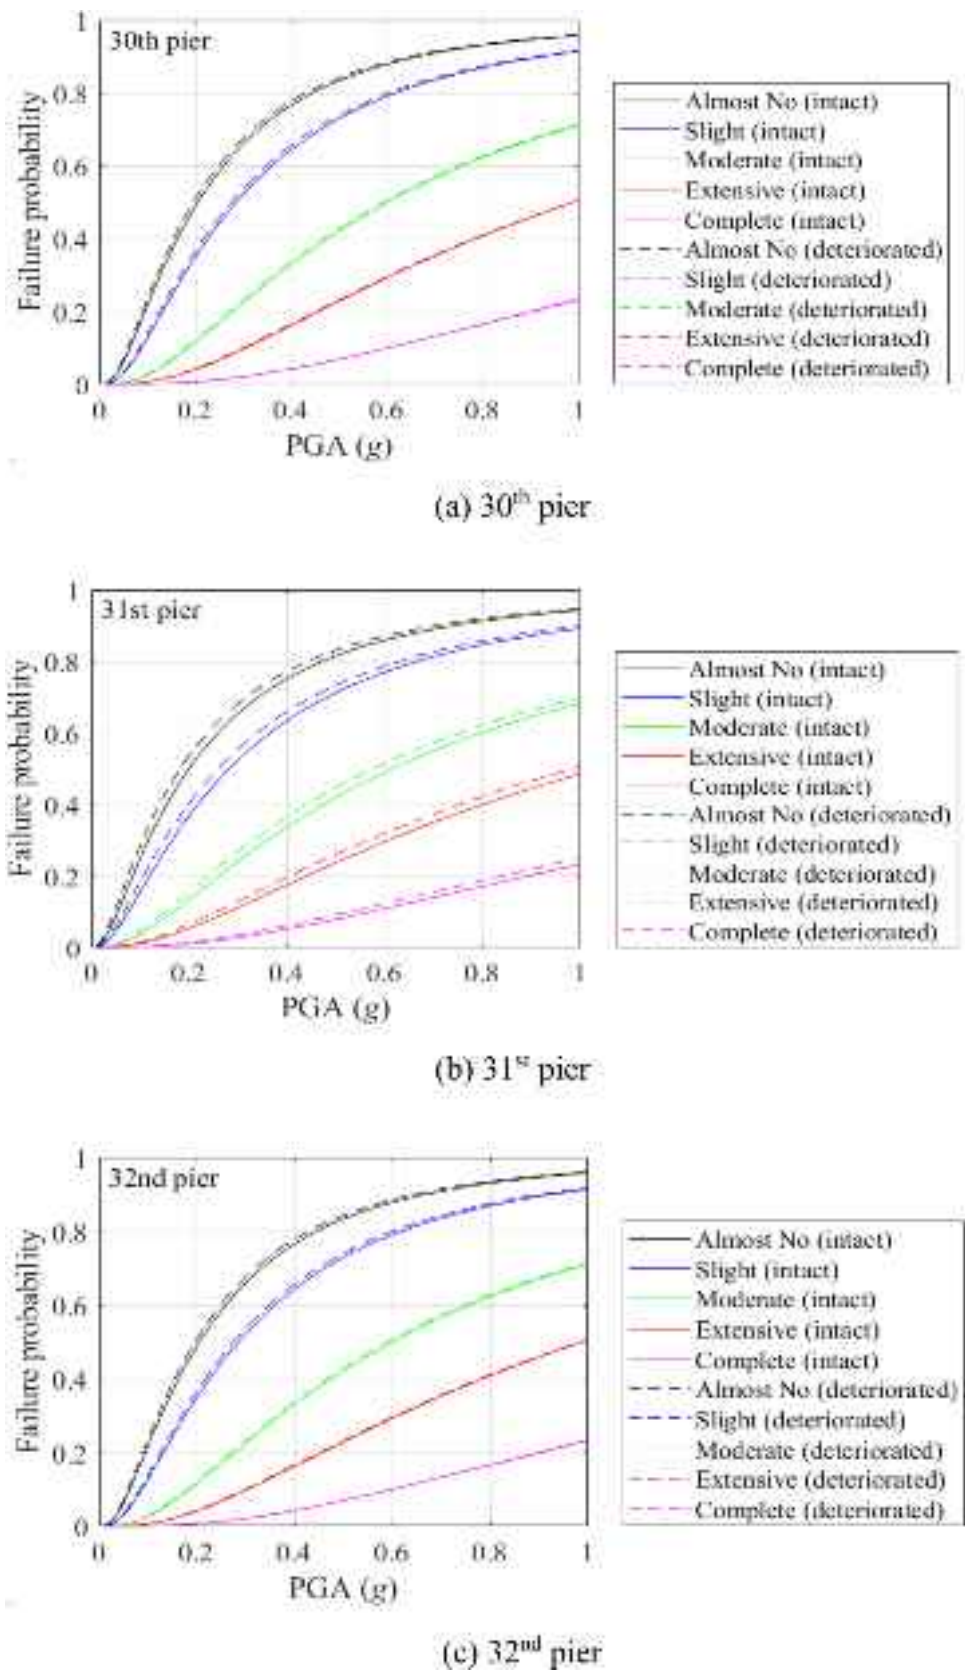
**Fig. 15** Seismic fragility curves of the deteriorated and intact bridge

From the calculated failure probabilities, seismic fragility curves were derived for each pier as presented in Fig. 15. In addition, the fragility curves of the deteriorated bridge were compared with those of the intact bridge. Overall failure

probabilities of the deteriorated bridge increased due to the detected crack damage which resulted in the reduction of elastic modulus. The damage grades of the 31<sup>st</sup> and 32<sup>nd</sup> piers were more severe than that of the 30<sup>th</sup> pier, but the structural response of the 30<sup>th</sup> and 32<sup>nd</sup> piers did not significantly influence the seismic fragility curve due to the

boundary condition of the PSC box girder (Note that both sides have equivalent spring element for connectivity). For this reason, a larger increase in failure probabilities was found at the 31<sup>st</sup> pier, and especially, the maximum difference of failure probability between the intact and deteriorated bridge was 3.6% at 0.1 g PGA, which was observed at almost no damage state. As the PGA increased, regardless of the damage state, the failure probability of deteriorated bridge was greater than that of an intact bridge. However, the effect of deterioration does not affect the failure probability of the intact and deteriorated bridges when the damage states are not severe after a certain PGA level (in case of almost no damage or slight damage).
