Article

A Comparative Study of Bridge Inspection and Condition Assessment between Manpower and a UAS

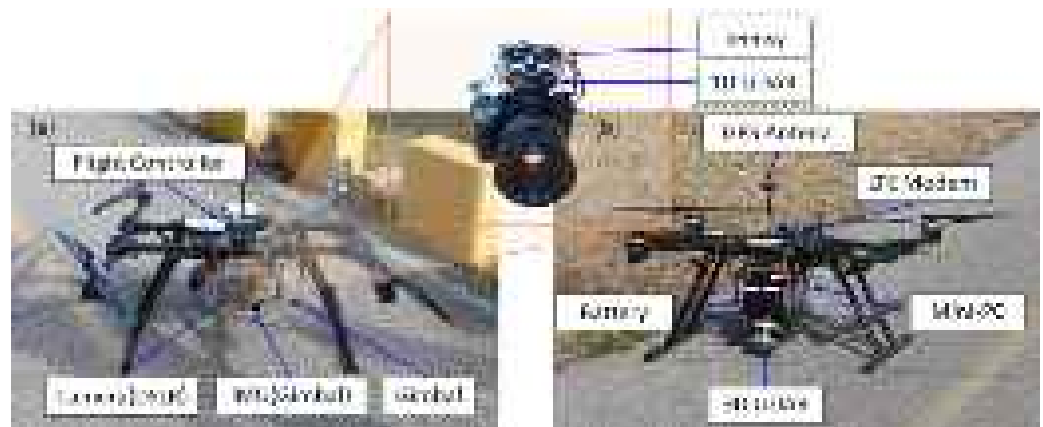
Figure 2. Developed UAS for bridge inspection (a) Front View (b) Rear View.

between a GCS and a UAS, and wind resistance capacity against gusts (i.e., maximum 10 m/s) is required. Therefore, a quad-rotor type UAV was developed to be suitable for bridge inspection in this study. Basically, a gimbal that can rotate 90 degrees up and down for checking the bridge deck was mounted, and the UAV was designed to reduce the interference between the gimbal and the propellers. The UAV's flight controller used a Pixhawk 2, equipped with a mini PC (i.e., Intel i7 NUC), 3D LiDAR (i.e., Velodyne Puck lite), and LTE modem for location estimation and autonomous flight. Figure 2 shows a customized UAV equipped with various sensors. The location recognition algorithm was used by improving the graph-based SLAM algorithm. Graph-based SLAM expresses the position and movement of the UAV with nodes and edges like a graph. Here, the node means the pose of the UAV, and the edge between the two nodes is the odometry information between the positions of the UAV and is called a constraint. Therefore, the UAV moves and creates nodes and constraints using odometry information. It acquires information in 3D space through pre-flight and recognizes the same location through newly acquired data and information in the main flight. Moreover, the position is estimated by adding a constraint between non-contiguous nodes and optimizing the graph. It has been improved by constructing the visual inertial mileage using the camera and IMU and generating a normal distribution transformation using 3D LiDAR to generate the base node [32,33]. As a result, it was possible to secure the stability of the basic node generation and to perform autonomous flight on the bridge deck. In this study, a flight path was generated by converting 3D into 2.5 dimensions (i.e., 2D and height) in consideration of the speed and computational power of creating a path in a 3D environment. In addition, the Teensy board on the camera stores the GPS obtained from the location recognition algorithm, 1D LiDAR for measuring distance, and IMU from the gimbal. Therefore, the position coordinate of the image could be estimated through transformation for each coordinate system. This can be used for missing area detection, which will be described in the next subsection, as well as obtain information on each pixel size of the image. As a result, information on the size of the detected damage can be derived from the acquired images.

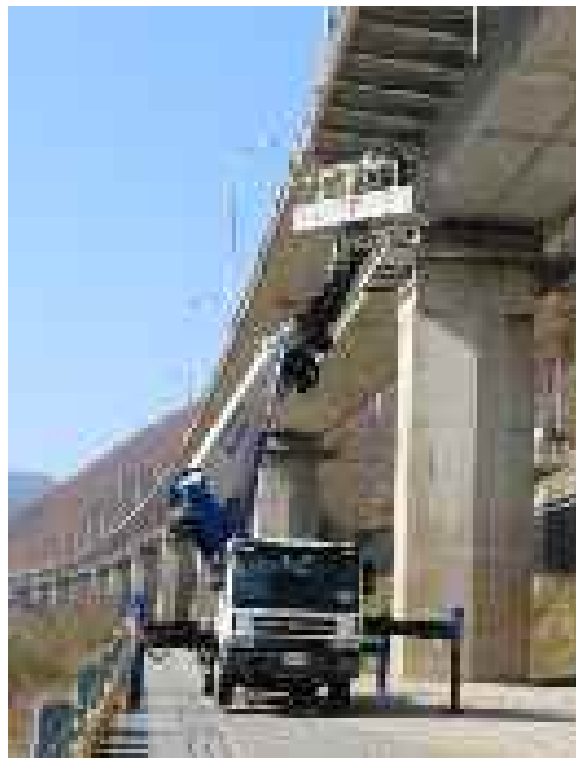
Figure 12. Bridge inspection comparison experiment.

In order to perform the UAS-based inspection and the manpower-based appearance inspection on the target bridge, the manpower-based inspection was performed with a ladder truck as shown in Figure 12. The manpower inspection consisted of a ladder truck driver and two bridge inspection experts, and the bridge inspection was performed through visual inspection. In addition, the inspection of the UAS-based bridge was performed by a UAS pilot and co-pilot.

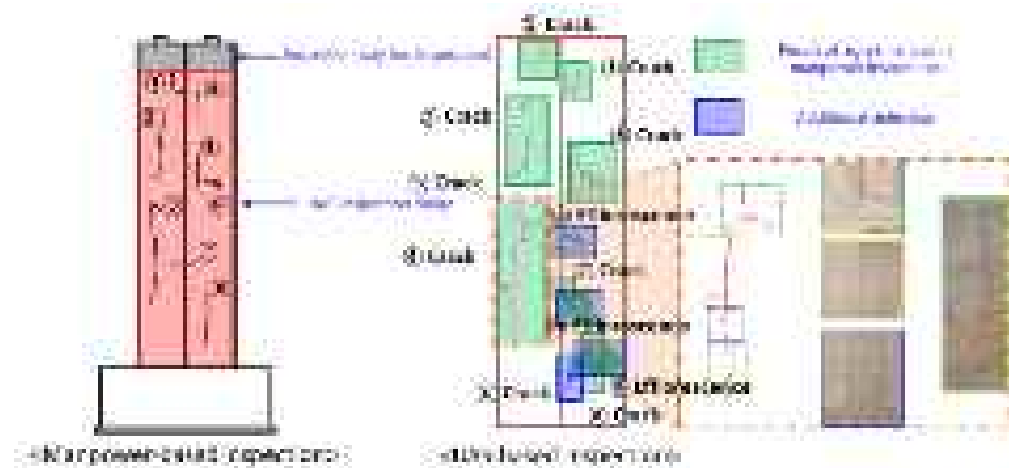
Figure 13. Comparison results in case of the pier(P-31).

For comparison of the two inspection methods, an experiment was performed on the same member, and the area where the railing structure was installed above the pier was excluded from the inspection for safety reasons. Figures 13 and 14 show examples of human-based visual inspection and UAS-based bridge inspection results for concrete piers and steel box spans, respectively. In the figure, the gray area indicates the inspection exclusion area, the green box indicates the damage that matches the human inspection result, and the blue box indicates the damage that was not found by the human inspection but was additionally detected by the UAS-based bridge inspection. As a result, the UAS-based inspection results found all damage detected through the human-based visual inspection results, and efflorescences were additionally detected. The reason for the additional detection of efflorescence was that the color of the concrete surface was changed and efflorescence was in progress, which was confirmed by bridge inspection experts. This shows that damage progress can be detected through UAS-based bridge inspection. In addition, it can be

confirmed that the detailed shape of the crack, which was difficult to express specifically with the conventional visual inspection method, can be expressed as shown in Figure 13. In this study, the objective of this study was to quantify the 0.3mm crack corresponding to the C grade in the relative evaluation grade of the concrete bridge. This requires keeping the UAS close to the structure, which results in a small field of view (FOV). Therefore, it is difficult to confirm the shape of a long crack with only one image. Moreover, extracting feature points from multiple images and stitching them is not easy. In this study, to solve this problem, the damage was connected using the coordinates of the four vertices of the image. In the results of the UAS-based check-in Figure 13, the inset represents the results of this check. In steel box girder, corrosion of steel and bolts, painting peeling, and steel member deformation were detected as shown in Figure 14. However, since the steel member deformation was not included in the damage detection range in this study, it was not confirmed in the UAS-based bridge inspection results. In the results, both inspection methods did not detect cracks in the steel bridge. If a crack is found in the steel bridge, it is judged to have a significant structural defect and cannot be serviced. For this reason, most steel bridges in service are practically free of cracks. However, even if there are cracks, it will be difficult to detect fine cracks using general vision-based object detection. In addition, the steel member is coated by paint, so it is impossible to detect the cracks inside. To solve this problem, an attached-type UAV equipped with a laser module and a thermal imaging camera was developed and applied to apply active-thermography in this project. However, the results of these techniques are omitted because an attached-type UAS is not the scope of this paper.

In the results of the damage map, the damage to the steel box girder and the concrete span did not significantly affect the bridge damage grade. Therefore, only the damage detected in the pier was quantified and shown in Table 2. In the table, the same damage as the result of the manpower test is indicated by the same number as in Figure 13, and the damage additionally detected in the UAS test is indicated by an alphabet, and the width(mm) and length(mm) of the crack were denoted by cw and L , respectively. As can be seen in the table, the human-based visual inspection result has a rough value up to the first decimal place. However, UAS-based crack inspection results have more detailed values compared to human inspection. Additionally, UAS-based bridge inspections revealed four more damages (i.e., ①, ②, ③, and ④) more than the visual inspection for the same pier. One additional crack was found at the bottom of the pier, and the other three efflorescences were detected. Among them, efflorescence was calculated by multiplying the number of pixels and the size of the detected mask because it is calculated as the area(A, m) of damage corresponding to the evaluation of the bridge condition. In addition, the reason for the detection of efflorescence was confirmed to be due to the occurrence of discoloration on the concrete surface as mentioned above. However, efflorescence was confirmed by a bridge inspection expert, and it shows that maintenance can be performed in advance using the proposed damage detection method, although further studies may be needed. Other PSC girders, deck slabs and piers appeared similar to those shown in the damage maps and Table 2.

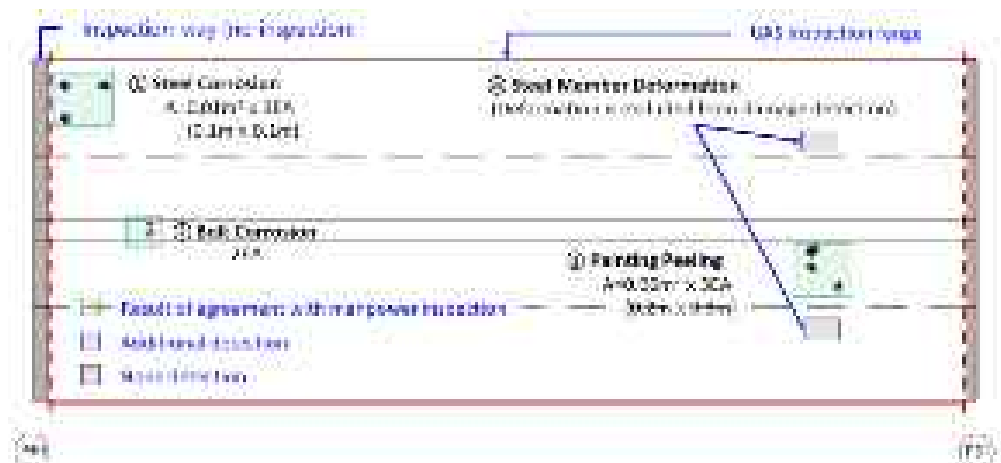
Figure 14. Comparison results in the case of the steel box girder.
