Drone-based impact-echo inspection system for non-destructive testing of concrete structures

Laboratory for Non-Destructive Evaluation, SVTI - Swiss Association for Technical Inspections, Richtistrasse 15, Wallisellen CH-8304, Switzerland

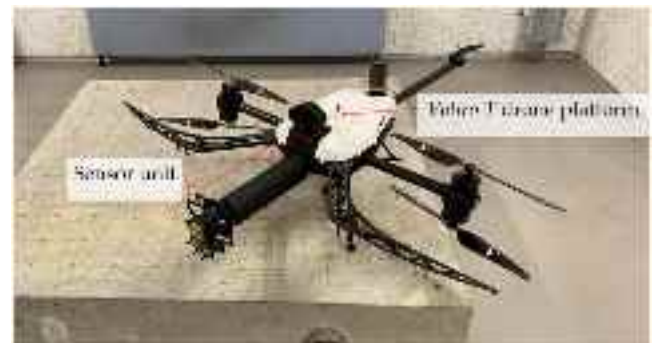
Fig. 1. Inspection drone with novel impact-echo sensor unit mounted.

The UAV inspection system used consists of the *Voliro T* flying robotic drone [20,49] and the novel sensor unit developed for this research. It is a unique platform suitable for contact-based inspection techniques. The flight controller has been developed by Kamel [19] with the specific purpose of enabling physical interaction between the drone and different structures. Fig. 1 shows the developed sensor unit mounted on the drone. The sensor unit is connected to the drone platform through a bayonet and is rapidly interchangeable. The payload-to-drone interface is designed such that it can supply 5 V and 12 V as well as transfer data through a USB or Ethernet protocol. The drone is complemented with two remote controllers; one is dedicated to the pilot and contains two first-person view (FPV) cameras, and the second is dedicated to the inspector and displays the collected time signals in real-time during the inspection. Each collected signal is finally stored together with the respective photo from the camera, which can be used in post-processing and reporting. The flight time with one battery is approximately 16 min and the batteries can be easily and quickly changed during the inspection job through a click closure. The position of the drone is controlled through GPS (in case of outdoor inspections) or optical flow sensors (in case of indoor inspections). The reading of the positioning accuracy of the measurement location can be further improved by equipping the drone with a laser reflector prisma and connecting it to a laser ground station. As of now, the flight controller of the drone has a manual pilot mode; however, automated flight modes along pre-defined flight paths, for instance, for automated grid collections, could be imagined to be implemented in the future.

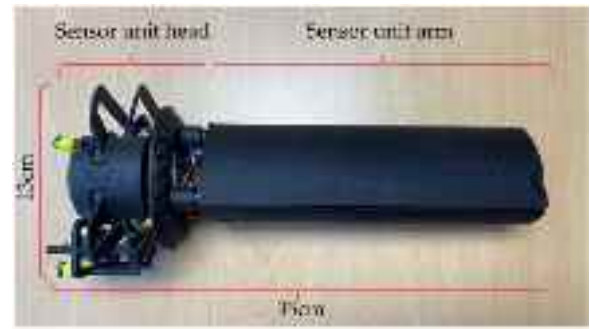
Fig. 4. Picture of the assembled sensor unit.

The assembled sensor unit is shown in Fig. 4. It consists of the sensor unit head and a sensor unit arm. The sensor unit head carries the sensor as well as the impactor through a sensor holder. The sensor unit arm houses the electronics, the sound card, and the payload interface. It also has an embedded status LED visible for the pilot during flight through the onboard camera that informs about the health status of the sensor before data acquisition.

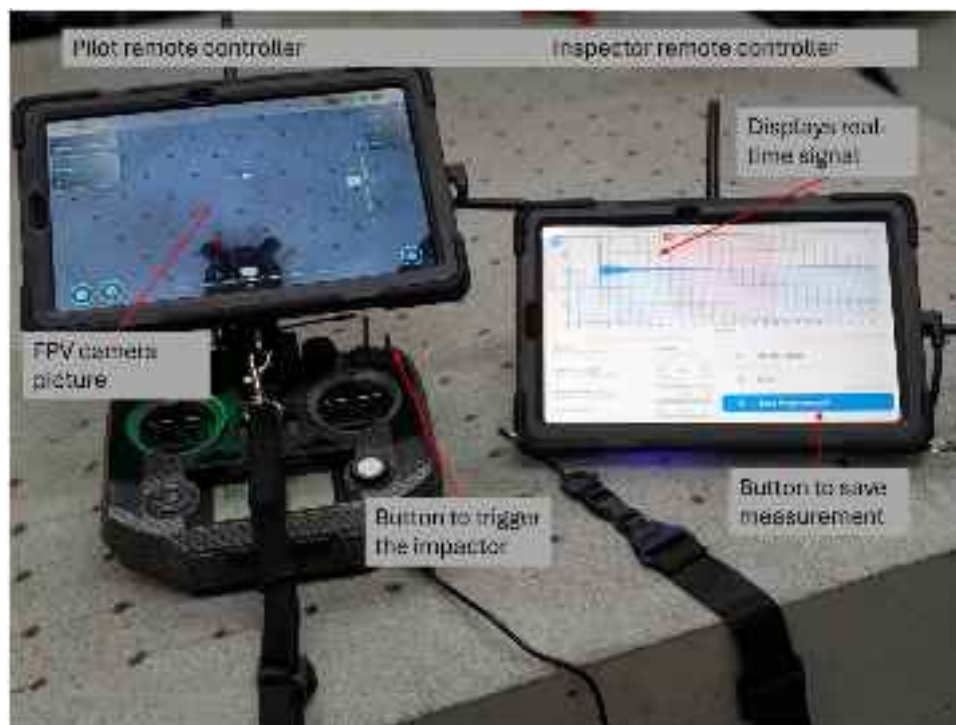
Fig. 3. Drone remote controllers, left: pilot remote controller and right: inspector remote controller.

quality. The inspection tablet with a live signal enables real-time assessment of coupling, as poor coupling results in a signal containing only noise, allowing for immediate corrective action and retaking the measurement in case of minor distractions, such as small pitch offsets. After the data collection the data is transferred to a computer and further processed in a volumetric manner (see Section 2.4). While data collection is fast and not very resource-intensive, the detailed signal processing requires in-depth analysis by a knowledgeable expert and is currently not easily automated. Therefore, the detailed signal processing and data analysis is performed afterwards on a laptop. Both remote controllers are shown in Fig. 3.

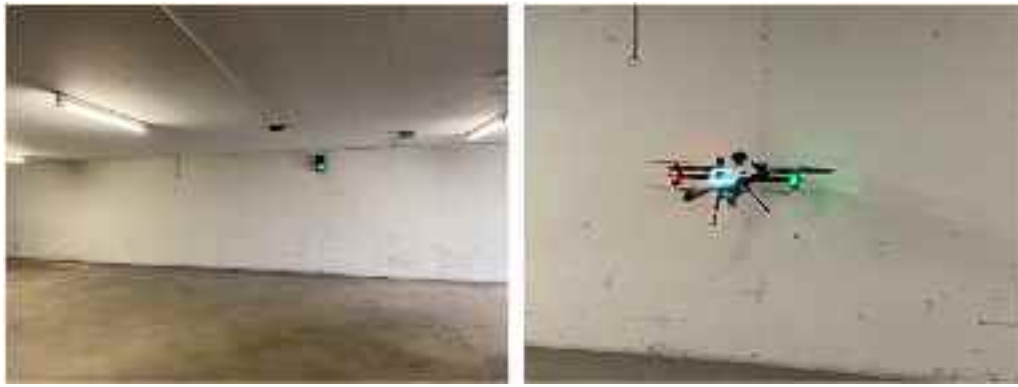
Fig. 8. Left: picture of the wall, and right: measurement location used in test 3 (flight test with vertical measurement).

The purpose of Test 3 was to demonstrate the drone's ability to perform impact-echo measurements in orientations beyond the horizontal plane measured in Test 1 and Test 2. Unlike previous experiments conducted on the same concrete reference block, Test 3 was carried out on a vertical wall shown in Fig. 8. The decision to use a wall, rather than the reference block, was necessitated by the latter's substantial weight and size, which precluded reorientation due to health and safety concerns. Consequently, the results of Test 3 are limited to a thickness assessment based on four impact-echo measurements collected along a horizontal line, rather than a grid acquisition with validation against a known reference. The wall thickness was determined with 8 manual impact-echo spot measurements at different locations on the concrete wall and showed a mean value of 24.1 cm with a standard deviation of

0.2 cm using a sound velocity of 4030 m/s for evaluation of the thickness. This value was used as a reference for validating the impact-echo thickness assessment in Test 3. This test provides a preliminary insight into the system's performance when applied to in-situ conditions and different pitch angles than shown in Test 1 and Test 2. Besides showcasing the system adaptability to different surface conditions and pitch angles, Test 3 also underlines the system's feasibility in obtaining meaningful thickness profiles and impact-echo data even with a limited set of measurements.

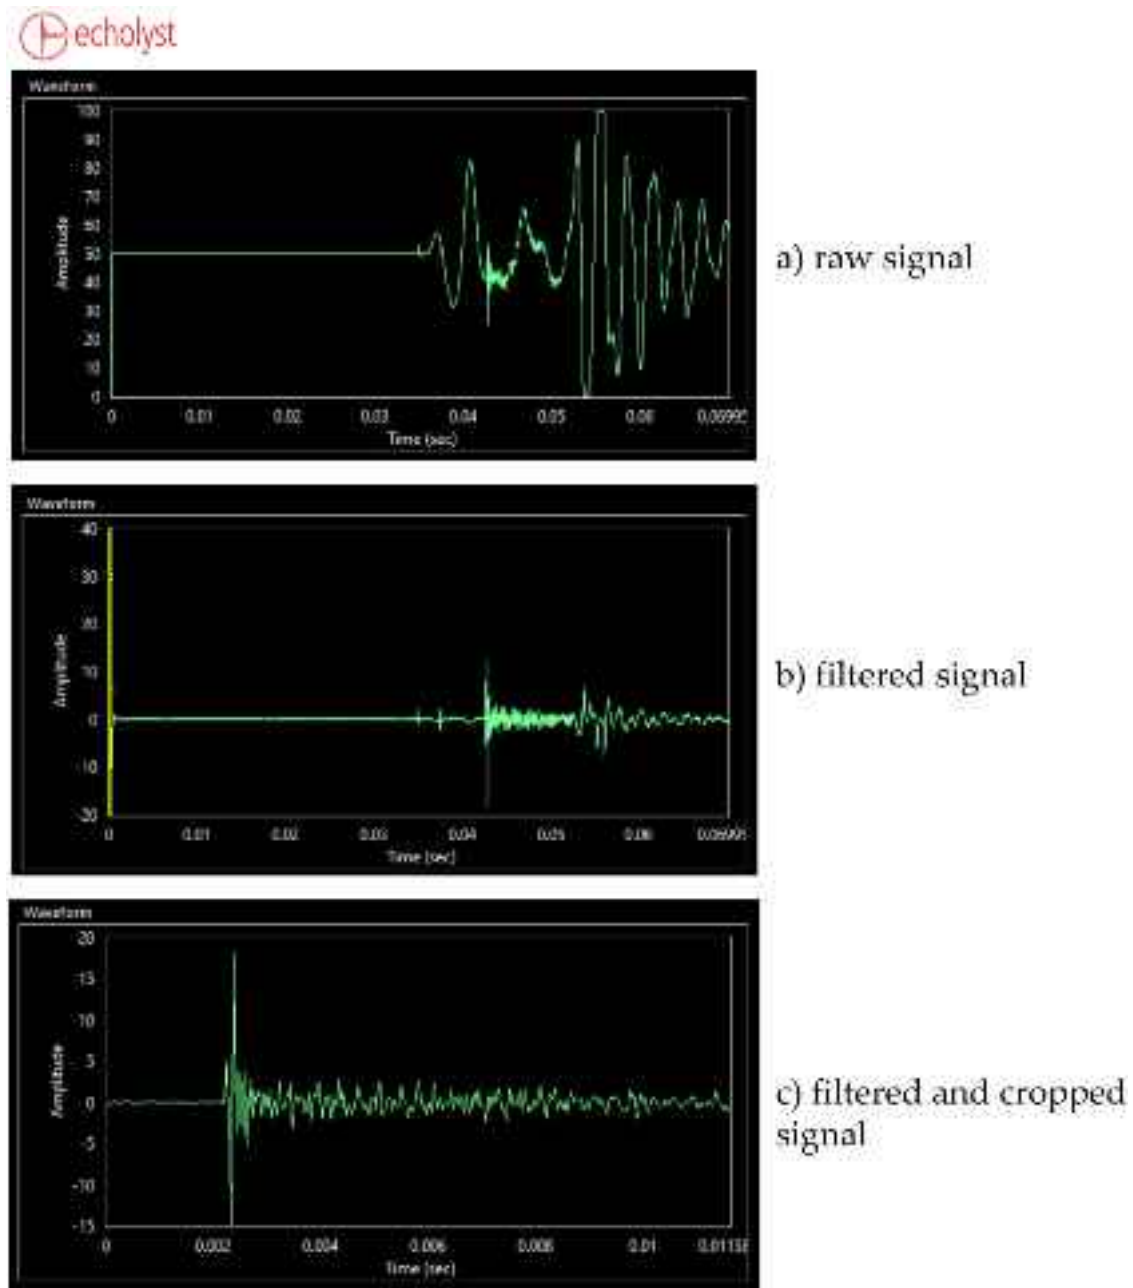
Fig. 10. Example time domain waveform collected with the drone and signal filtering and cropping before analysis: (a) raw signal, (b) filtered signal, and (c) filtered and cropped signal.

representation of the gridded dataset. The original signals obtained with the drone are 90 ms long. This interface crops each original signal into a section of interest spanning over 15 ms and containing the impact-echo signal. As an initial step, the original signal is filtered using a high-pass filter. The cut-off frequency can be manually adjusted by the inspector and is usually set around 1.5 kHz. This also ensures that the rotor-induced vibrations are filtered out which are below 100 Hz in the current experimental set-up. In the next step, the onset of the impact-echo signal was identified by looking for an amplitude rise above an arbitrarily set threshold in order to distinguish the signal of interest from the noise. The threshold value was selected based on multiple laboratory experiences and observation of the expected amplitude response from the concrete structure. An example of such amplitude response is illustrated in Fig. 10, which shows a standard raw signal collected during flight testing and containing an impact-echo response with an onset at around 35 ms.

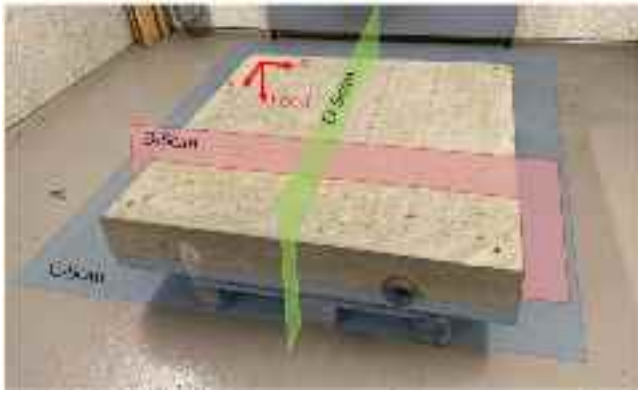
Fig. 11. Definition of B-, C-, and D-Scans illustrated on the concrete test block. Note that in the axis direction f or d may be represented as frequency (f) or thickness (d) in the scans.

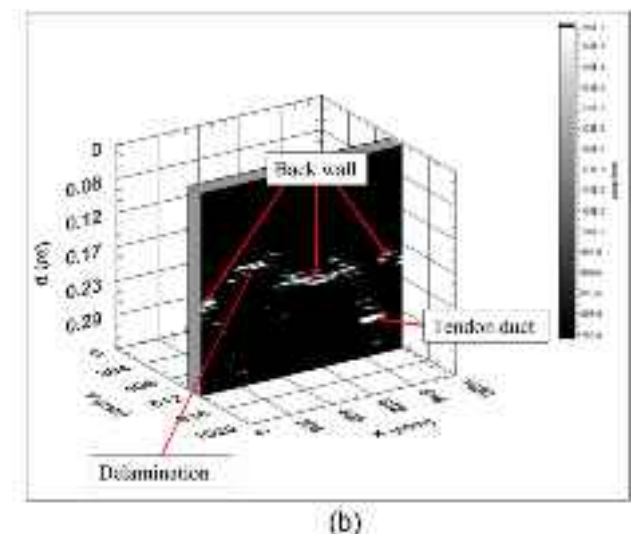
Fig. 12. Results of the reference ground testing dataset.

This section shows the results of the reference ground testing, also referred as Test 1 (as introduced in Section, 2.3), obtained using the *echolyst* software. Fig. 12a) shows a thickness profile obtained from the reference dataset. This thickness profile provides an overview of the dominant frequency component found in the individual spectrum of each of the impact-echo signals from a gridded dataset.

Fig. 12b) shows a cross-section (B-scan projection) of the block, at a distance of 600 mm along the y-axis. This cross-section is strategically positioned to cross both the delamination and the tendon duct perpendicularly. Note that the bandpass filter setting of the software was left on its default settings (respectively 5 kHz high-pass and 18 kHz lowpass cut-off frequencies) for the data processing and visualization.

The main features of the test block are observable in the frequency response: the orange blob on the left side and the blue line on the right side of each image are consistent with the shape and position of the delamination and the tendon duct. The dominant frequency found around the delamination area is 13 kHz which corresponds to the expected depth of 150 mm (based on Eq. 1 and the set wave velocity of 4030 m.s⁻¹). Similarly, most of the background representing the back wall has a frequency of 10 kHz, corresponding to the block's thickness of 200 mm. The main frequency of the tendon duct is 7 kHz, which corresponds to a depth of 276 mm, hence placing the duct deeper than the back wall; however, Eq. (1) (which is based on the Lamb waves' behavior) does not apply to shallow objects. Instead, in shallow regions

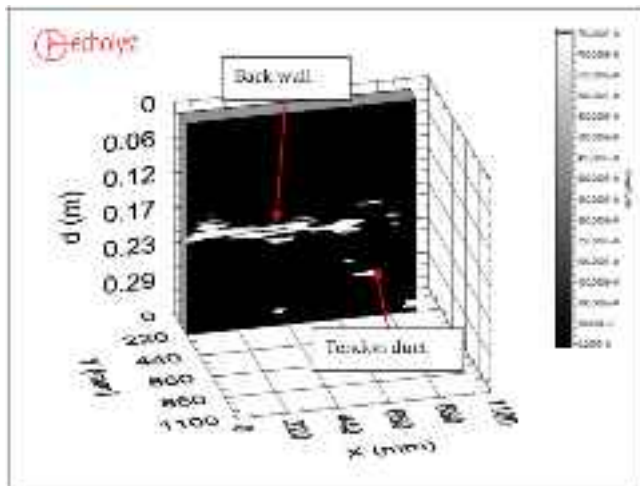
Fig. 16. B-Scan of the measurements at the test block visualizing the tendon duct at $y = 200$ mm.

closer to the edge of the concrete test block ($y = 200$ mm) is shown in Fig. 16. The B-Scan shows the back wall as well as the tendon duct. As expected, the delamination is not visible anymore at this location. With this strategy of analyzing the B-Scan subsequently at different locations the size and specifically the x- and y-extension of the delamination can be determined which is particularly important for diagnostics and assessments of built infrastructure and to achieve a good data basis for repair decisions.
