A robotics and computer-aided procedure for defect evaluation in bridge inspection

Abstract

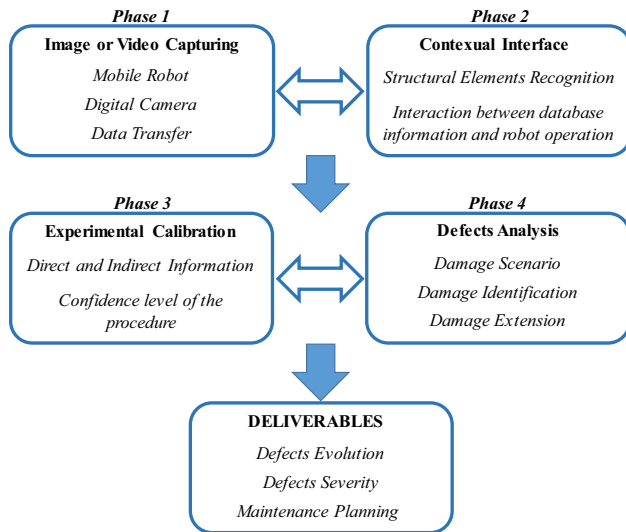
Fig. 1 Novel framework of the defect evaluation for image-based bridge inspection

The flow chart in Fig. 1 describes schematically the proposed procedure showing also the outcome: fast damage evaluation, defects evolution, defect severity and maintenance planning. In the block diagrams, the horizontal arrows indicate that the procedure can be reiterated based on the information obtained by a specific phase.

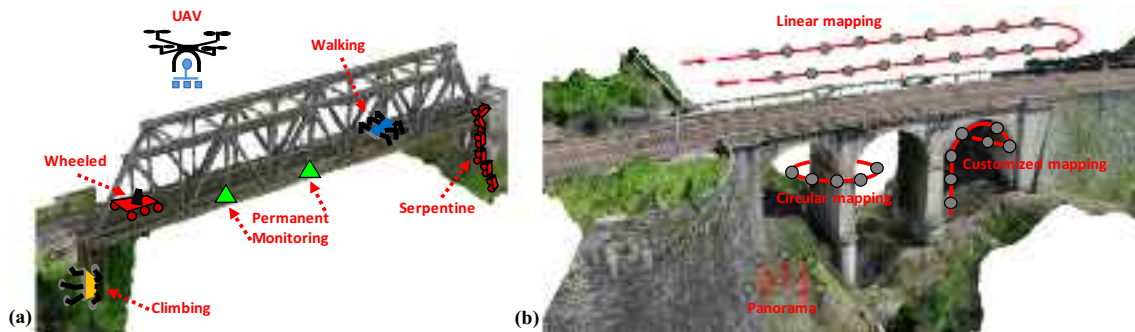
Fig. 2 Bridge image acquisition: **a** automatic/robotic systems, **b** path planning for an automatic/robotic access

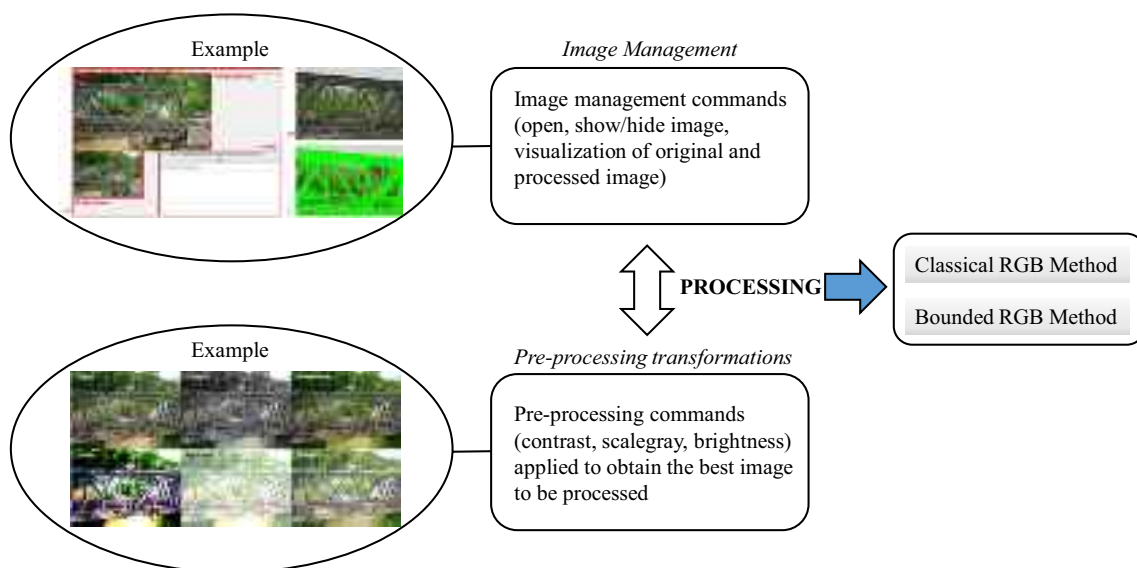
Fig. 3 Flow chart that highlights the main characteristics of the DEEP software

When the software is started the menu permits to activate the classical commands needed to manage an image, such as open, show/hide. Subsequently, the toolbox can be activated to carry out some pre-processing transformations such as

gray scale, brightness, contrast. These two command areas can be used to get the pre-processed image.

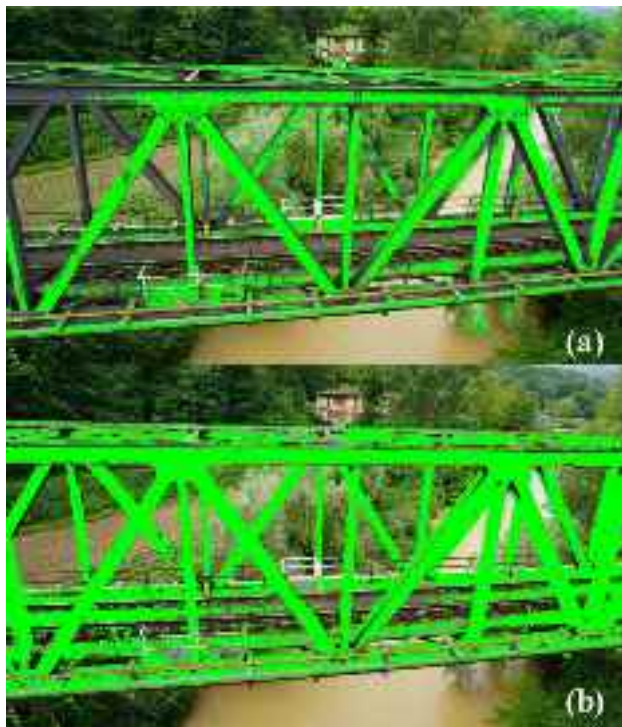
Fig. 4 Result coming from Classical RGB Method (a) and Bounded RGB Method (b)

The B-RGB command carries out a search of the pixels whose RGB color satisfies Eqs. (1)–(3). The procedure is called bounded RGB method because it has to fulfill different constraints, as illustrated in Fig. 4b.

The output of the processed image shows an improvement if compared to that obtained through the previous analysis (C-RGB). Indeed, almost all structural elements have been entirely selected especially regarding the external and vertical ones.

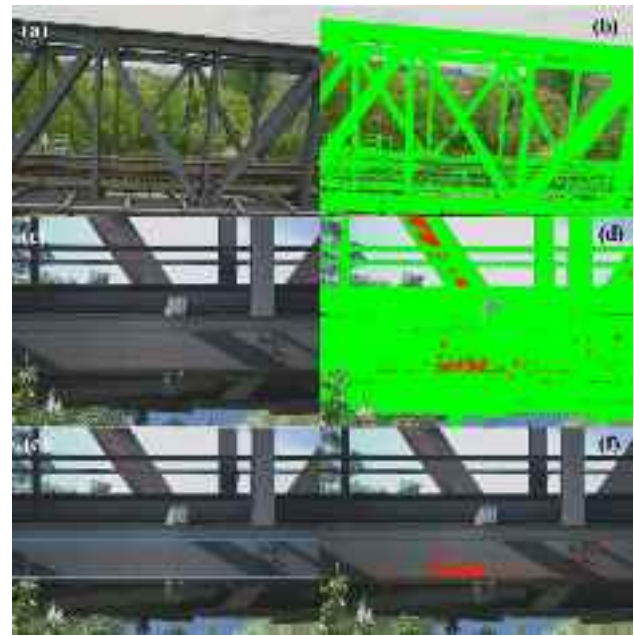
Fig. 5 Steel bridge A: **a**, **c** and **e** original and **b**, **d**, and **f** processed images: structure and defect recognition

Figure 5a, c and e are related to the original images while Fig. 5b, d and f are the processed ones. Three different targets have been pursued in these analyses: in the first case (Fig. 5a, b) only the element recognition, in the second both element and defect, while in the third one only defect. It is worth to note that in all processed images, the green color is referred to the element, while the red one to the defect. This is only a choice of the authors to better identify and highlight the corresponding areas and so it has no relation with the RGB values.

In particular, in Fig. 5d it is shown the ability to capture also paint absence in structural elements not in foreground as the red area found also in the diagonal brace in the background.

Instead, the third processing concerns only one structural element, i.e. the longitudinal and horizontal beams picked out by the blue lines in Fig. 5e. In this case, the method can be also used to investigate the evolution of a local material degradation.

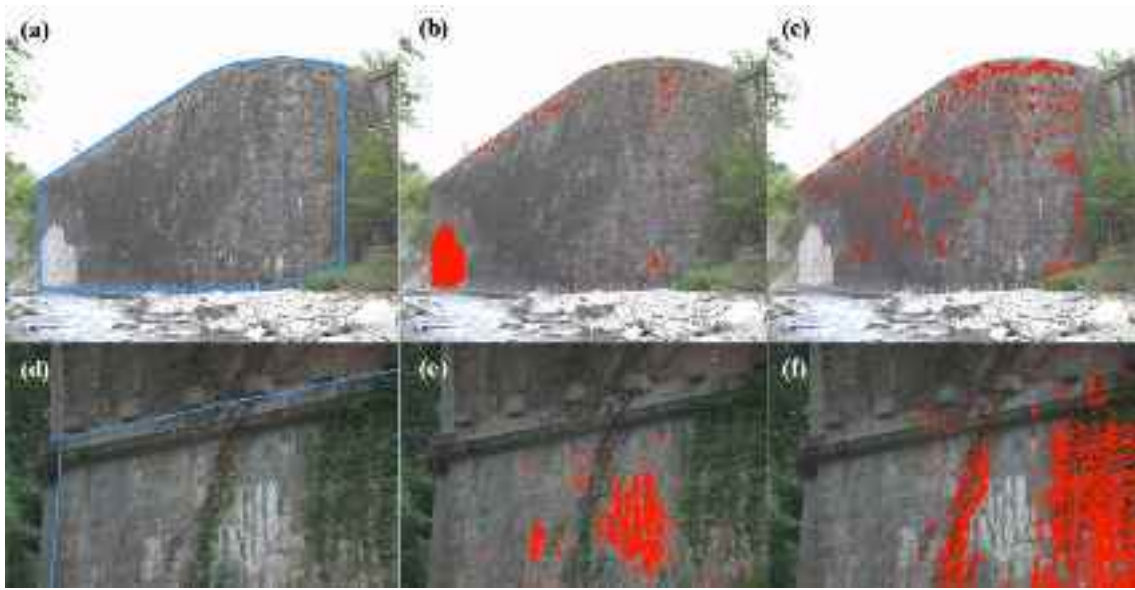
Fig. 6 Elements and defects of masonry bridge B and C: **a, d** original images, **b, e**, efflorescence, **c, f** vegetation

Figure 6 shows the obtained results in the defects analysis conducted on the masonry retaining wall of the shoulder and the pier of the arch for a masonry bridge. Even in this case, in Fig. 6a and d the original images are given. The aim of the image processing is to show the ability of the procedure to recognize two typical masonry defects: contemporary presence of both efflorescence and vegetation. The exact area to be investigated has been indicated by a contour with blue lines (Fig. 6a, d). Fig. 6b, e try to identify the efflorescence. In the literature, this physical effect is related to the migration of a salt on the porous masonry surface phenomenon where it forms a coating. Usually, these occurrences are transient events especially at the end of the construction phase but they can become chronic due to the presence of the surrounding terrain, behind the porous material or due

to polluted rains. In particular, this damage is primarily aesthetic, but it can induce also degradation in the mortar and bricks. For example, in Fig. 6a is well-visible a wide zone affected by efflorescence (lower left) while other smaller parts are spread especially in the top of the masonry. Such areas have been taken looking to the results in Fig. 6b. For the same image, the vegetation is widespread in all surface and even in this case there is a correspondence between defect and the highlighted pixels (Fig. 6c). Interesting it is to note how in the masonry C (Fig. 6d) the efflorescence defect is collocated between two areas defected by vegetation.

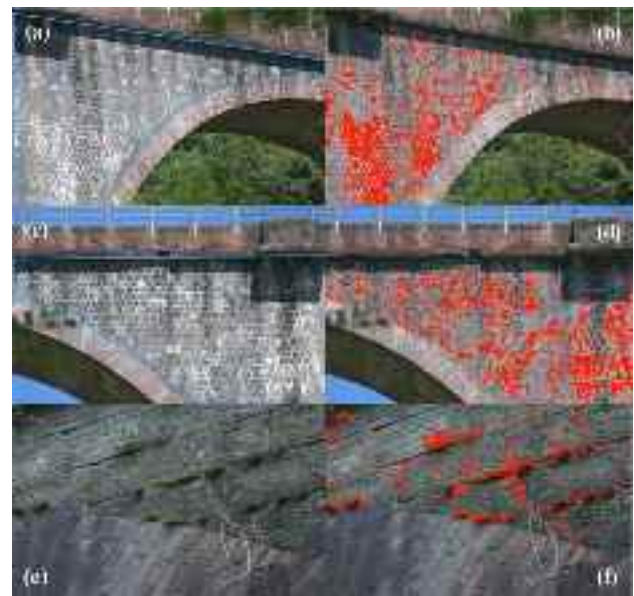
Fig. 7 Masonry bridge D: **a–d** original images and efflorescence defect. Masonry bridge E: **e, f** original image and vegetation defect

The defect highlights the shape of the brick and it is clearly identified in the corresponding processed images (Fig. 7b, d). In the left part of Fig. 7c and d, where is depicted the masonry arch, a portion of the element is hidden by leaves that are in foreground and blurred due to the distance with respect to the observed object. However, the element for which the defect is evaluated is not affected by this disturbance. In Fig. 7e and f, the vegetation in the brick joint is precisely evaluated.

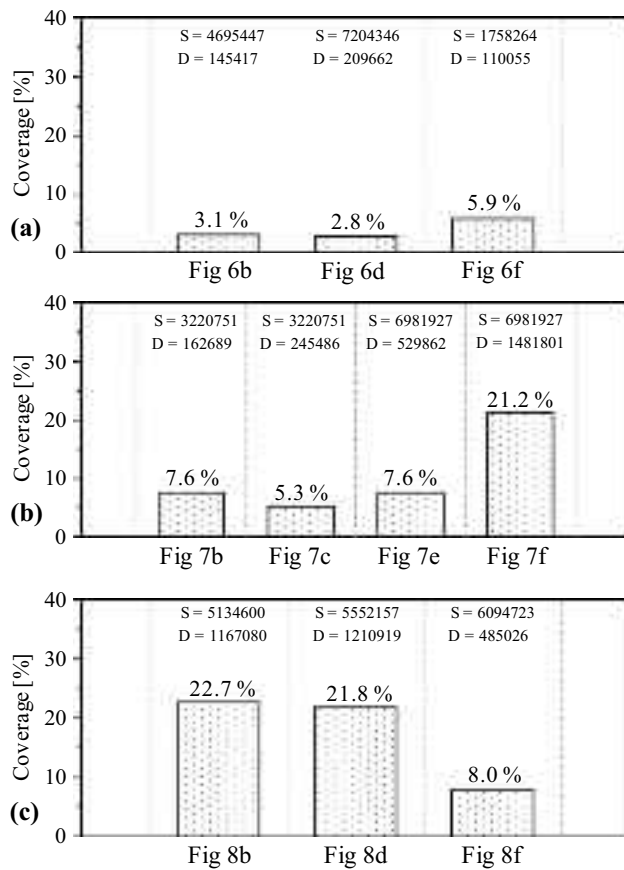
Fig. 8 Presence of the defect in percentage for the processed images. *S* and *D* indicate the number of pixels for structure and defect, respectively

Figure 8 reports a quantitative evaluation of the defect extension conducted through the newly developed software DEEP. For each analyzed image previously presented, the percentage of surface covered by the defect has been calculated with respect to the relative structural element. Such

percentage has been measured through the pixels' ratio between the number of pixels associated with the selected structural element and the ones associated with the defect. For this reason, in each corresponding figure the upper part of the table presents the number of pixels for the structure (S) and for the defect (D). Moreover, Fig. 8a summarizes the results obtained in the evaluation of the number of pixels related to a defect with respect the number of pixels related to an element of the steel bridge, while Fig. 8b and c for the masonry ones. In the first case, the evaluation conduces

Differently, in Fig. 8b a relatively large portion of the considered element has been found affected by a defect of vegetation.

The result agrees with a rough visual estimation of the inspector, which can look directly at the original image (Fig. 6d). Instead, in Fig. 8c the displayed results show that looking at two different portions of the same bridge an exact comparison of defect extension can be done only through the proposed procedure, which permits to determine, in a situation difficult to analyze by the inspector, which is the portion of the bridge more affected by the efflorescence defect. The developed tool permits a fast evaluation of the defect extension based on the RGB method. The procedure appears reasonable for the aim of the entire process and for its capacity to be automated in the processing of a large number of images. The proposed DEEP software can be used for other types of defects, which are characterized by evident superficial color change by properly setting the ranges of the parameters.

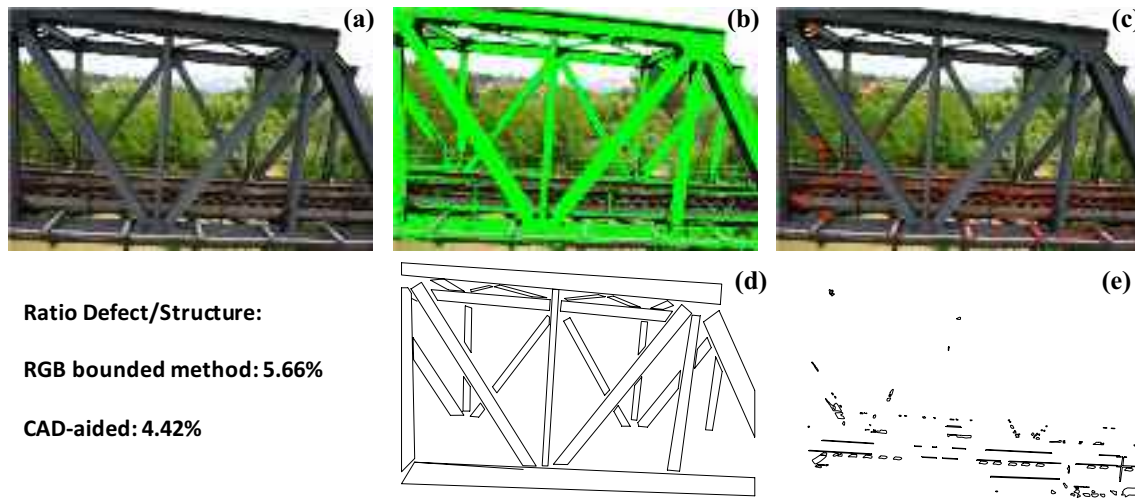
Fig. 9 Comparison between the results obtained through the RGB bounded method and a CAD-aided one: **a** original image, **b** structure and **c** defect detection in RGB bounded method; CAD-aided procedure: **d** structure and **e** defect

Figure 9 shows a comparison between the results obtained in the defect extension evaluation using the RGB bounded method (Fig. 9b, c) and a CAD-aided procedure (i.e. by tracing the edges of the structure and defect in computer-aided design, CAD, environment from the original image, as provided in Fig. 9d and e).

1. both methods depend on the image resolution;
2. regarding the area related to the elements, a manual selection provides more accurate results, while the RGB bounded one is faster;
3. differences between the two procedures can be assumed as minimal (indeed, the ratio between the defected area over the structure is 5.66% and 4.42% for the RGB bounded method and the manual one, respectively);
4. RGB bounded method provides a greater percentage value because a few number of pixels have been associated with other objects, highlighted in the background.

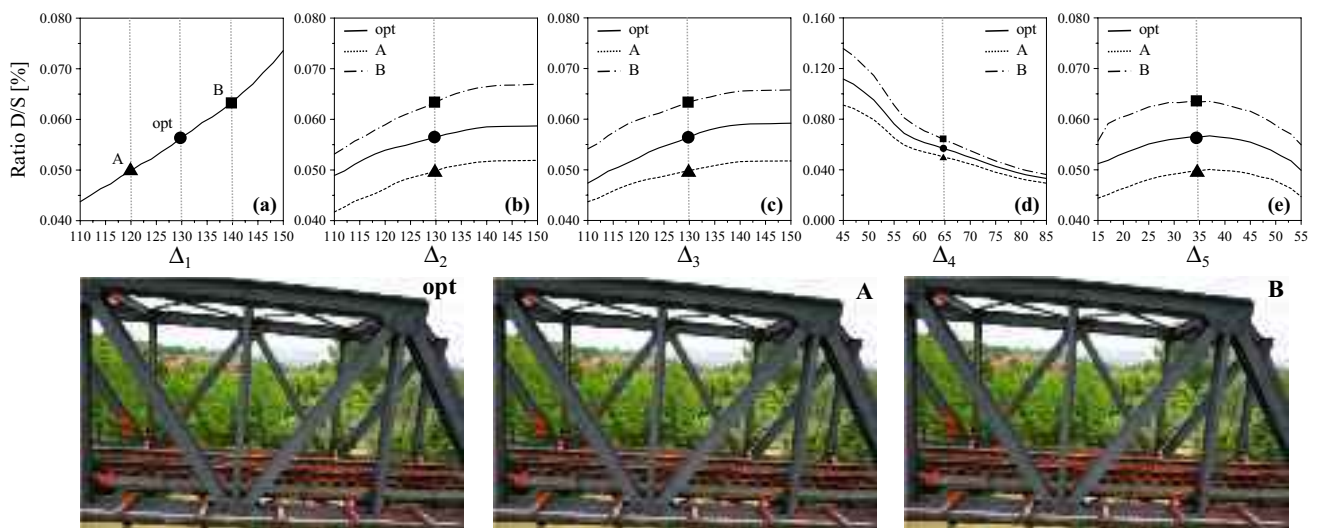
Fig. 10 Sensibility analysis of the Paint Absence defect conducted by varying the limits of the intervals in the Eqs. (1)–(3). The images below are related to the ranges defined in the corresponding of points opt, A and B

The defect percentage D/S has been evaluated by varying one of the range variable defined by Eqs. (4)–(8) and keeping the other ones fixed to the values used in Table 4. In Fig. 10 are reported the results of this analysis related to the case of the Paint Absence defect. Figure 10a shows the variation of the first variable Δ_1 corresponding to the interval of the red color of Eq. (1). The label “opt” is used for optimal value Δ_1 of the Paint Absence defect (in Table 4, $\Delta_1 = 130$). The label “A” represents the varied value $\Delta_1 = 120$ and “B” the varied value $\Delta_1 = 140$.

1. from the first three figures, it can be observed that among the RGB-parameters, the one more sensitive to the analyzed defect extraction is the Red color.
2. even if there are differences in the choice of the range Δ_1 (from 120, A-point, to 140 B-point) large changes of the evaluated damage percentage are not observed. Indeed, looking at the reasonable minimum and maximum val-

ues that should be considered, which are correspondent to the triangle and square symbols respectively, the difference in the obtained results in terms of defect extension is about 1%. This observation can be supported by looking at the processed images reported in the lower row of Fig. 10. The paths corresponding to the ranges of the A-point, opt-point and B-point are very similar each other in Fig. 10a–e.

3. when the range for the choice of the R-parameter is very large (B-point) the damage percentages assume the highest values vice versa in the A-point (narrow range).
4. finally, in the Fig. 10e three maximum points can be observed, one for each path. The optimum in the Δ_5 parameter is independent with respect to the other parameters, which is a feature that permits to highlight the importance of the introduction of the inequality expressed by Eqs. (2)–(3). The results indicate that the color pattern associated with the defect has its own structure.
