# Semi-autonomous inspection for concrete structures using digital models and a hybrid approach based on deep learning and photogrammetry

Ali Mirzazade<sup>1</sup> · Cosmin Popescu<sup>1,2</sup> · Jaime Gonzalez-Libreros<sup>1</sup> · Thomas Blanksvård<sup>1</sup> · Björn Täljsten<sup>1</sup> · Gabriel Sas<sup>1</sup>

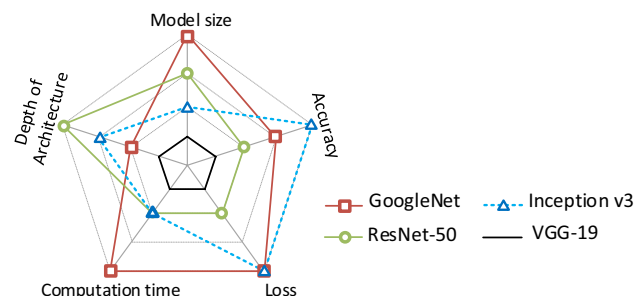
**Fig. 1** Damage detection performance of four CNN architectures. In all cases, the 1st and 4th levels correspond to the worst and best performance with respect to the indicated items, respectively [11]

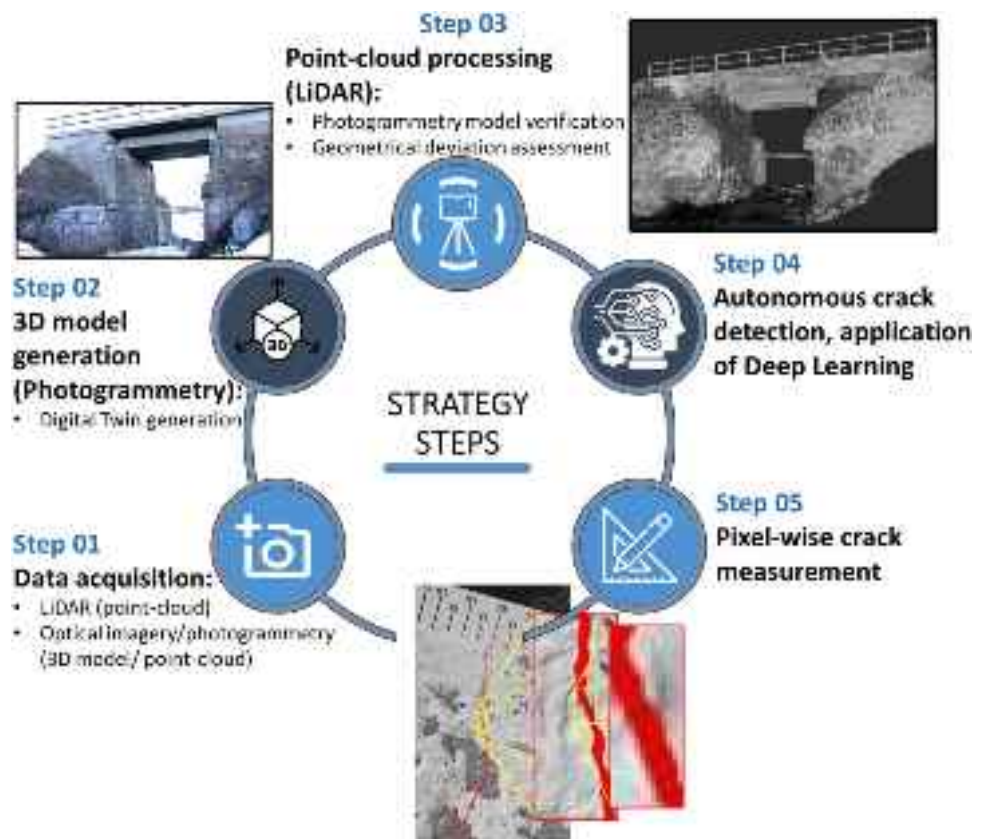
**Fig. 2** Overview of the autonomous damage detection and quantification workflow

called digital model). In the third step, generated point cloud by photogrammetry technique is analyzed for geometrical deviation assessment. In this study, another 3D point cloud of the structure is generated by laser scanning to verify the accuracy of image-based point cloud. The point cloud serves as a reference for geometric verification of the photogrammetric model generated in step two.

Finally, in steps four and five, two Convolutional Neural Networks (CNN) are used for autonomous damage detection and pixel-wise segmentation to quantify the extent of the detected cracks in collected images. These two tasks have five distinct steps: (1) data acquisition, (2) dataset preparation, (3) designing and training CNNs, (4) damage detection and localization by splitting images into sub-images that are classified into “Crack” or “No Crack” areas using the CNN classifier, and (5) crack segmentation, mapping cracks onto a 3D model, and crack quantification. In step 5, pixel-wise crack segmentation is performed by applying U-Net semantic segmentation on 2D images that are then stitched together to reconstruct a 3D model and generate an orthophoto of

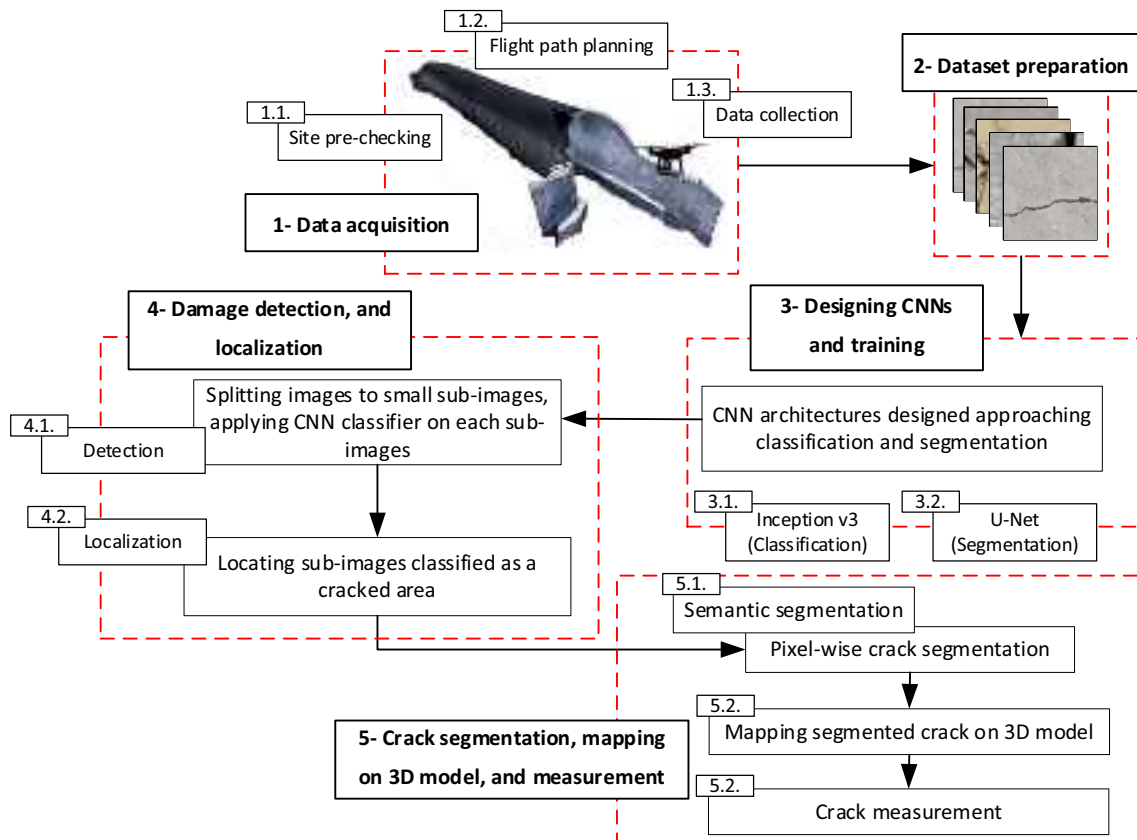
**Fig. 3** Workflow of the proposed method for semi- automated damage detection and quantification

the defect-containing areas. The segmented crack can then be measured by determining the orientation of the camera’s position for each photo relative to the crack. Figure 3 shows a flowchart of the procedure.

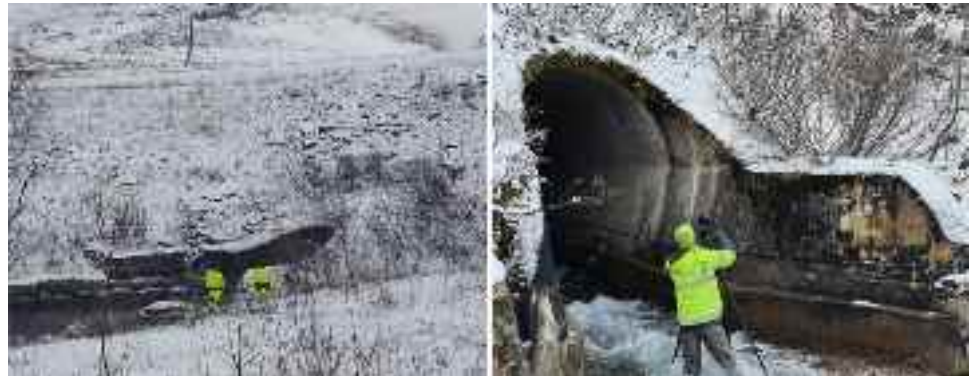
**Fig. 4** Photos of Kedkejokk tunnel

The Kedkejokk tunnel is a concrete arch tunnel built in 1906. It is located in the Riksgränsen region (at km 1533 + 175 according to the nomenclature of Trafikverket, the Swedish Transport Authority), near the Norwegian border in northern Sweden. As shown in Fig. 4, it crosses a narrow stream of water. The tunnel width is 4.0 m and its total length is 41.2 m. It is located on a hillside, and there are steep slopes between the tunnel's foundation and existed railway. The surrounding area is sparsely vegetated with scattered small trees and bushes. The tunnel was surveyed on two consecutive days, during which the weather conditions varied from cloudy to sunny. Because the tunnel under the railway infrastructure was dark, images were captured with the camera in AV mode and the ISO was set automatically based on the light environment. It was necessary to use a shutter time of almost 20 s to capture sufficient light, which made the process time-consuming.

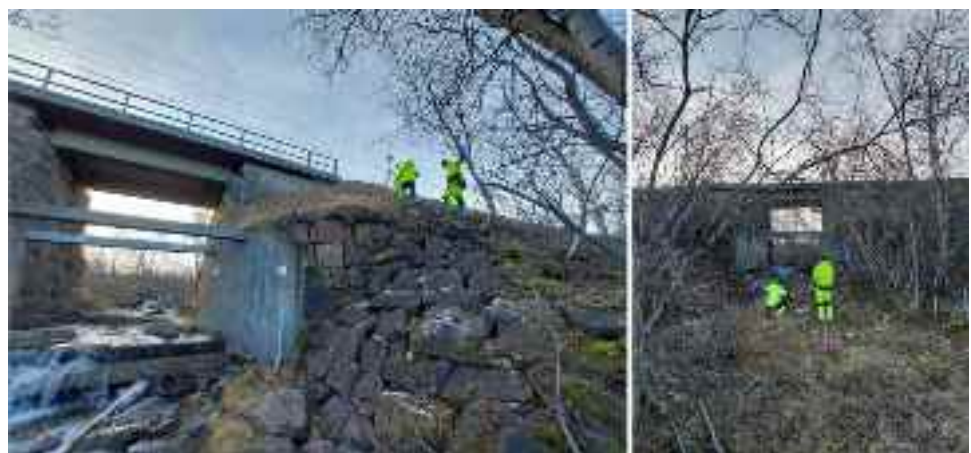
**Fig. 5** Photos of Juovajokk bridge

The Juovajokk bridge is a simply supported bridge made from reinforced concrete that was built in 1902 in the vicinity of Abisko in northern Sweden (at km 1504 + 915 using the Trafikverket nomenclature). Its superstructure was replaced in 1960, and it spans a stream as shown in Fig. 5. The bridge's span and width are 5.5 m and 3.8 m, respectively. The surrounding area is densely vegetated and there are steep slopes behind the abutments that made it difficult to balance a tripod for image acquisition. During the survey, some areas under the bridge were frozen, making the surface slippery. It took around 3.5 h to completely survey the bridge during a partially sunny morning with temperatures below 0 °C.

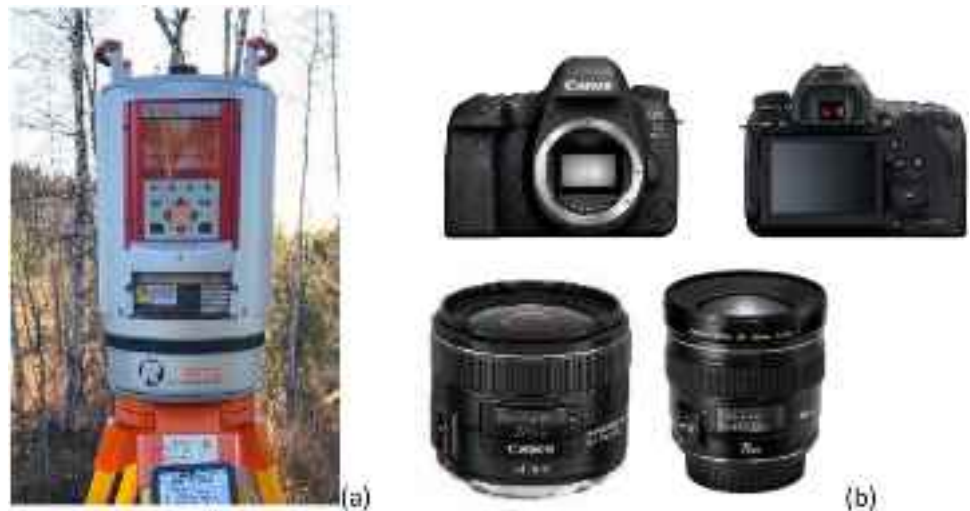
**Fig. 6** Data acquisition equipment. **a** RIEGL VZ-400, 3D terrestrial laser scanner, **b** Canon EOS6D Mark II digital camera with lenses

The equipment used for TLS was a long-range RIEGL VZ-400 3D terrestrial laser scanner (see Fig. 6a). This 3D scanner operates on the time-of-flight principle and can perform measurements at distances between 1.5 and 600 m with a nominal accuracy of 5 mm at 100 m. It uses near-infrared laser wavelengths with a laser beam divergence of

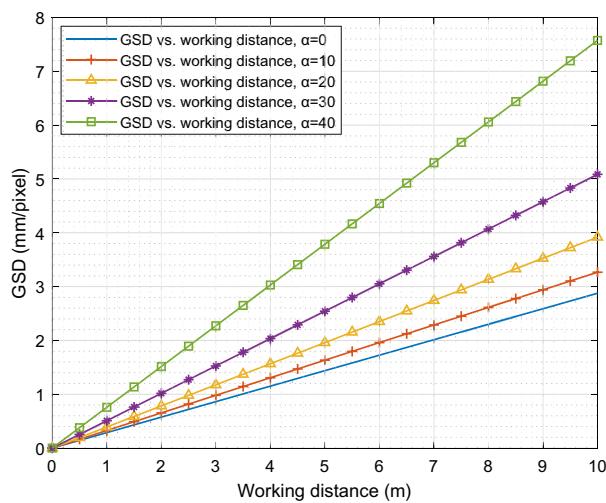
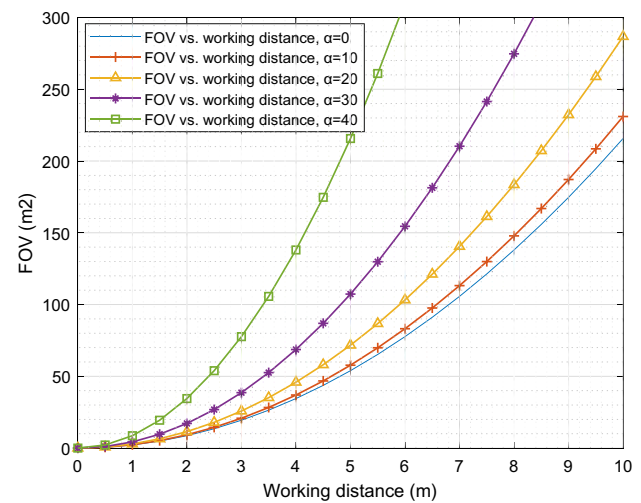
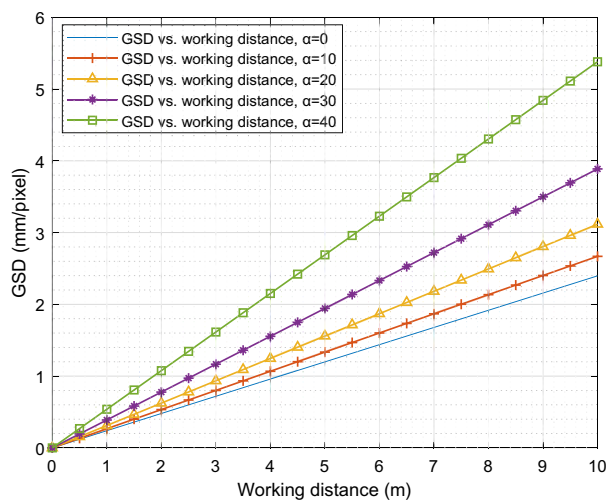
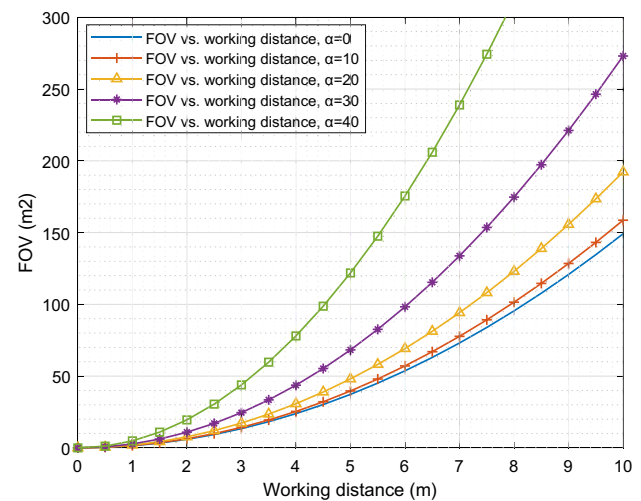
a. GSD and FOV as functions of the working distance for the 20 mm lens

b. GSD and FOV as functions of the working distance for the 24 mm lens

**Fig. 7** **a** GSD and FOV as functions of the working distance for the 20 mm lens. **b** GSD and FOV as functions of the working distance for the 24 mm lens

After calculating the GSD and FOV, an appropriate Working Distance (WD) and tilt angle ( $\alpha$ ) can be selected to match the surveying objectives for image collection. The graphs presented in Fig. 7a, b show that at any given working distance, the 24 mm lens gave a lower GSD (and, thus, a higher resolution leading to the capture of more detail) than the 20 mm lens. However, its FOV is lower than that of the 20 mm lens, making it necessary to acquire and process more images to cover all the surfaces of the structure. Consequently, more processing time and resources are needed to generate the 3D model when scanning with the 24 mm lens. To strike an optimal balance between processing time and resolution, a zoom lens can be used for data acquisition. A zoom lens is a mechanical assembly of lens elements whose focal length can be varied to maintain a consistent GSD at different working distances, which is

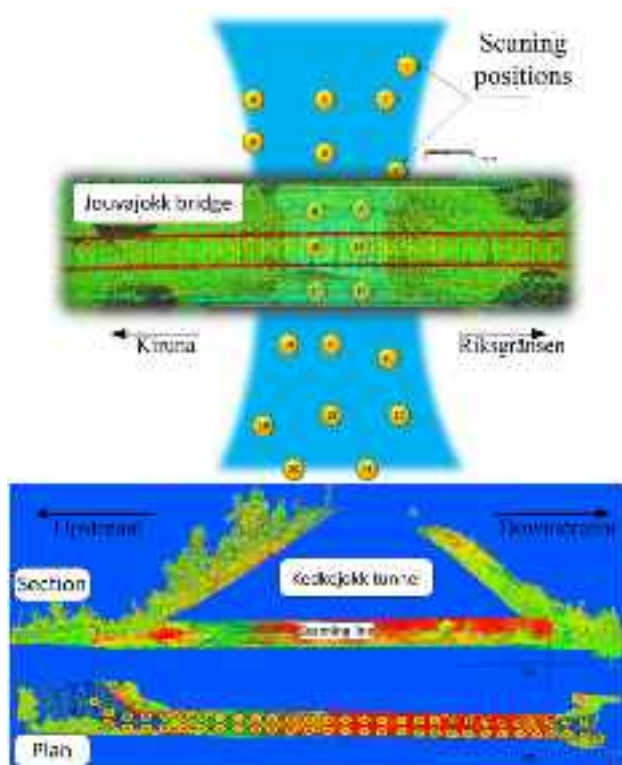
**Fig. 8** Photogrammetric scanning positions for the Juovajokk bridge and Kedkejokk tunnel

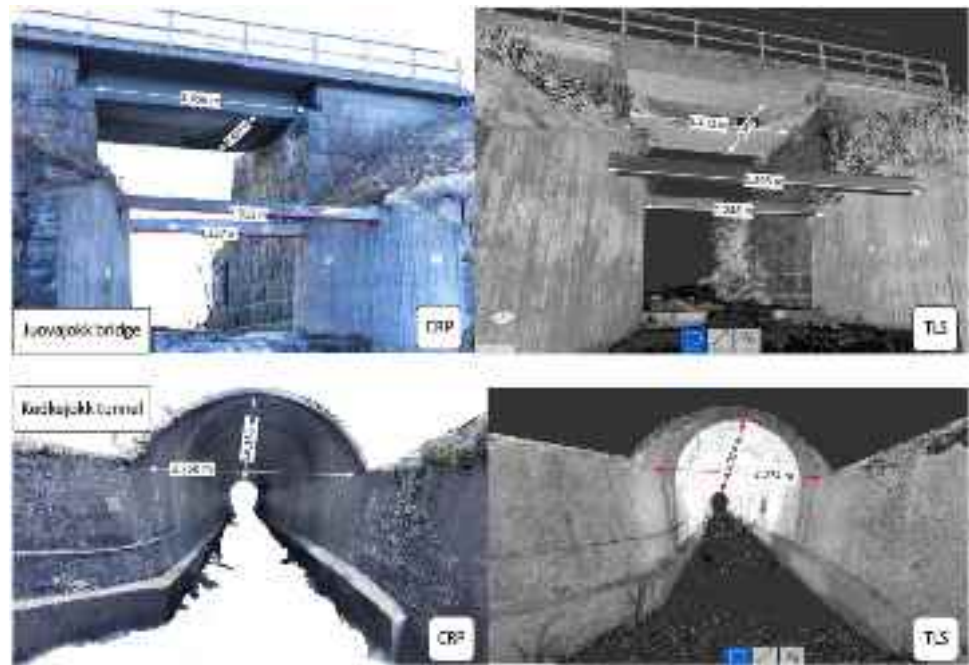
**Fig. 9** Measurements of bridge structural elements by CRP (left), and laser scanning (right)

Both generated point clouds were imported into Autodesk ReCap to extract measurements of the bridges' structural elements (see Fig. 9). Measurements of the bridges' structural elements can be found in as-built drawings to obtain ground truth as a reference model; however, in Kedrejokk tunnel, due to the performed repairment and new installed lining, the existed as-built is totally different compared with current condition. Therefore, TLS model

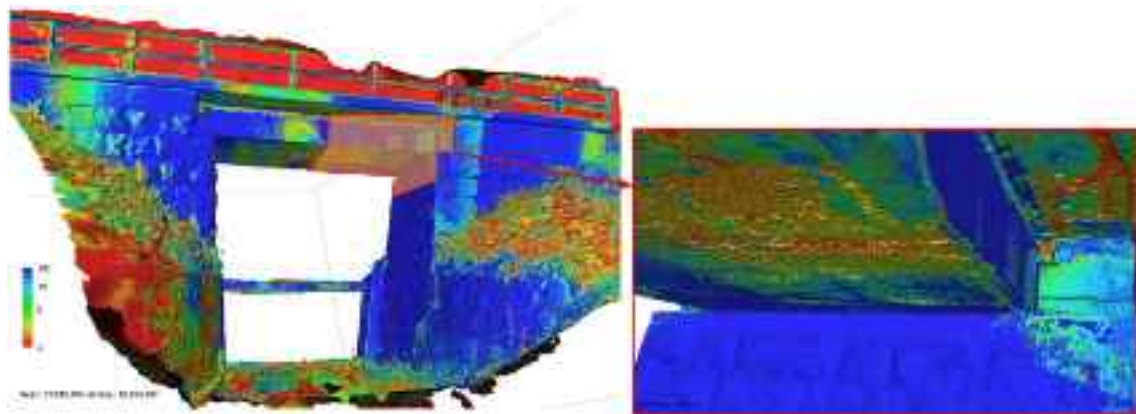
**Fig. 10** Confidence model of the Juovajokk Bridge. Blue parts have reliable triangulation while red parts have comparatively high noise levels

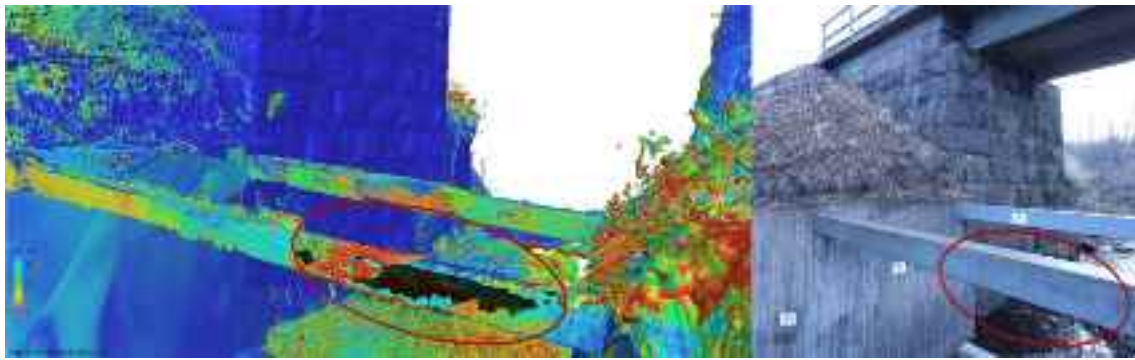
**Fig. 11** An example of a missing data problem resulting from a lack of features on the struts

parts of the structure such as struts (Fig. 11) or cables, because of a lack of sufficient features for image matching.

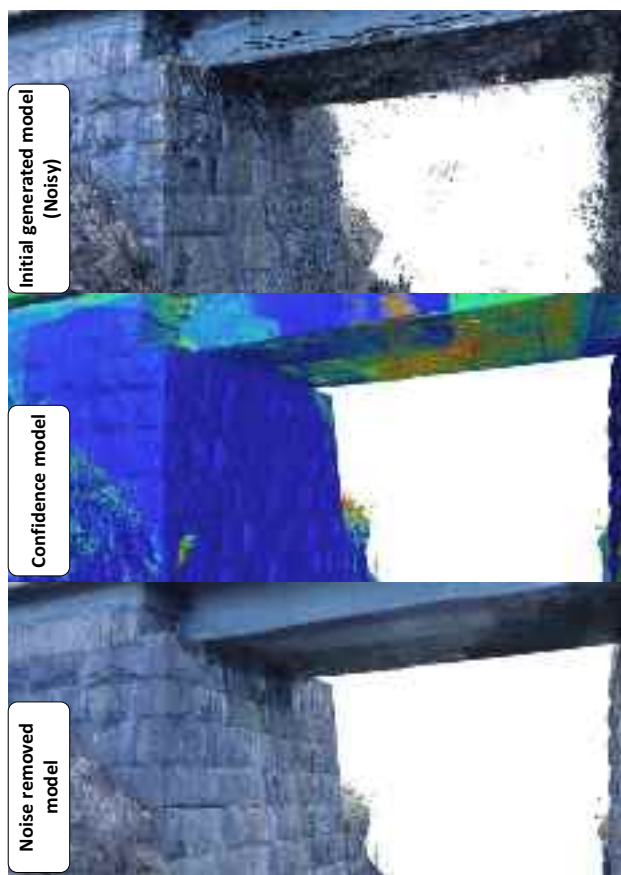
**Fig. 12** Removal of outlier noise from the initially generated model by Agisoft PhotoScan Pro (Agisoft LLC, 2017)

(sky) as part of the front object (bridge). Furthermore, since the camera failed to fully observe the area beneath the beam, many outliers appear around the border. Those outlier points will affect subsequent surface reconstructions and generate floating artifacts around the object. In addition, shadows and large tilt angles can weaken or hide surface textures, making this part noisier. Commercial software tools such as Agisoft PhotoScan Pro (Agisoft LLC, 2017), which was used in this work, include outlier noise removal as part of the standard rendering procedure (see Fig. 12).

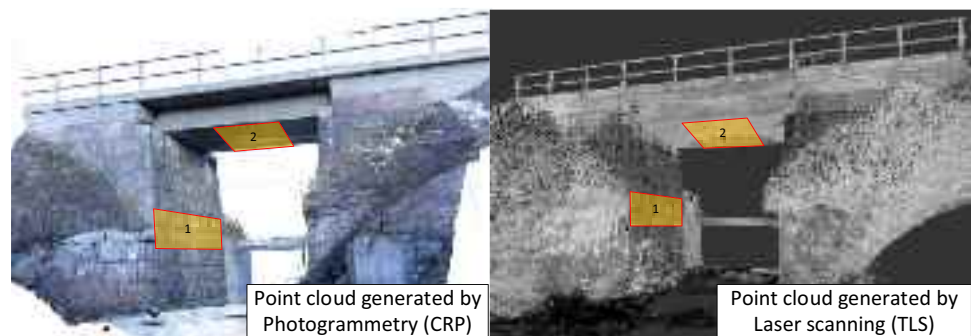
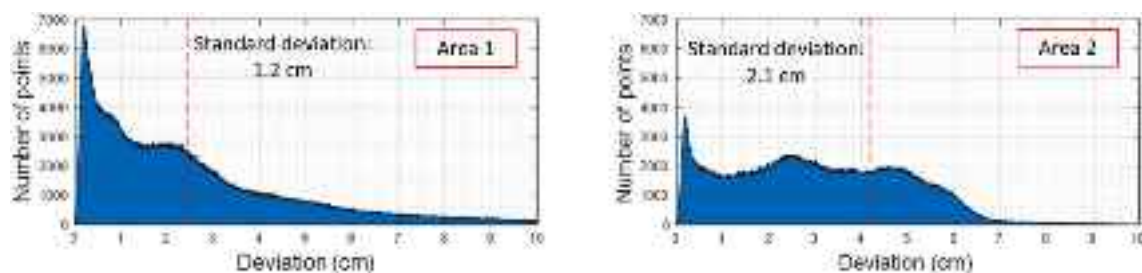
**Fig. 13** Areas of the abutment and underneath of the bridge used to evaluate the point cloud densities of the CRP and TLS models

**Fig. 14** Absolute cloud-to-cloud deviations between the CRP and TLS point clouds, using the TLS cloud as a reference, for areas 1 (abutment) and 2 (underneath) of the Juovajokk bridge**Table 5** Absolute numbers of deviating points in the CRP clouds, percentage of surface deviation, and local point-cloud density after noise removal for areas 1 and 2 of the Juovajokk bridge when applying different noise removal thresholds

results obtained when applying the suggested threshold of twice the standard deviation for the area under consideration. As expected, the local point density in both areas of the CRP cloud after noise removal is lower than that of the TLS cloud, and lowering the threshold to increase noise removal exacerbates this difference. This means that while these CRP point clouds could be used to monitor geometric deviations of the structure, they cannot be used for small-scale damage detection due to their low point density. However, this is not a severe limitation because damage detection using deep CNN is performed using image data rather than a 3D point cloud.

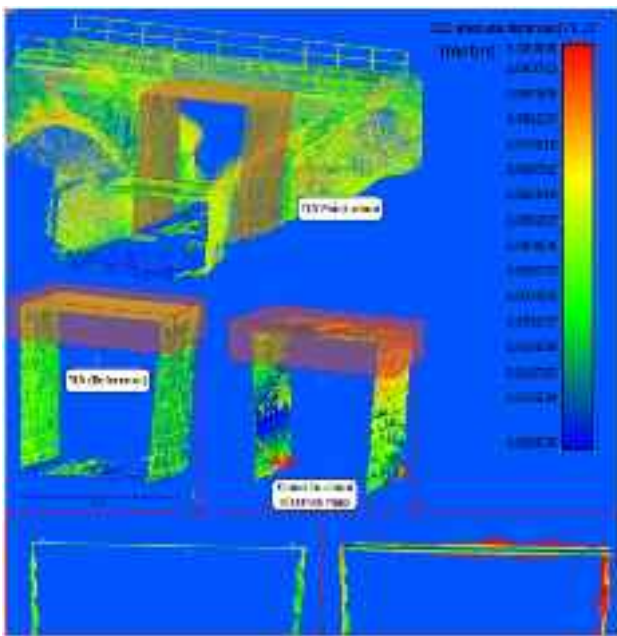
**Fig. 15** A cloud-to-cloud absolute distance map for the region underneath the bridge

A representative cloud-to-cloud distance map, to illustrate outlier noises, is shown in Fig. 15. In this figure, points with

warmer colors have higher deviations. Surface deviations can be filtered out by applying a threshold based on the absolute cloud-to-cloud distance.

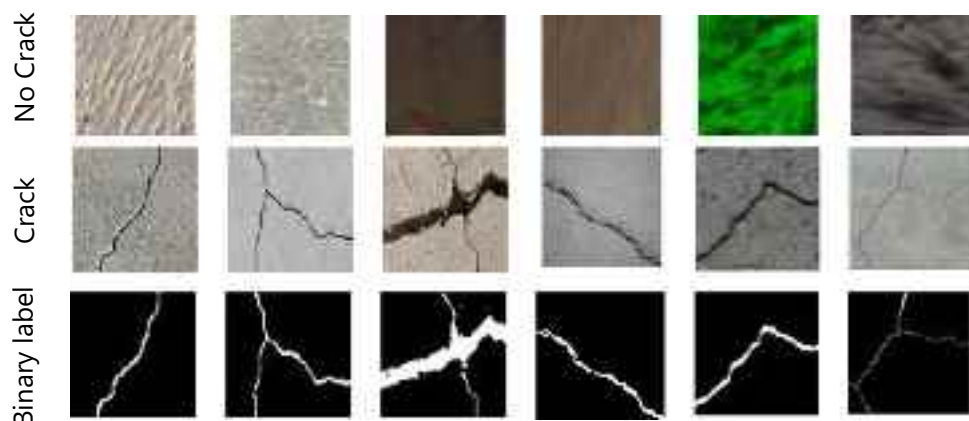
**Fig. 16** Representative images from the dataset prepared by Özgenel et al. (2018) [56] that was used for training both CNNs

The Kedkejokk tunnel was used as a case study to test the capabilities of deep learning algorithms for crack detection and quantification in hard-to-access areas with poor lighting. Then after data acquisition, which is discussed in Sect. 3.2, datasets for training CNNs must be pre-processed. The training dataset used in this work consists of 40,000 images with RGB channels ( $227 \times 227$  pixels each) divided into two classes (Crack and No Crack) comprising 20,000 images each. The dataset was generated by Özgenel et al. [56] from 458 high-resolution images ( $4032 \times 3024$  pixels) of concrete surfaces at the METU campus; the high-resolution images were converted into a much larger set of smaller images using the method proposed by Zhang et al. [27]. Two models were trained using this dataset: (1) a classification CNN model based on the Inception V3 architecture, and (2) a semantic segmentation with an end-to-end CNN based on the U-Net architecture that was trained using binary segmented crack images. Some representative images from the dataset are shown in Fig. 16.

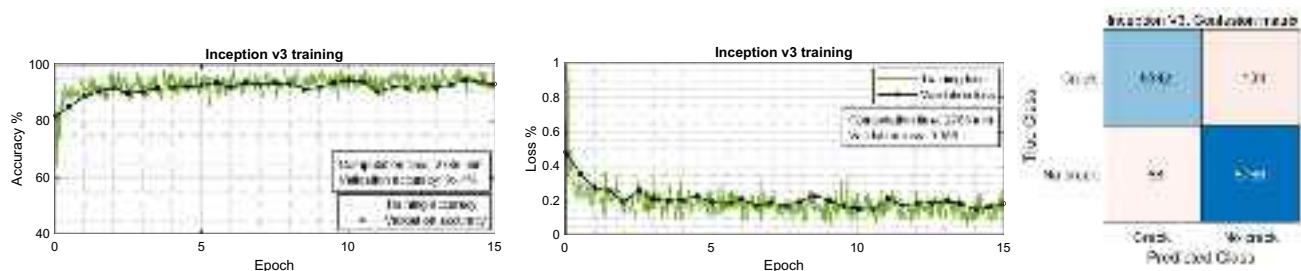
**Fig. 17** Accuracy and loss curves for the training and validation of the Inception V3 classifier model and the confusion matrix obtained after applying the trained model to the test dataset

In general, increasing the number of training epochs increases the training accuracy and, thus, reduces the training loss. However, too many training epochs may cause the model to overfit the training data. In other word, model does not learn the training dataset and memorizes that. Therefore, validation accuracy is found for each epoch to investigate whether it overfits or not. Figure 17 shows how the training accuracy and training loss varied with the number of epochs when training the InceptionV3 CNN-based classifier. After training, the model's confusion

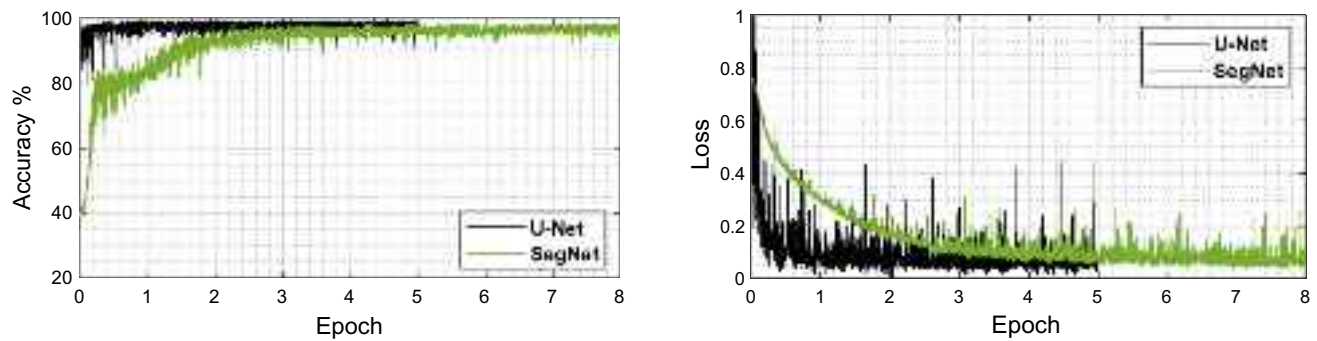
**Fig. 18** Accuracy and loss training curves for semantic segmentation using U-Net and SegNet

Semantic segmentation is an important task in computer vision whose goal is pixel-wise segmentation. This is typically performed using an end-to-end network consisting of two cooperative sub-networks (encoding and decoding) classifying individual pixels as Crack or No Crack areas. A previous study [10] comparing the performance of U-Net [57] and SegNet [58] for semantic segmentation of small-scale block openings concluded that U-Net offered better performance. In this work, both models were tested for crack segmentation. Figure 18 shows the corresponding training accuracy and loss graphs.

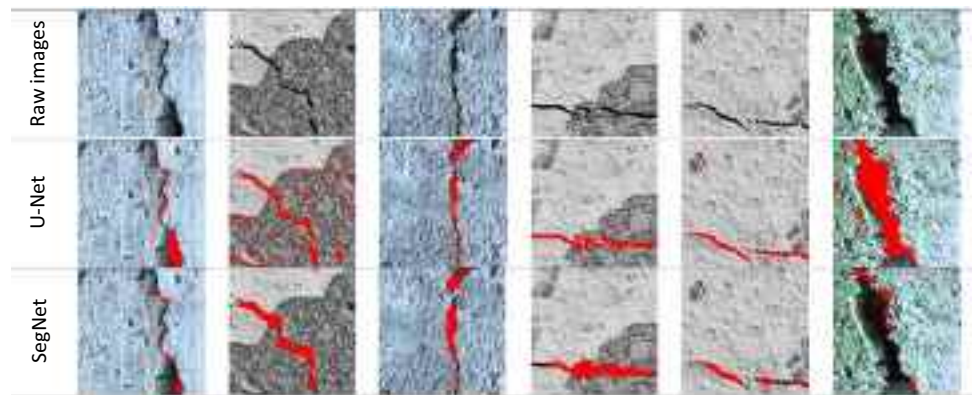
**Fig. 19** The performance of the two trained CNNs in crack segmentation; pixels classified as parts of cracks are shown in red

As found in the earlier study, U-Net achieved a higher overall accuracy than SegNet and required fewer training epochs to achieve good accuracy. Figure 19 shows the pixel-wise crack segmentation results obtained using the U-Net and SegNet models after 5 and 8 training epochs, respectively. Because the U-Net model achieved better crack segmentation performance even with less training epochs, it was applied to all sub-images that were found to contain cracks using the classifier model to segment the defects. Final images were then generated by merging the processed sub-images.

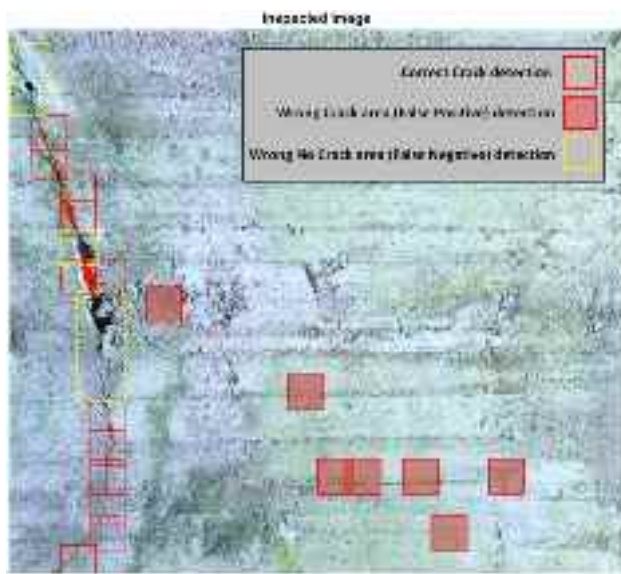
**Fig. 20** Cracks detected and segmented by the studied CNNs

The developed workflow was tested by applying it to a new high-resolution image ( $6240 \times 4160$  pixels) of the Kedke-jokk tunnel, captured in an area that would be difficult for a human inspector to access. Figure 20 shows the cracks detected by the CNNs, with damaged areas enclosed in red bounding boxes and segmented cracks shown using red pixels. Both false positives and false negatives were obtained. False positives (indicated by filled red boxes) occurred in areas containing crack-like patterns, while false negatives (indicated by dashed yellow boxes) are areas that contain clearly visible cracks whose shapes and scales differ from those of the cracks included in the dataset used to train the Inception V3 classifier model. To avoid false positives, a deeper CNN could be trained to extract deeper features from the training dataset. The incidence of false negatives could be reduced by further augmentation of the training dataset

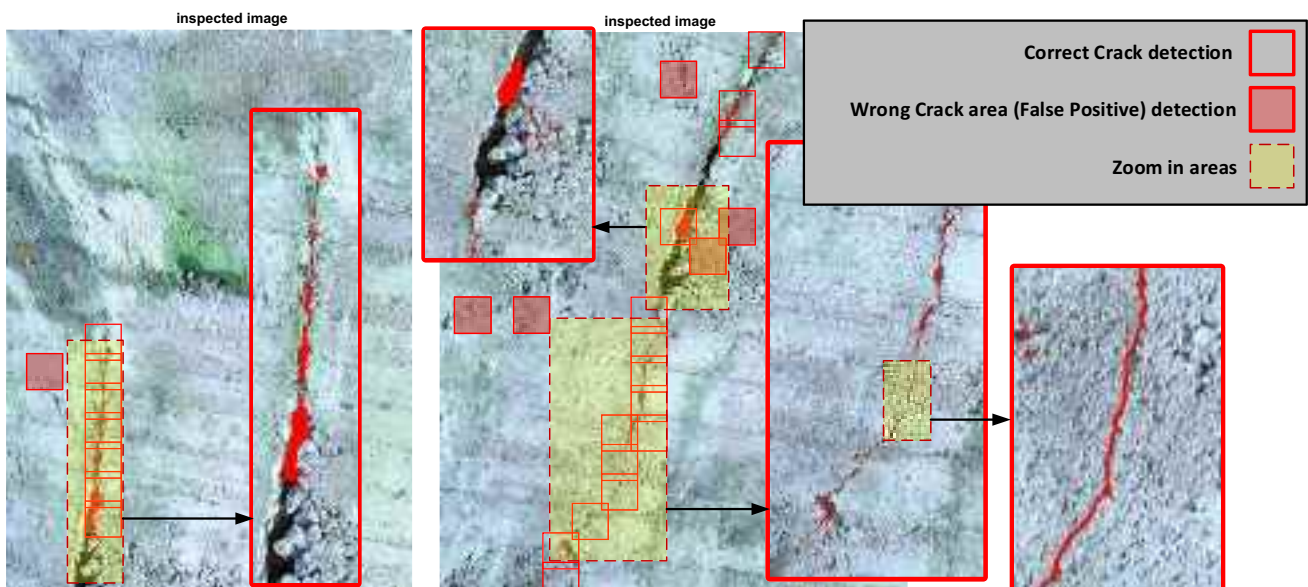
**Fig. 21** Accuracy of crack segmentation using trained U-Net

with randomly rescaled images to enable the detection of cracks with different scales and shapes. Figure 21 shows the precision of crack segmentation achieved with U-Net which is needed for crack quantification.

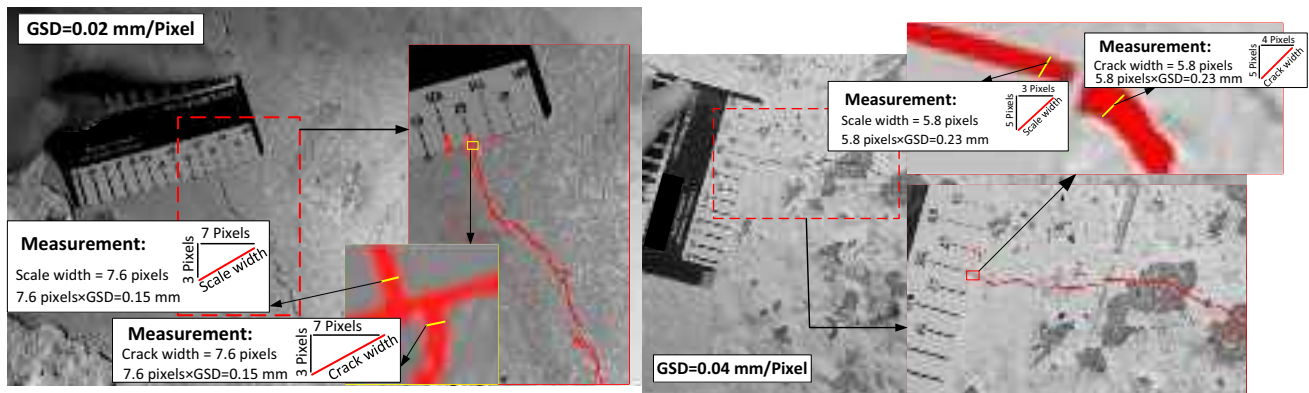
**Fig. 22** Crack quantification in a controlled environment

After crack detection and segmentation, realistic 3D coordinates of the detected defects are extracted to measure the dimensions of the segmented cracks. For this purpose, an orthomosaic image or orthophoto must be generated, providing a photorealistic representation of the region of interest (ROI) from which crack dimensions can be measured. Orthophotos can be generated from images captured from different perspectives using collinearity equations [59]. The distance of the camera from the surface and the ground sampling distance (GSD) can then be calculated, allowing the dimensions of the cracks to be determined by counting the numbers of crack pixels in the horizontal and vertical directions. Figure 22 illustrates this process as performed in a controlled environment.

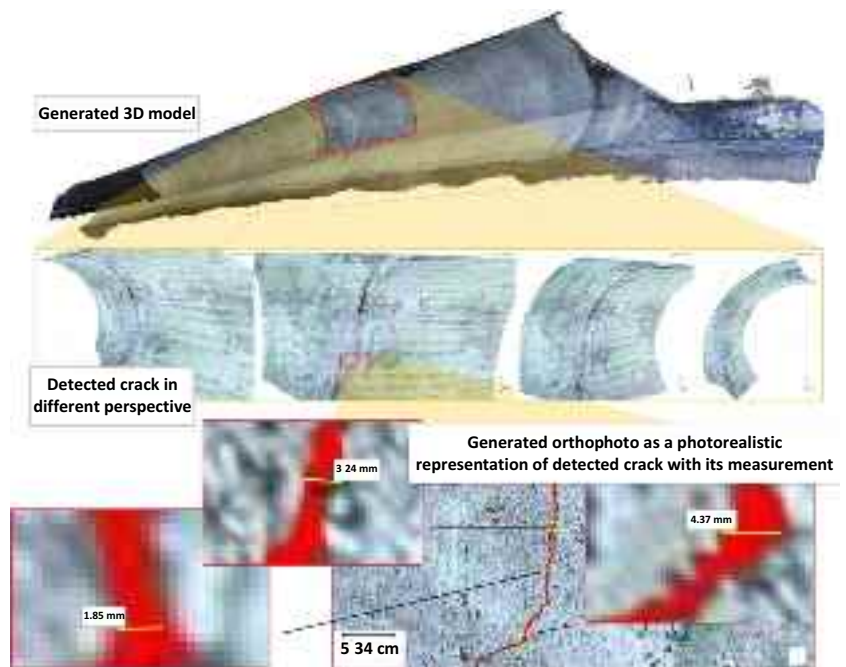
**Fig. 23** Crack quantification in a hard-to-access area of the Kedkejokk tunnel using the proposed method

Using the approach described above, a 3D model of the Kedkejokk tunnel was generated by the hierarchical Dense Structure-from-Motion (DSfM) method, with an elevated resolution in the defected area. Cracks in this area were then segmented with the trained CNNs and an orthophoto was generated to measure the width of the cracks. Figure 23 shows the results obtained at three points along a detected crack whose coordinates were recorded on the digital model to serve as documented data from the autonomous inspection. A good accuracy was achieved, although it should be
