# A Comparative Study of Bridge Inspection and Condition Assessment between Manpower and a UAS

**Keywords:** bridge inspection; unmanned aerial system; automatic damage detection; damage mapping; condition assessment

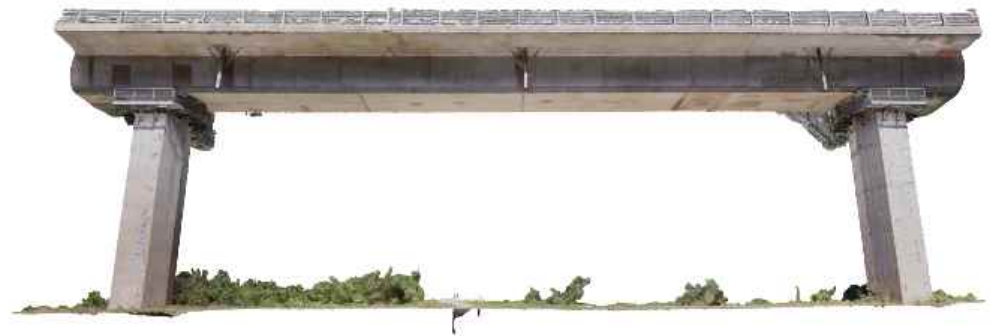
**Figure 8.** Point cloud-based 3D modeling for target bridge.

In the case of the D bridge, it was constructed approximately 30 years ago, but it is a well-managed B-grade bridge that has bridge information with appearance inspection results. Although there were drawings or damage information on the bridge, a preliminary flight was performed to obtain a 3D/2D model of the bridge considering that there was no bridge information. In the preliminary flight, images were collected for 3D model generation taking into account the longitudinal and lateral overlap, and as shown in Figure 8, a 3D point cloud-based background model of the bridge was generated using Pix4D. The 3D point cloud technique can extract and match feature points from geo-tagged images containing the UAS information (i.e., location, pose), and the 3D model is made by mesh and texture. Digitizing the 3D/2D background model of the bridge is an essential task to manage data and make decisions on the U-BMS. It can also be used to draw a bridge damage map. The final step in the pre-inspection phase is preparation for the main inspection. This step confirms the UAS-based bridge inspection scenario and flight path. If the record of performing UAS-based bridge inspection in the past is on the U-BMS, it can be used or modified, otherwise, a new record must be created. Lastly, the UAS setup and flight path setup are performed prior to the main flight for bridge inspection. UAS setup includes inspection of sensors installed on the UAV for flight and camera setup. In this study, a high-resolution DSLR camera (i.e., Sony alpha 9) with a lens (i.e., ZEISS Batis 85 mm f/1.8) was used. The camera and lens were determined considering the minimum pixel size that can be obtained when the distance between the target member and the UAS is 2 to 3 m. In addition, the JPEG format and RAW data were simultaneously stored on the high-speed SD memory card in order to improve the quality of the image in the future. For mapping and localization, the Robot Operating System (ROS) read the 3D point cloud map obtained from the preliminary flight with a 3D LiDAR. In addition, 3D path designation is performed considering the size of the UAS and obstacles. Finally, the flight preparation is completed after the inspection path is transmitted to the mini PC mounted on the UAS through the LTE network. The main flight proceeds according to the UAV location estimation technique mentioned in Section 2.2 and the optimal path set in advance. Figure 9 shows the UAV trajectory in the field test. Based on the 3D point cloud map, it can be confirmed that the UAV flight along the pre-considered waypoint in Figure 9a. In general, the lower part of the deck on a bridge is not well received by GPS. This can be confirmed through the red line in Figure 9b. Nevertheless, the reason why the UAV was able to fly under the deck stably was that the location of the UAV was estimated using SLAM technology. Figure 9b shows the trajectory comparison with raw GPS and estimated location using the SLAM under the deck slab of the D bridge. In the area where GPS is well received, the results of GPS raw data and SLAM-based location estimation are similar, and the error is small even with the pre-made graph construction. However, since GPS shading occurs under the bridge, the red line, which is the result of GPS mapping, appears to deviate from the flight path, and the blue line, indicating the location estimation result, shows the stable position of the UAV on the flight path.
