# A Comparative Study of Bridge Inspection and Condition Assessment between Manpower and a UAS

**Keywords:** bridge inspection; unmanned aerial system; automatic damage detection; damage mapping; condition assessment

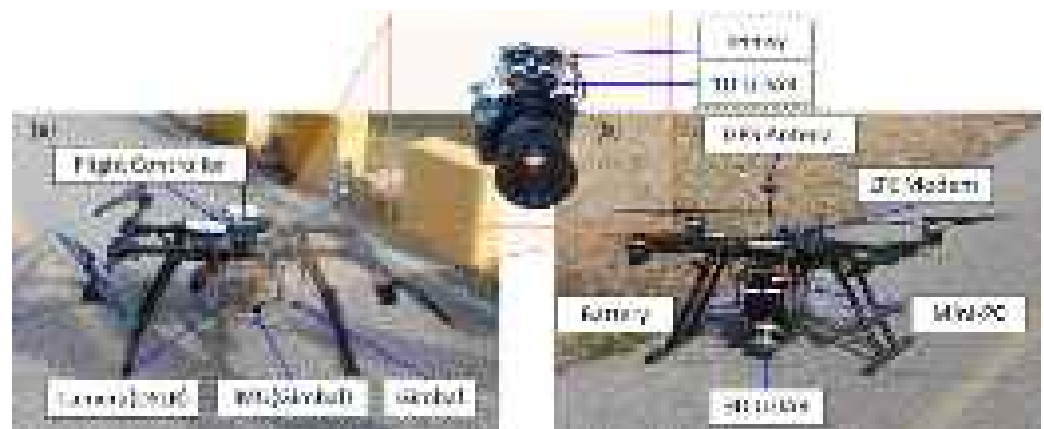
**Figure 2.** Developed UAS for bridge inspection (a) Front View (b) Rear View.

between a GCS and a UAS, and wind resistance capacity against gusts (i.e., maximum 10 m/s) is required. Therefore, a quad-rotor type UAV was developed to be suitable for bridge inspection in this study. Basically, a gimbal that can rotate 90 degrees up and down for checking the bridge deck was mounted, and the UAV was designed to reduce the interference between the gimbal and the propellers. The UAV's flight controller used a Pixhawk 2, equipped with a mini PC (i.e., Intel i7 NUC), 3D LiDAR (i.e., Velodyne Puck lite), and LTE modem for location estimation and autonomous flight. Figure 2 shows a customized UAV equipped with various sensors. The location recognition algorithm was used by improving the graph-based SLAM algorithm. Graph-based SLAM expresses the position and movement of the UAV with nodes and edges like a graph. Here, the node means the pose of the UAV, and the edge between the two nodes is the odometry information between the positions of the UAV and is called a constraint. Therefore, the UAV moves and creates nodes and constraints using odometry information. It acquires information in 3D space through pre-flight and recognizes the same location through newly acquired data and information in the main flight. Moreover, the position is estimated by adding a constraint between non-contiguous nodes and optimizing the graph. It has been improved by constructing the visual inertial mileage using the camera and IMU and generating a normal distribution transformation using 3D LiDAR to generate the base node [32,33]. As a result, it was possible to secure the stability of the basic node generation and to perform autonomous flight on the bridge deck. In this study, a flight path was generated by converting 3D into 2.5 dimensions (i.e., 2D and height) in consideration of the speed and computational power of creating a path in a 3D environment. In addition, the Teensy board on the camera stores the GPS obtained from the location recognition algorithm, 1D LiDAR for measuring distance, and IMU from the gimbal. Therefore, the position coordinate of the image could be estimated through transformation for each coordinate system. This can be used for missing area detection, which will be described in the next subsection, as well as obtain information on each pixel size of the image. As a result, information on the size of the detected damage can be derived from the acquired images.

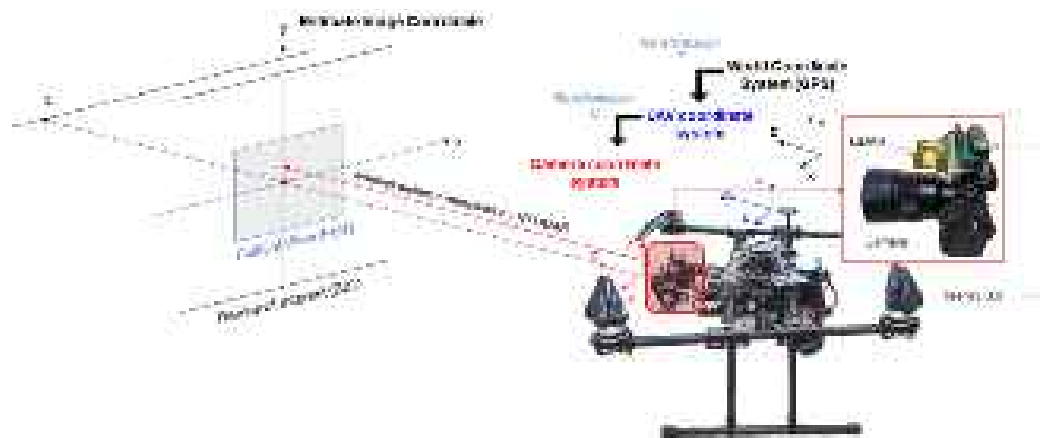
**Figure 3.** The schematic of the estimation method of image coordinates.

The center coordinate of the images collected from the UAS can be calculated through the transformation of the homogeneous coordinate system. Figure 3 shows the schematic of the estimation method of image coordinates.

The first coordinate transformation can be conducted through the location information and the IMU data of UAS and can be moved to the gimbal considering the position of the sensor installation. After that, the camera coordinate connected with the gimbal is converted using another IMU data of the gimbal. Finally, the working distance information obtained from the 1D LiDAR enables coordinate conversion to an image center point [24,28]. The result of estimating the coordinates of the image can be utilized in the quantification of the detected damage as it allows us to determine the pixel size within the RoI (Region of Interest). In addition to missing area detection, there is another procedure that must be performed between bridge inspection and damage detection procedures. This is to evaluate the quality of the images obtained from the UAS. Image quality is affected not only by the stability of the UAV but also by various environments such as wind and light. In particular, when the UAS photographs the surface in close proximity to the bridge, the image quality problem is represented by motion blur due to UAS's vibration, insufficient shutter speed, and errors in camera focus. Since motion blur causes a decrease in the sharpness of an RGB image, the level can be evaluated by checking the change in the gradient value of gray intensity. Therefore, an image quality assessment (IQA) index can be derived from considering characteristics of motion blur as follows [24]

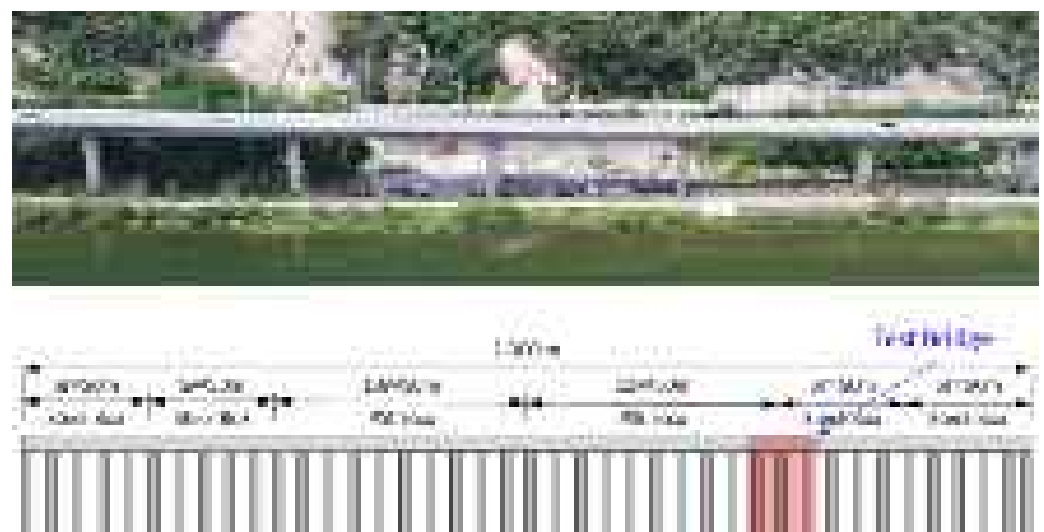
Figure 6. Inspection bridge.

This section discusses the field test results performed in this study. In consideration of accessibility and safety, the target bridge was selected as the D Bridge in Gangwon province, Korea, as shown in Figure 6. The D bridge is a structure in which 10 steel boxes and 10 PSC box girders are combined, with a width of 11.0 m and a total span of 2000 m. The span of the test bed is the area where the PSC and steel box are connected as shown in the figure, and the corresponding piers (i.e., pier 29–31) were targeted. Task definition is performed on U-BMS and can input basic task information (i.e., target bridge, date, inspection type), inspector and UAS information, and inspection scope as shown in Figure 7. The preliminary information analysis and preparation step are carried out considering the existence of bridge information. In addition, the inspection scenario and flight path are planned.

Finally, bridge condition assessment was performed targeting the area shown in Figure 6. The PSC girder is between piers 29 and 30, and the steel girder is between piers 30 and 31. Table 3 shows the bridge condition grade determined based on the results of the damage map for the target bridges. The PSC girder was graded as C due to cracks exceeding 0.3 mm, and the steel girder was graded as B due to corrosion and paint loss area, and the width of the cracks identified in the three piers including pier 31 showing the damage map in Figure 13 was 0.3 mm or less. Nevertheless, pier 30 and pier 31 were graded C because the surface damage area was between 2–10% as shown in Figure 5. In order to determine the bridge condition grade in the bridge maintenance manual and regulations, the durability evaluation of the structure should be included in South Korea. Therefore, it is difficult for UAS-based bridge inspection results to replace the existing manpower-based bridge maintenance system. However, it can replace visual inspection and is expected to be able to efficiently perform bridge inspection.

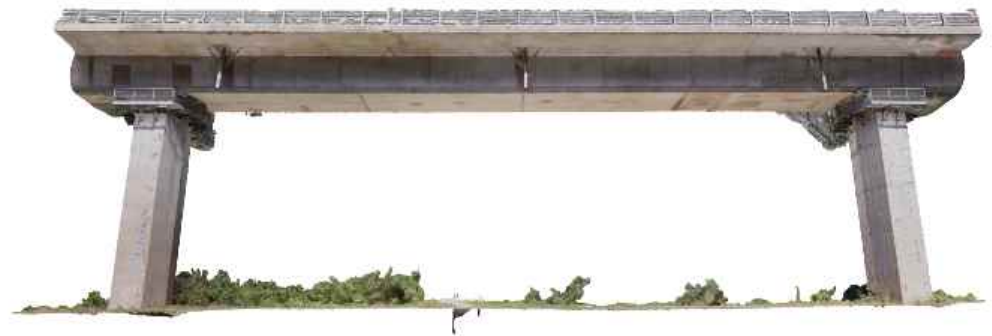
**Figure 8.** Point cloud-based 3D modeling for target bridge.

In the case of the D bridge, it was constructed approximately 30 years ago, but it is a well-managed B-grade bridge that has bridge information with appearance inspection results. Although there were drawings or damage information on the bridge, a preliminary flight was performed to obtain a 3D/2D model of the bridge considering that there was no bridge information. In the preliminary flight, images were collected for 3D model generation taking into account the longitudinal and lateral overlap, and as shown in Figure 8, a 3D point cloud-based background model of the bridge was generated using Pix4D. The 3D point cloud technique can extract and match feature points from geo-tagged images containing the UAS information (i.e., location, pose), and the 3D model is made by mesh and texture. Digitizing the 3D/2D background model of the bridge is an essential task to manage data and make decisions on the U-BMS. It can also be used to draw a bridge damage map. The final step in the pre-inspection phase is preparation for the main inspection. This step confirms the UAS-based bridge inspection scenario and flight path. If the record of performing UAS-based bridge inspection in the past is on the U-BMS, it can be used or modified, otherwise, a new record must be created. Lastly, the UAS setup and flight path setup are performed prior to the main flight for bridge inspection. UAS setup includes inspection of sensors installed on the UAV for flight and camera setup. In this study, a high-resolution DSLR camera (i.e., Sony alpha 9) with a lens (i.e., ZEISS Batis 85 mm f/1.8) was used. The camera and lens were determined considering the minimum pixel size that can be obtained when the distance between the target member and the UAS is 2 to 3 m. In addition, the JPEG format and RAW data were simultaneously stored on the high-speed SD memory card in order to improve the quality of the image in the future. For mapping and localization, the Robot Operating System (ROS) read the 3D point cloud map obtained from the preliminary flight with a 3D LiDAR. In addition, 3D path designation is performed considering the size of the UAS and obstacles. Finally, the flight preparation is completed after the inspection path is transmitted to the mini PC mounted on the UAS through the LTE network. The main flight proceeds according to the UAV location estimation technique mentioned in Section 2.2 and the optimal path set in advance. Figure 9 shows the UAV trajectory in the field test. Based on the 3D point cloud map, it can be confirmed that the UAV flight along the pre-considered waypoint in Figure 9a. In general, the lower part of the deck on a bridge is not well received by GPS. This can be confirmed through the red line in Figure 9b. Nevertheless, the reason why the UAV was able to fly under the deck stably was that the location of the UAV was estimated using SLAM technology. Figure 9b shows the trajectory comparison with raw GPS and estimated location using the SLAM under the deck slab of the D bridge. In the area where GPS is well received, the results of GPS raw data and SLAM-based location estimation are similar, and the error is small even with the pre-made graph construction. However, since GPS shading occurs under the bridge, the red line, which is the result of GPS mapping, appears to deviate from the flight path, and the blue line, indicating the location estimation result, shows the stable position of the UAV on the flight path.

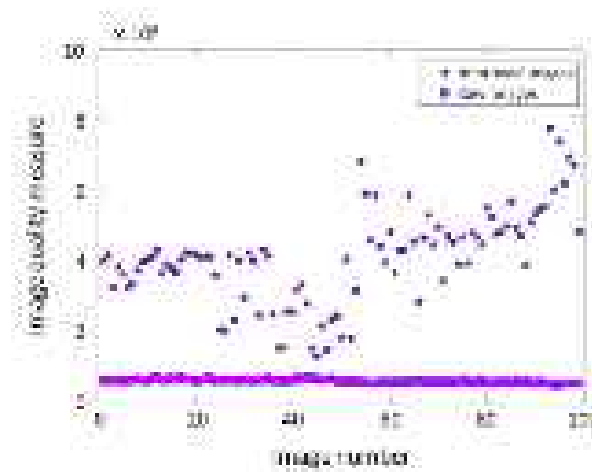
Figure 11. Image quality assessment of measured images.

As a final phase of the main inspection phase, the missing area detection and image quality assessment mentioned in Section 2.3 were performed on-site. In most bridge inspection studies with UAS, this step is not considered. After returning from the field, if a missing area or low-quality image is found in the critical inspection area, a proper evaluation cannot be performed and the experiment must be repeated. Therefore, it is necessary to carry out the corresponding process on-site. In the experiment, considering the stable flight speed of the UAV, the frame per second (FPS) of the camera was set to 10, and the overlap rate between frames was 50%. Figure 10 shows the result of missing area detection using 270 images for the front side of the pier. By performing missing area detection based on image coordinate estimation at the field of the bridge, it was confirmed that UAS-based bridge inspection covered the target inspection area. If the missing area is detected, the supplementary inspection is performed by additional flying to cover the inspection range. Then, the image quality assessment is conducted for the improved images using IPTs. Figure 11 shows the image quality assessment results for 100 images acquired through UAS. Image enhancements in this step took into account motion blur, illumination, and noise, which frequently occur in UAS-based bridge inspection images. As a result of using the basic image processing algorithm, it was confirmed that the image was improved by three times or more compared to the original images. However, some images do not appear to have improved much because the image quality evaluation index developed in this study is related to motion blur affected by the vibrations of the UAS. In the image quality index, it was not possible to confirm the improvement of the image quality, but it was confirmed that the quality was improved by visually checking these images. These results demonstrate the need to diversify the index when evaluating the quality of images acquired from UAS.

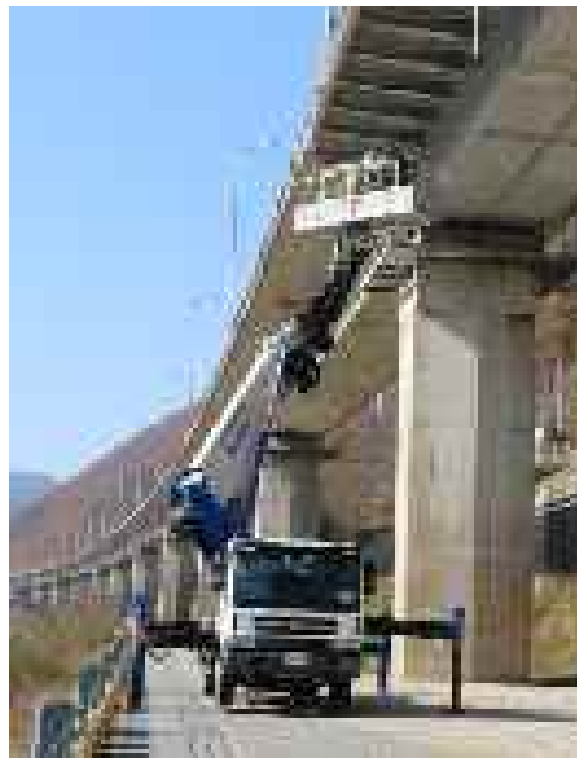
**Figure 12.** Bridge inspection comparison experiment.

In order to perform the UAS-based inspection and the manpower-based appearance inspection on the target bridge, the manpower-based inspection was performed with a ladder truck as shown in Figure 12. The manpower inspection consisted of a ladder truck driver and two bridge inspection experts, and the bridge inspection was performed through visual inspection. In addition, the inspection of the UAS-based bridge was performed by a UAS pilot and co-pilot.
