How to replace the screws for anti-scratch the belt

The belts may touch screws for the first batch Z9V5Pro , which may cause scratch on the belt surface. Replacing some screws and gaskets can solve this problem.

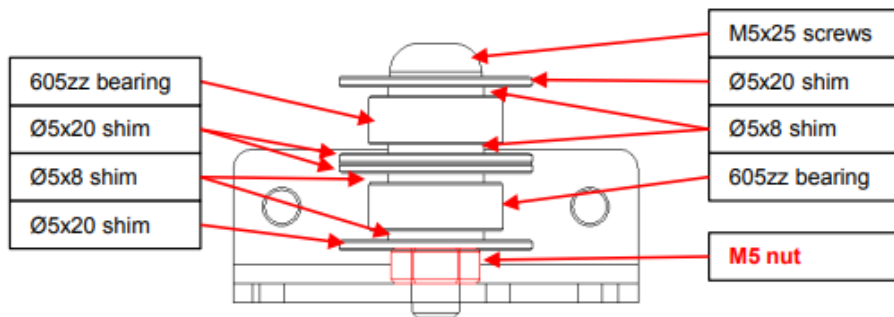
1. Add M5 nuts on the bottom of two Idlers

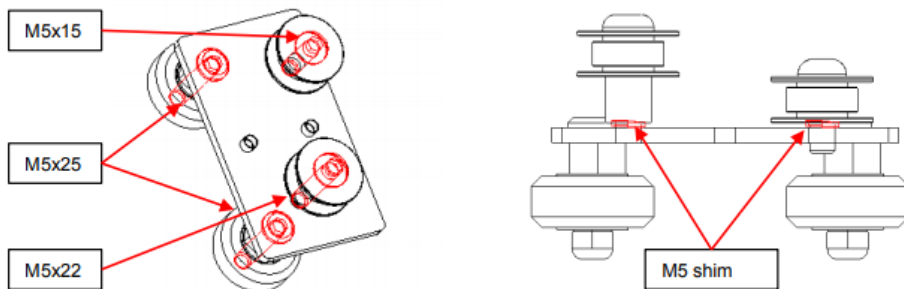
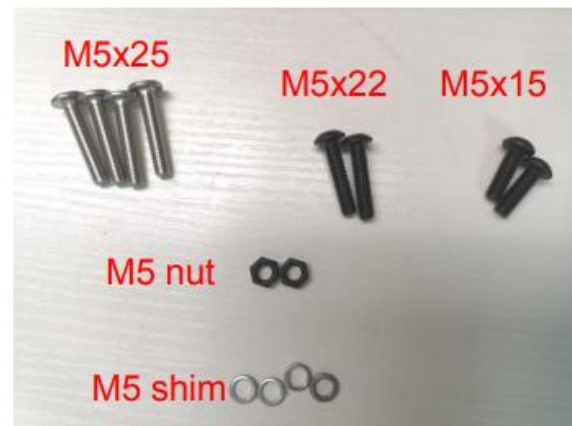
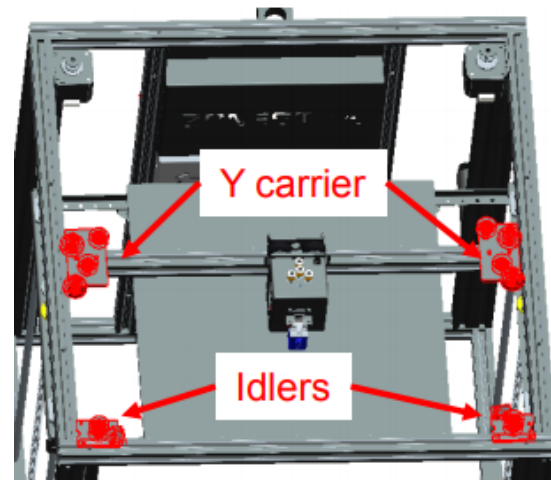
2. Replace the screws and add shim on the bottom of two Y carriers
