## Substance

We found that some extruders may not be well installed, which will lead to insufficient conveying force of the extruder and more likely to scratch the filament. This article describes how to check and solve this problem.

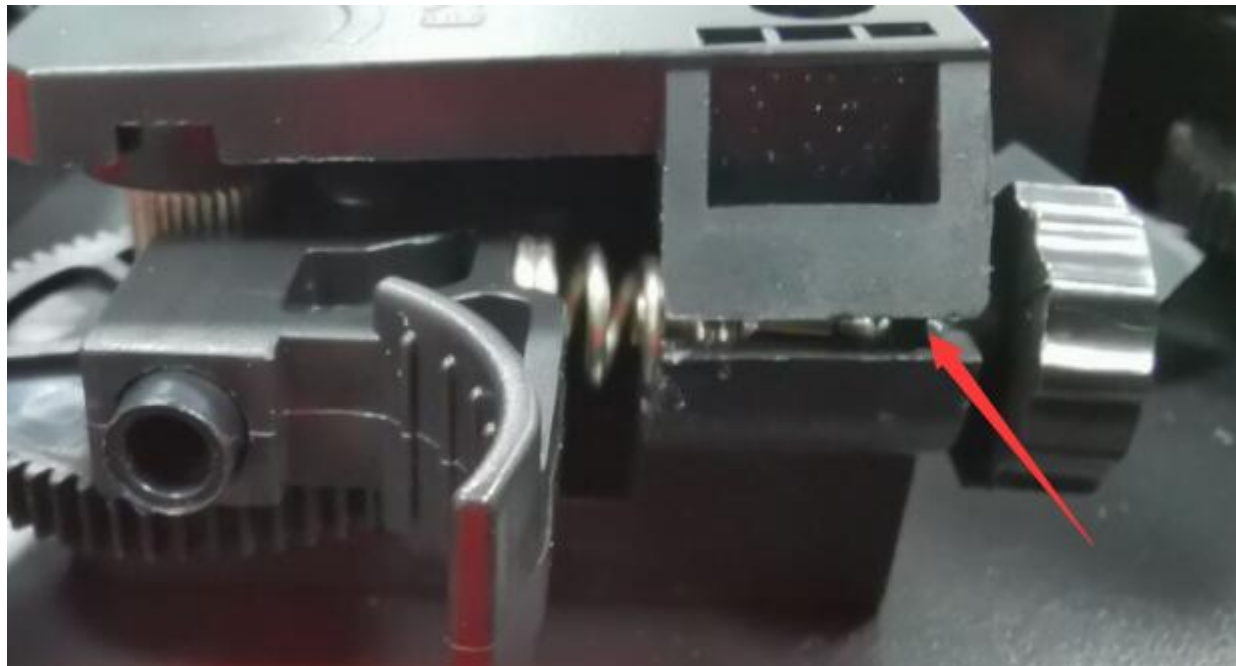
**Please check whether there is obvious gap here, refer to the below picture:**

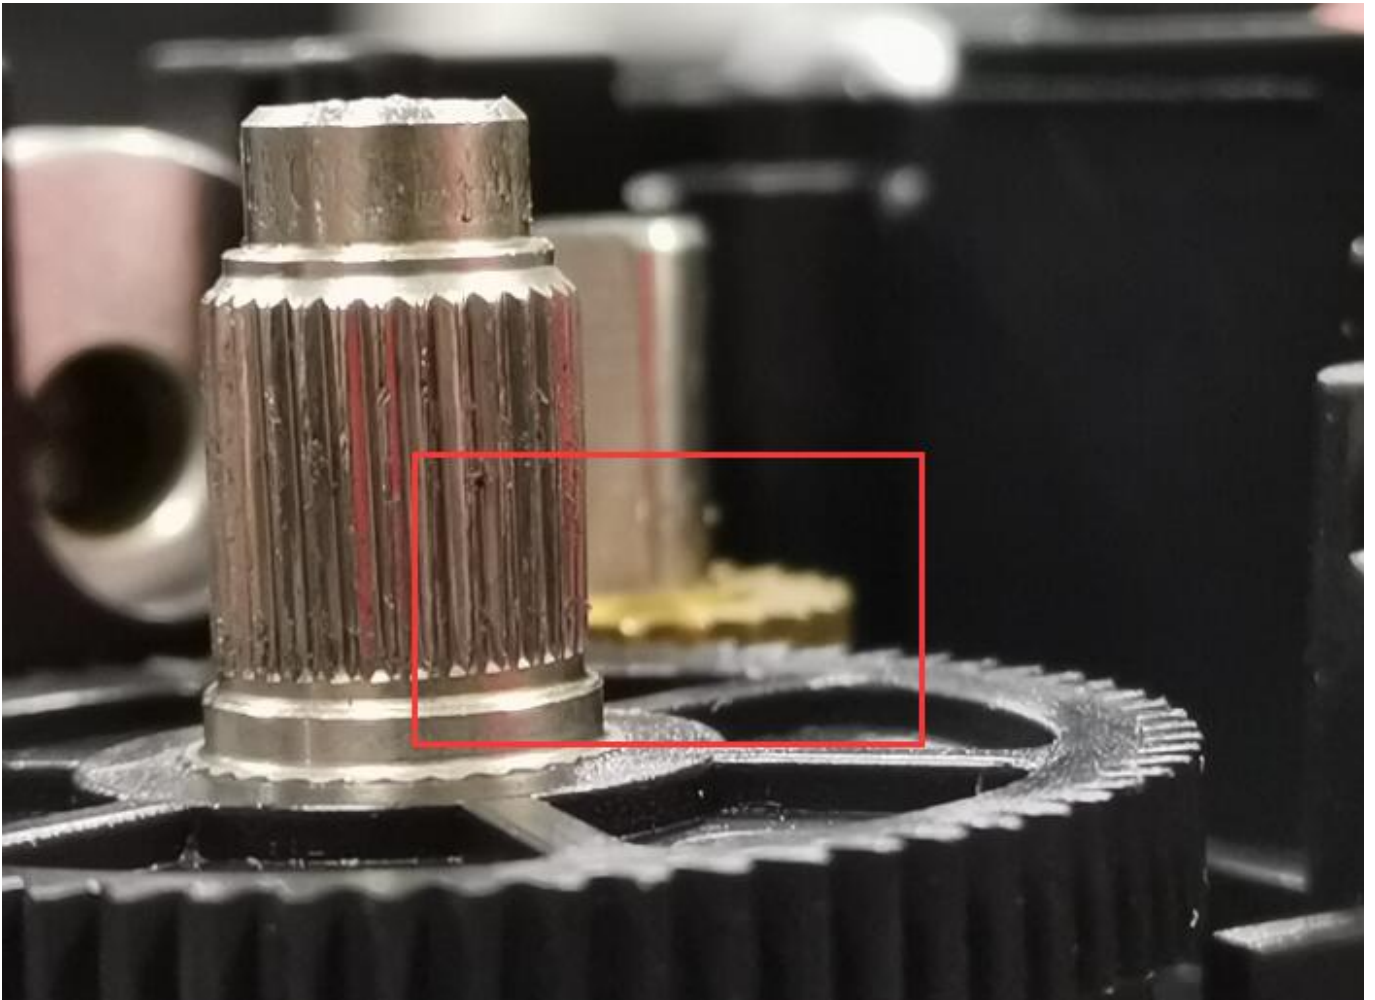
1. The top of the copper gear is at the same height as the big gear.

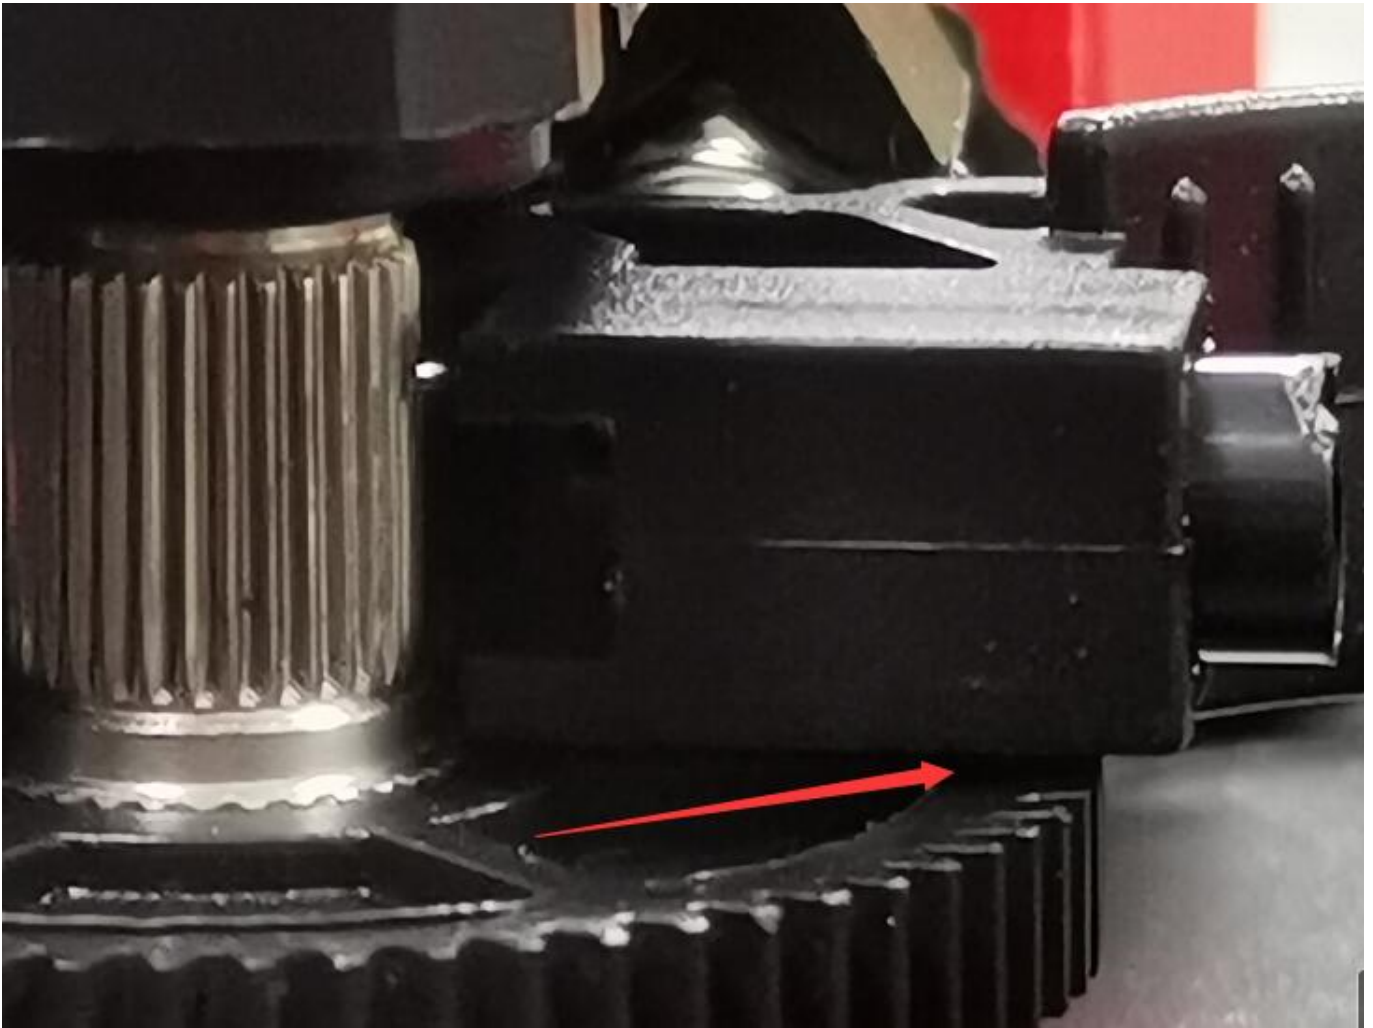
**2. After installation, the clearance between the indenter and the big gear is less than 1mm**

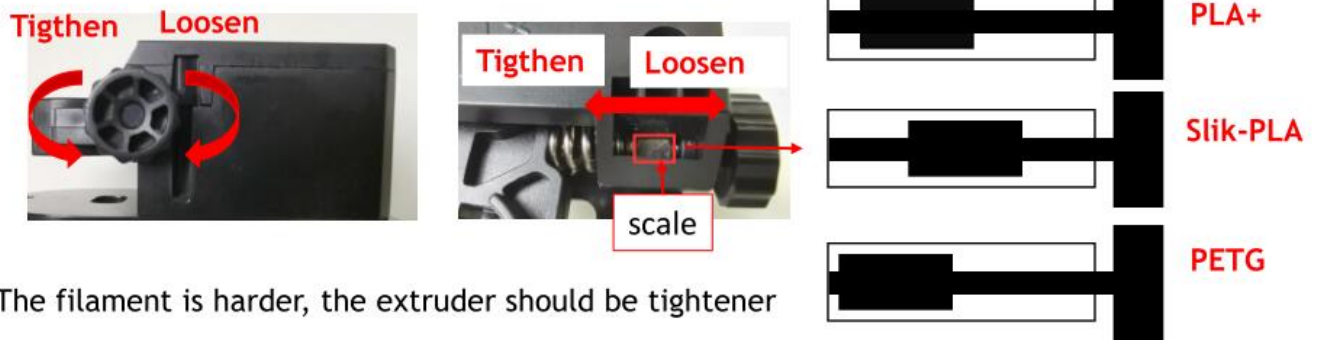
namely, several examples for your reference as below.

The filament is harder, the extruder should be tightener

**Step 4: Properly adjust the extruder pressure according to the hardness of filament.**
