Demonstration of Abyss Solutions Mooring Chain Inspection Technology

ExxonMobil Test Tank Chain Pilot – Final report

Proceanic Ltd
712 Main Street
Suite 700
Houston, TX 77002
Unites States of America

Abyss Solutions Pty. Ltd.
Unit 35, 11-21 Underwood Road
Homebush NSW 2140
Australia

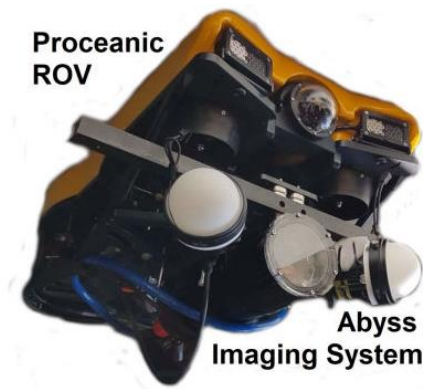
Abyss Solutions integrated its high-fidelity optical imaging system on a third party ROV within 50 minutes. The process was relatively simple and required a single member of staff only. The system that was integrated consisted of a stereo imaging set as well as specialized strobe lighting. The system was capable of capturing high detail and accurate color imagery as well as precise 3D measurements.

Figure 1: Image of Abyss Solutions' imaging system integrated on the third party ROV.

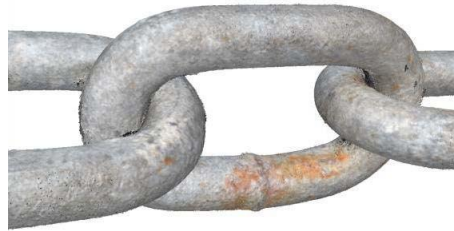
The enhanced imagery was used to re-construct an enhanced color and high-detail virtual replica of the chain links. The models were produced to scale for the purpose of 3D measurement.

Figure 4 Image of photorealistic 3D model of a chain link.

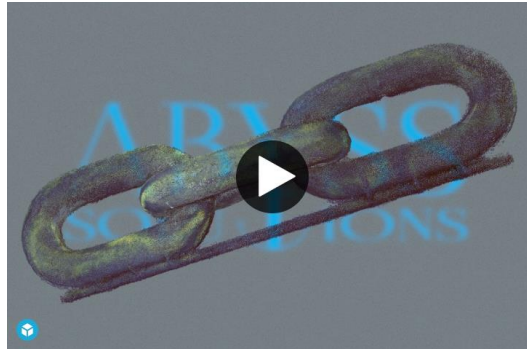
3D models of the static and oscillating chains generated using data collected on October 29-30, 2018 are shown in Figures 8-9. Click on the figures below to launch and interact with the 3D models. The 3D model of the oscillating chain has been used to generate engineering drawings of the bar sections for each link as shown in Figure 10.

Figure 8 Interactive 3D model of the static mooring chain. Click on the figure above to launch the model.
