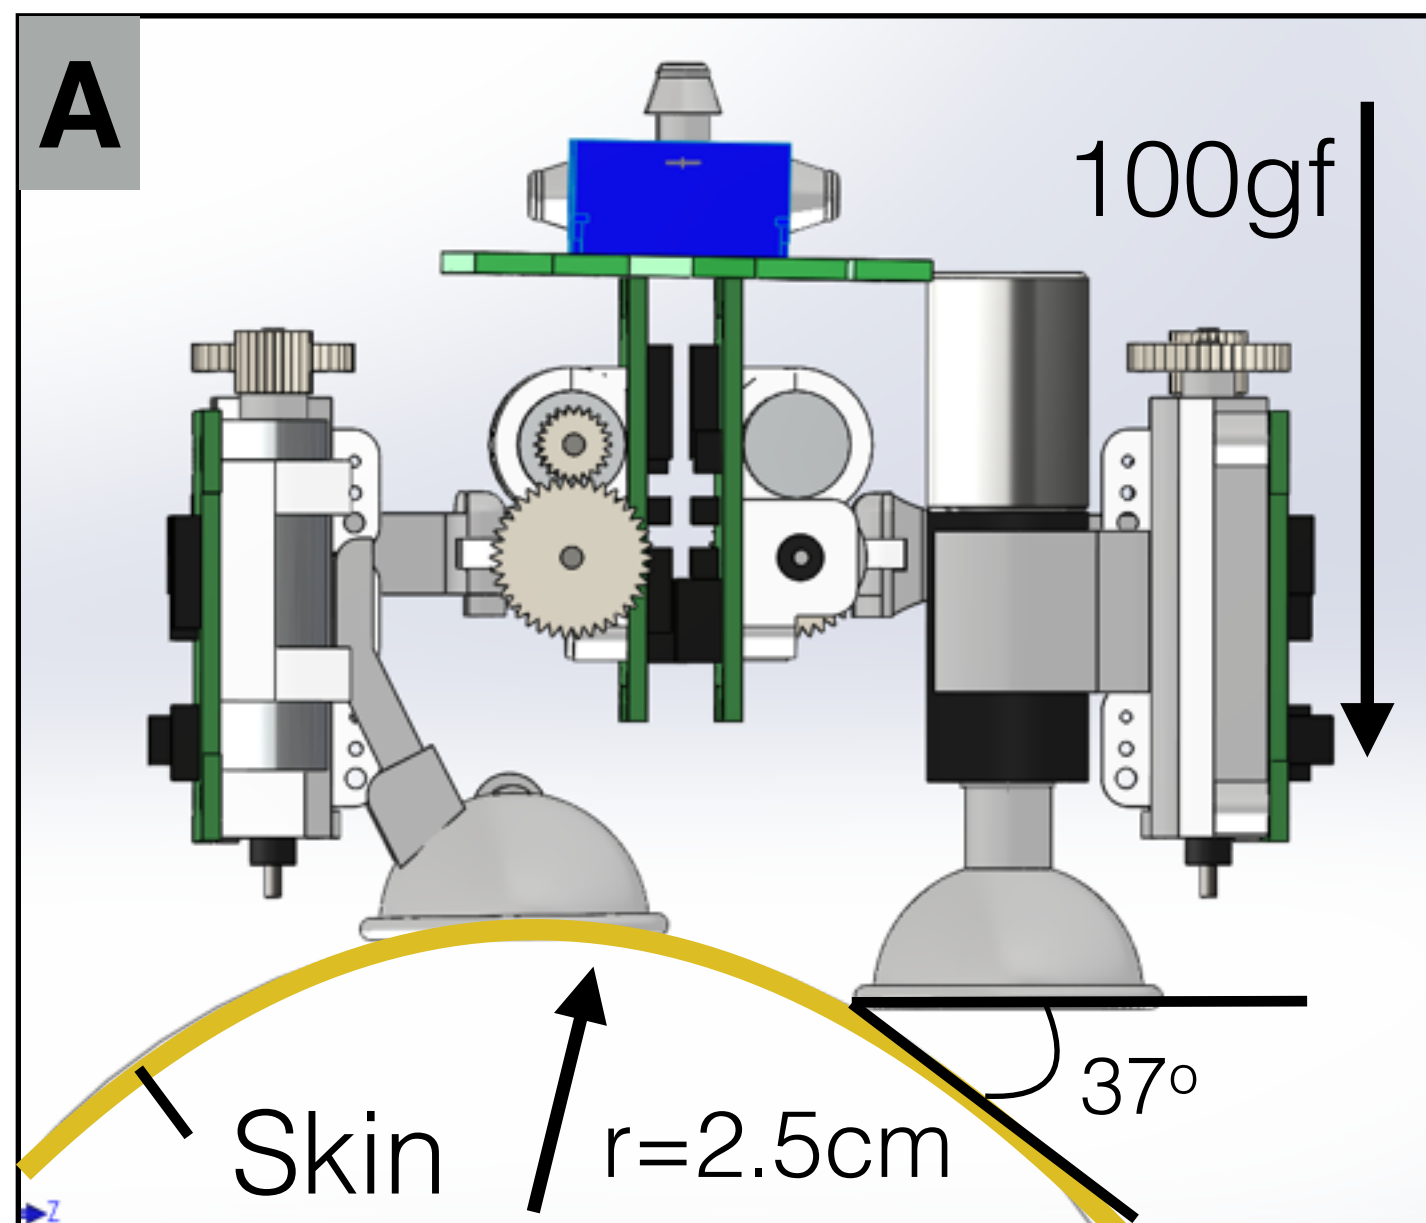
before motor pushes suction cup

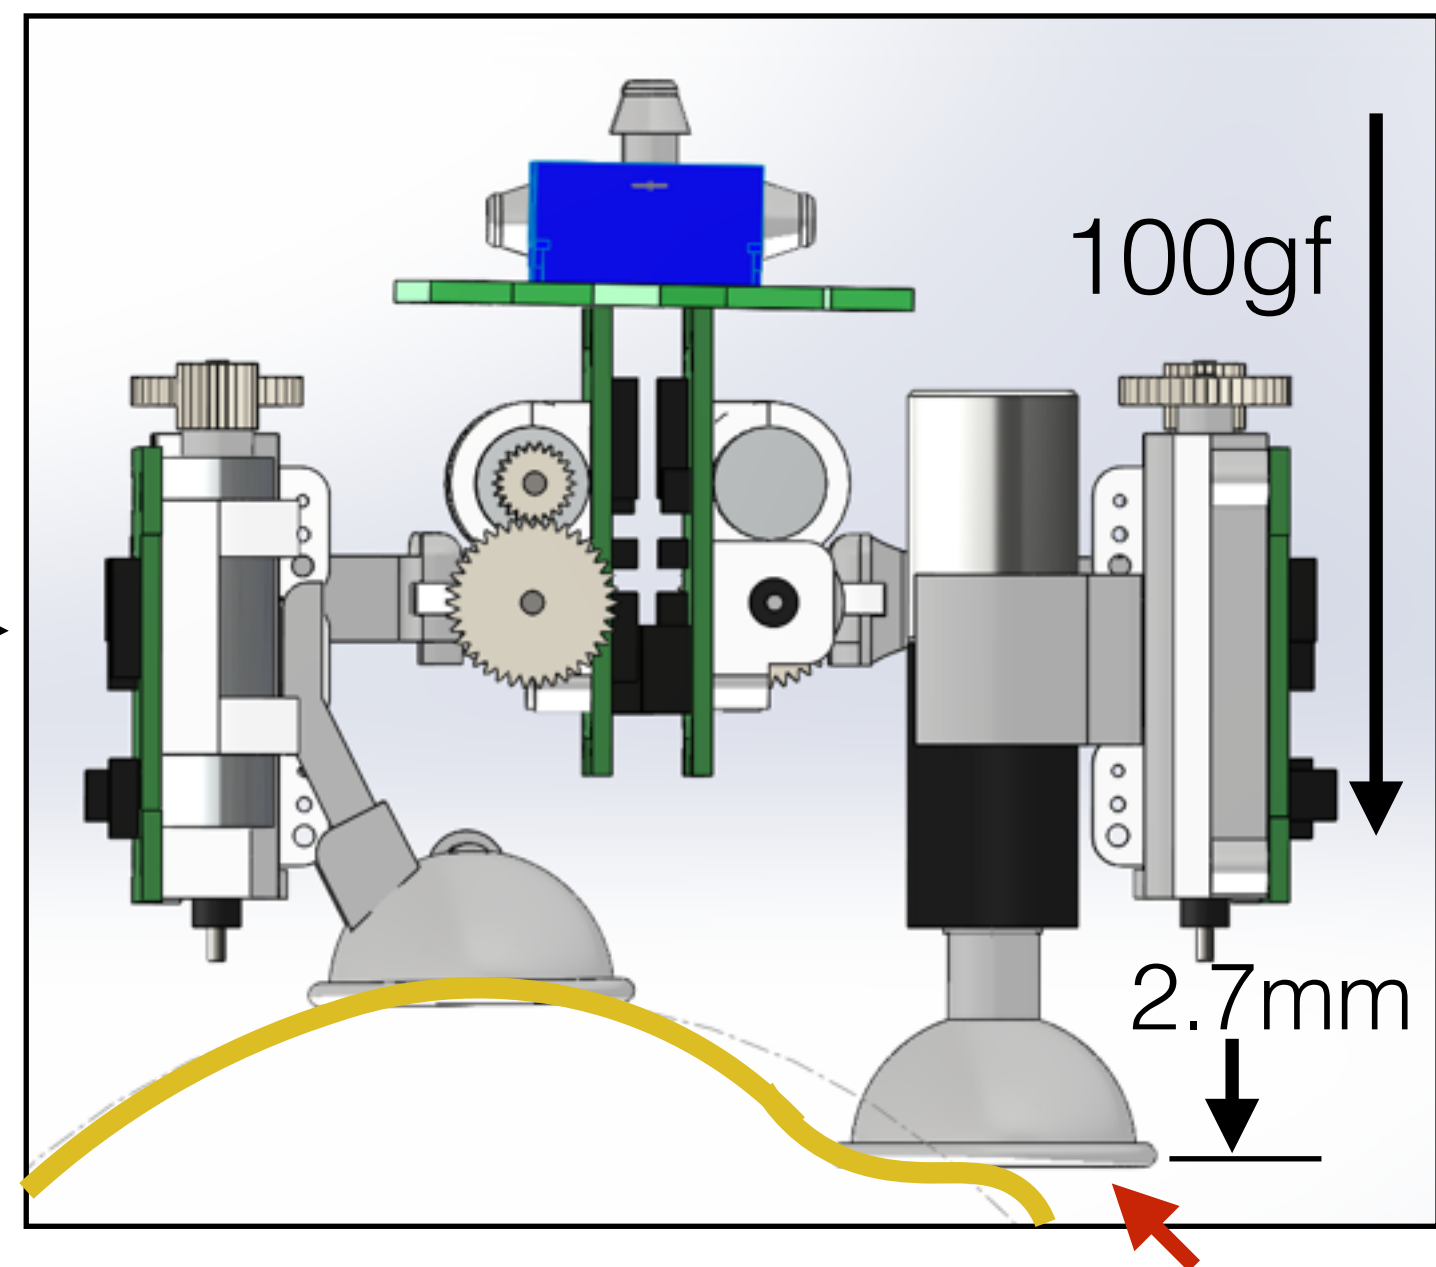
Skin deforms by 2.7mm

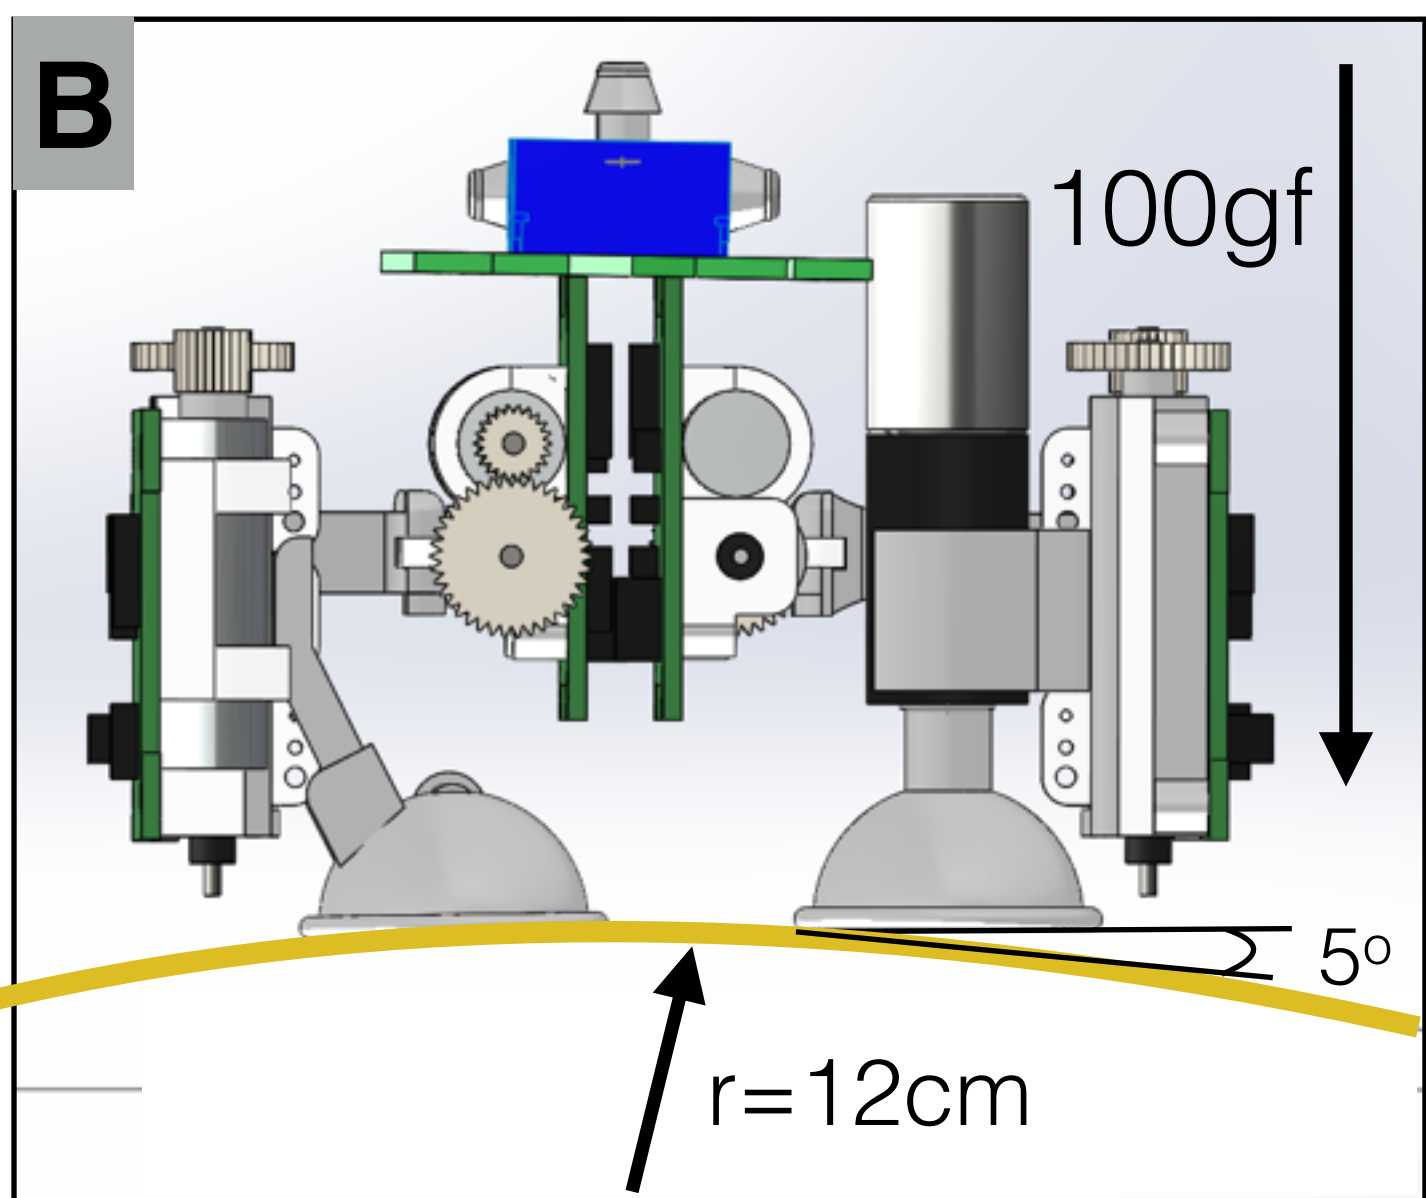
Gap; no seal

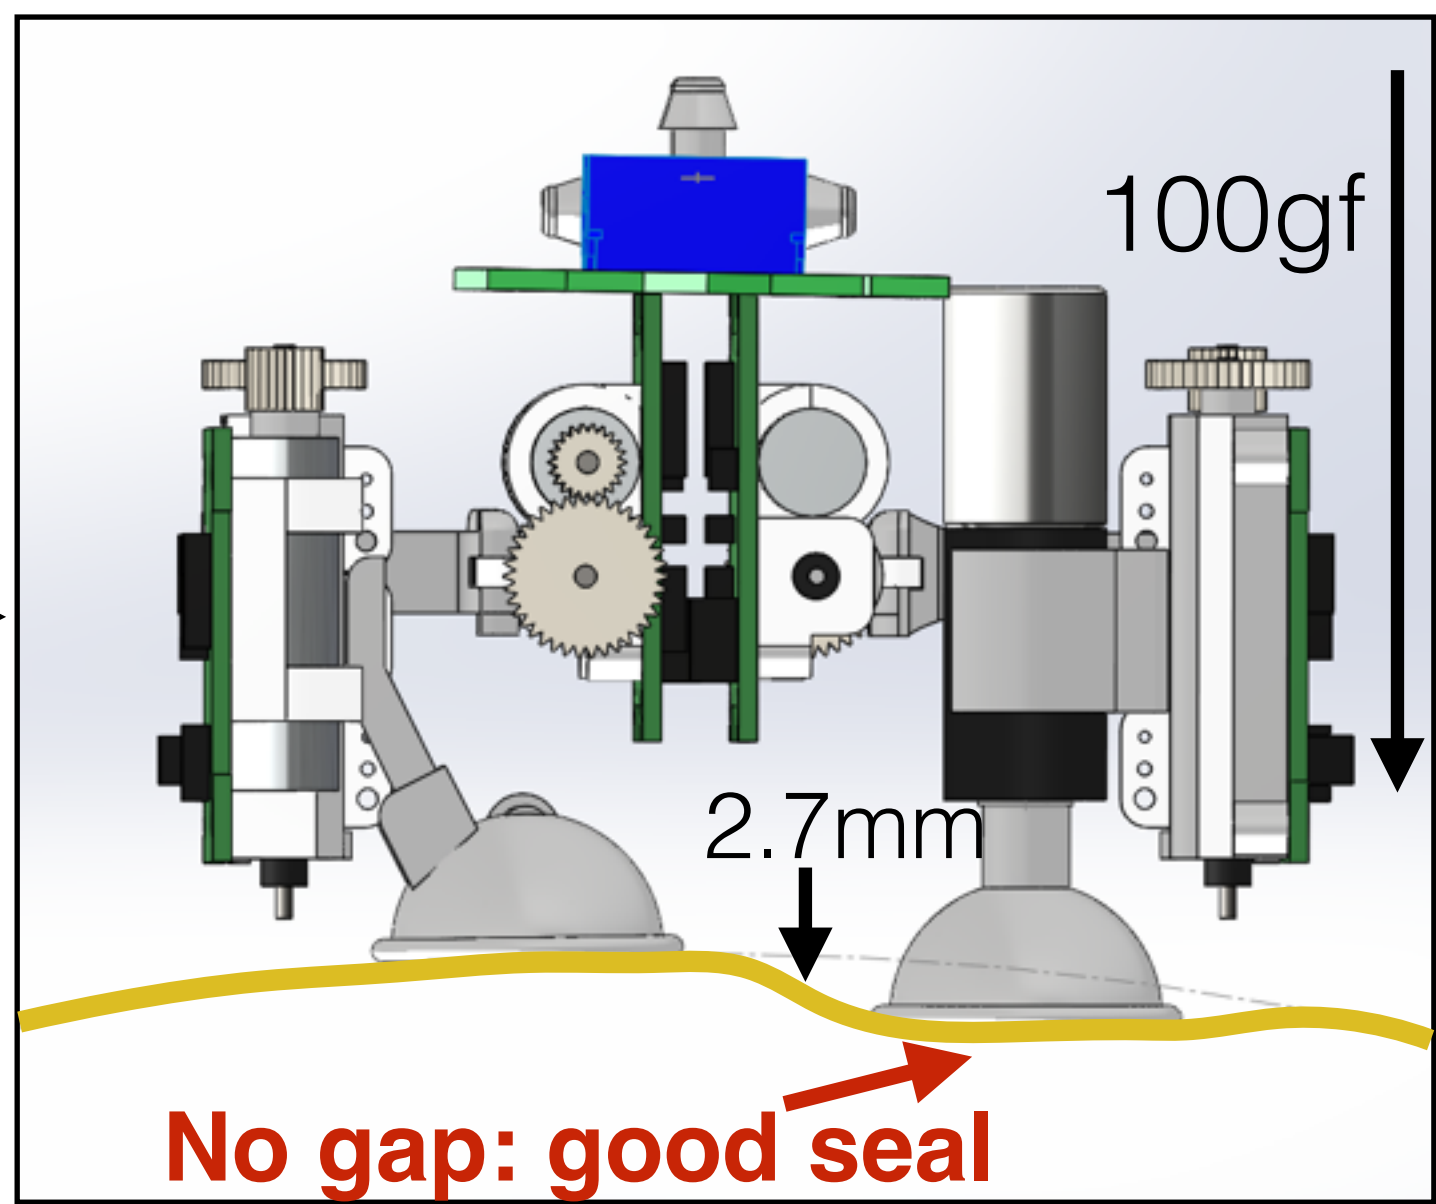
No gap: good seal
