Silver Spark Apparel Limited

Development of Real Time Production Monitoring System &
Enhancement of Productivity of Cutting Department

- Aditi Galada

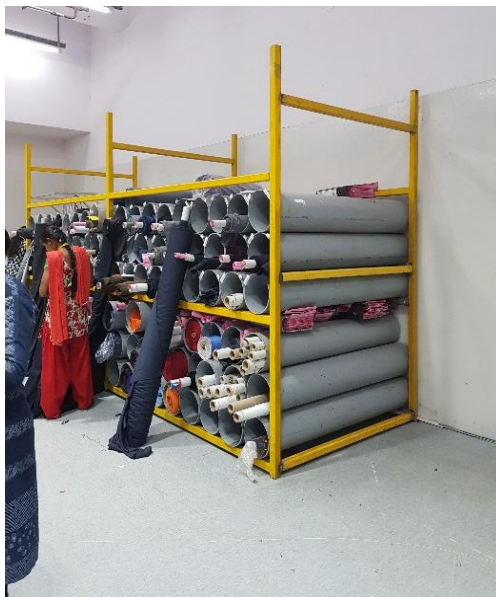
Fig: Before installation of board

- Fusing was added to the tray provided from the sub-store.
- Formerly, operators had to match the code written on each fabric roll with the fabric code on the tracksheet. Later, each fabric roll was given an alphanumeric code and this code was written on board which allowed the operators to identify required rolls faster.

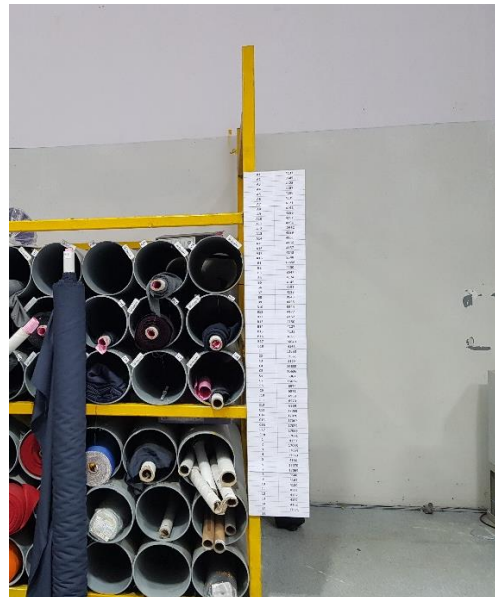
Fig: After installation of board

The number of orders with fabric code wrong reduced drastically after installation of the board with fabric codes (refer 2.1.) in the sub-store.

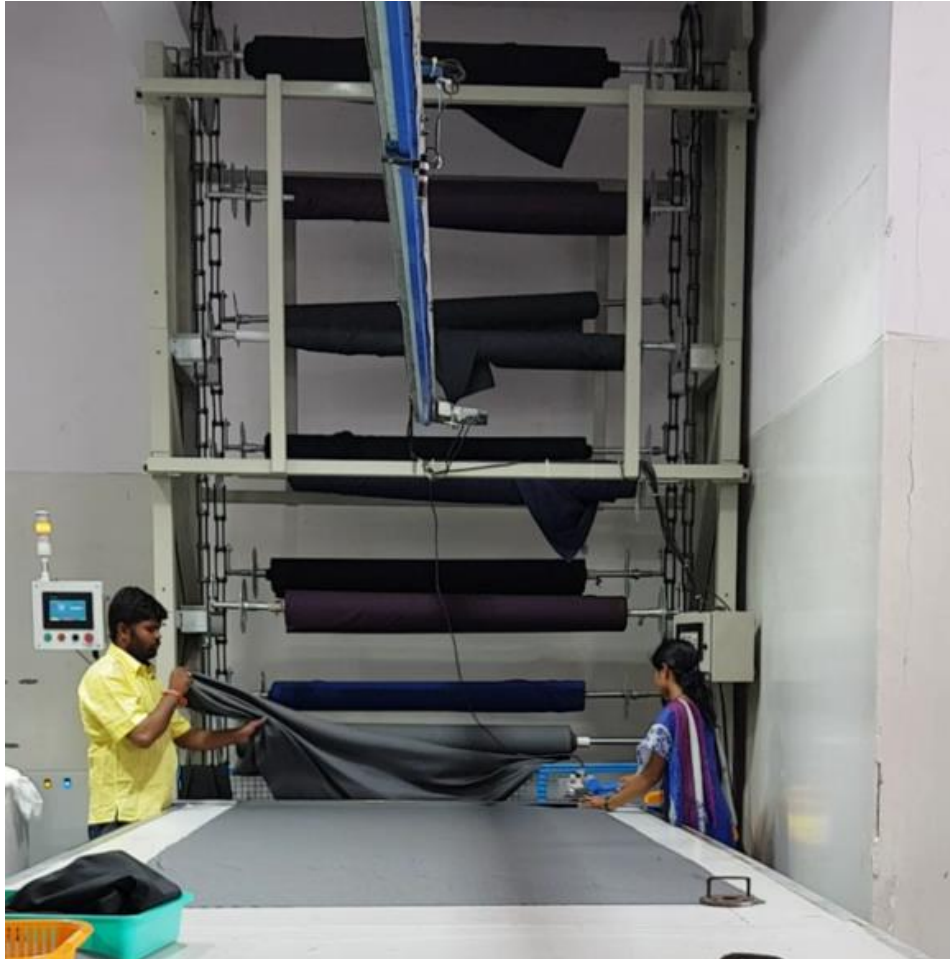
Fig: Laser light with carousel machine

A laser light, round knife cutting machine and a table were installed in front of the carousel machine. When the consumption was entered in a touch screen monitor the laser light would move the required distance, the operator would pull the fabric till the laser light and cut the fabric using the round knife cutting machine placed at the end of the table.

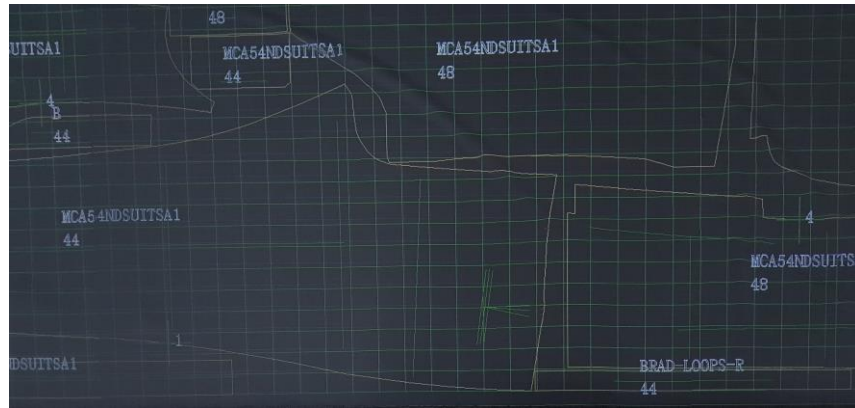
Fig: Matching of the projected grid with checks of the fabric

- a. On the Ruizhou Cutting Machine, the checks matching process included a step where a projected grid (neon green) was resized using the arrows keys in order to match the checks on the fabric. This process took about one minute per garment being cut.

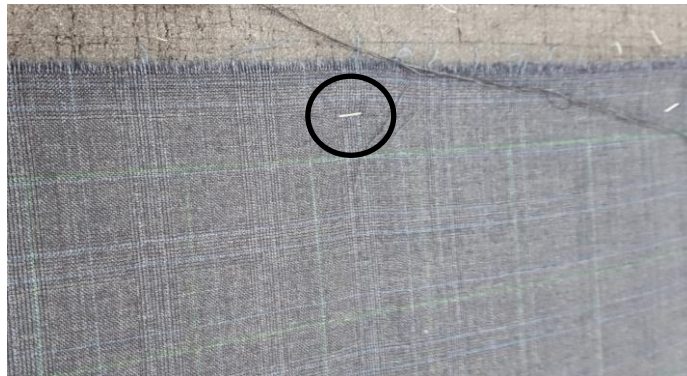
Fig: Use of staples on Ruizhou Machine Bed

The Ruizhou machine is used to cut garments with checked shell fabric. The fabric is laid on fold. In order to match the checks and prevent the layers from moving, the operators would staple the fabric onto the bed. Later, these pins would break the knife and cause rash cutting.

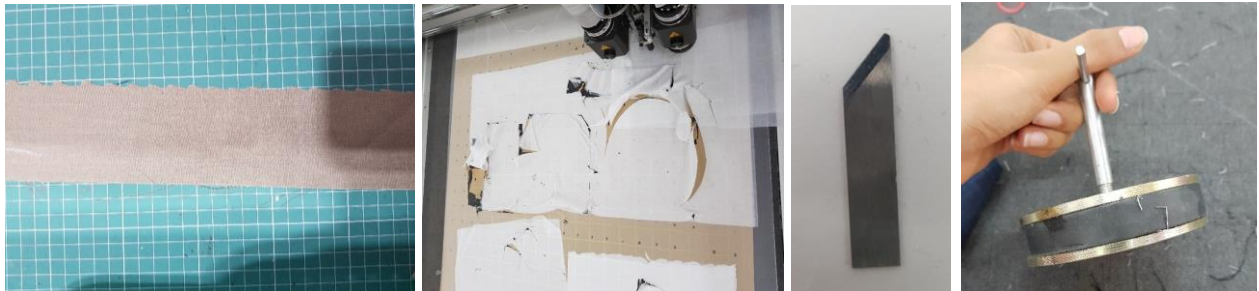
Fig: Rash Cutting, Joint Cuts, Damaged Knife, Pins Picked Using Magnet (left to right)

- Cost
 - The cost of each blade was Rs.750
 - Nearly 4 blades were getting damaged on daily basis.
- Time
 - The knife change process required 20 minutes
- Hazard

The magnetic property of the pins was used in order to remove all the pins from the bed before laying the next fabric. A powerful magnet provided to the machine operators who were trained to pick up all the pins from the bed using the magnet by just moving it across the bed once.

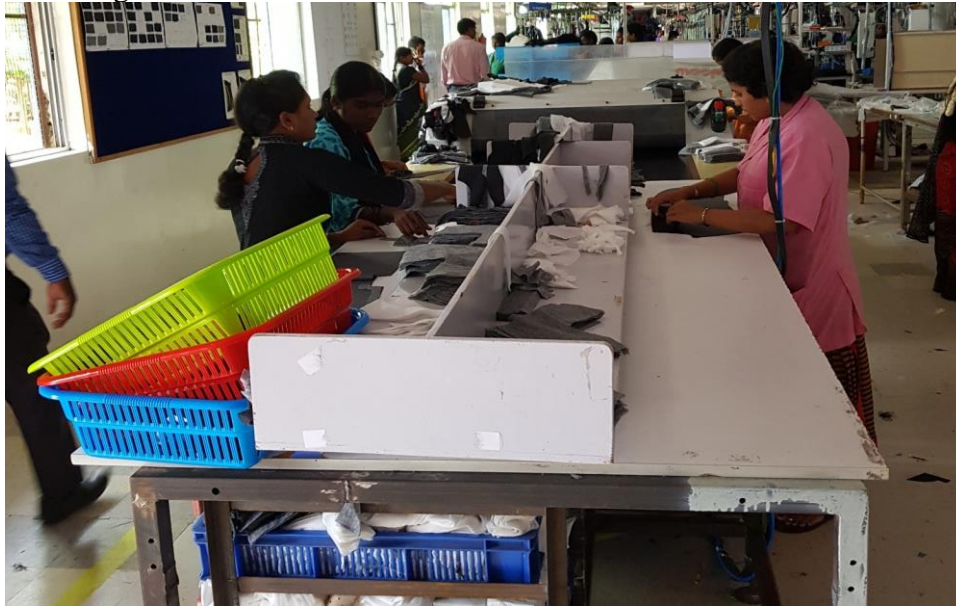
Fig: Fusing Machine before Installation of Rack

- Crowded workspace
- Parts Missing
- Low output
- No Standard Operating Procedure

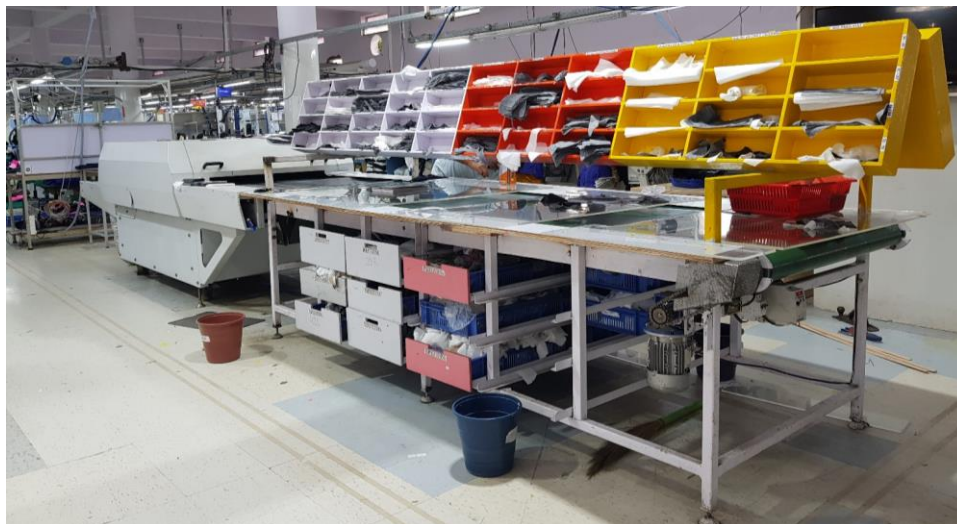
Fig: Fusing Machine after Installation of Rack

To solve this problem, a rack and conveyor set up was added in front of the fusing machine.

- Conveyor: A longer conveyor was added in front of the fusing machine, so that operators could directly put the pieces onto the conveyor once the fusing and shell set up was ready.
- Panel over the conveyor: Panels were made of acrylic sheets to keep on top of the conveyor between railings. This increased the workspace for the operators.
- Angled rack: Two racks were placed back to back at a 120° angle. These racks were divided into 3 color coded columns and 4 rows. Each column was assigned one operator.
- Job Reengineering: Each operator was assigned to work on specific panels. As they worked on the same panels repeatedly, their efficiency increased.

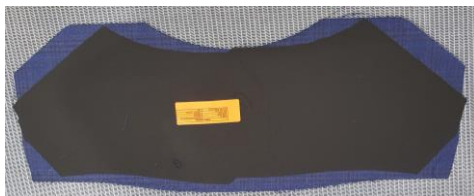
Fig: Block Cutting Collar

The process of cutting collar and collar stand of checks garments manually was a very tedious process, the paper pattern had to be procured and cut using the rotary knife.

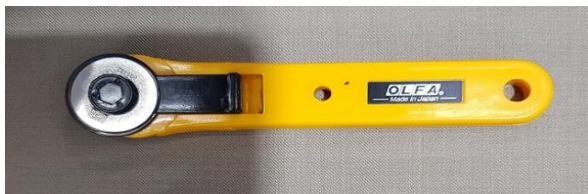
Fig: Rotary knife used to cut collar

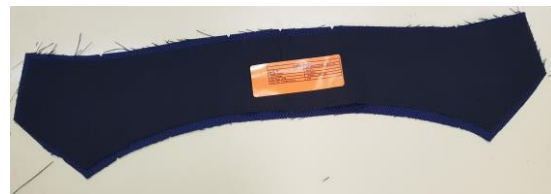
Fig: Collar cut using rotary

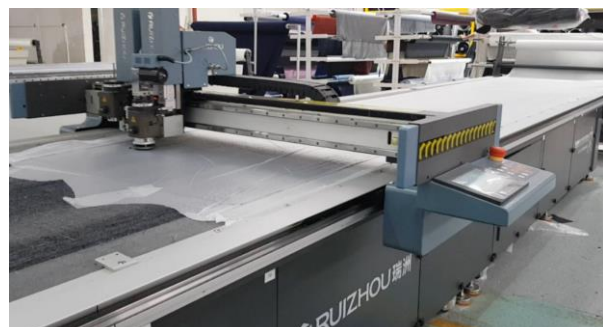
Fig: Cutting Collar Components

The collar and collar stand were cut on the cutting machine by aligning the checks with the projection of patterns on the machine bed. This increased the output from 10 pieces per hour to 40 pieces per hour and reduced the man power requirement.

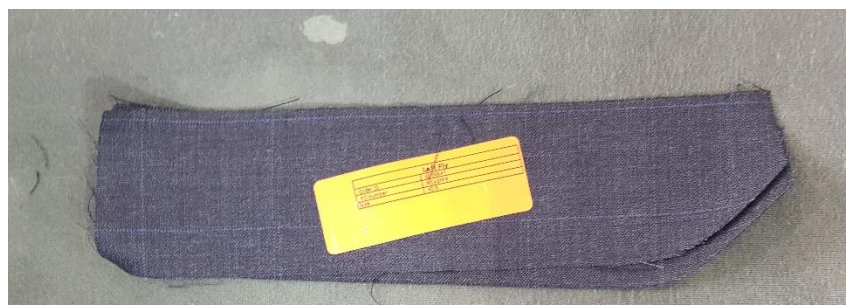
Fig: Stickering Process

The tagging process was eliminated by a stickering process. Stickers were printed from the CAD department and provided to the cutting machine operators along with the tracksheet who could attach the stickers while picking the part from the machine bed.

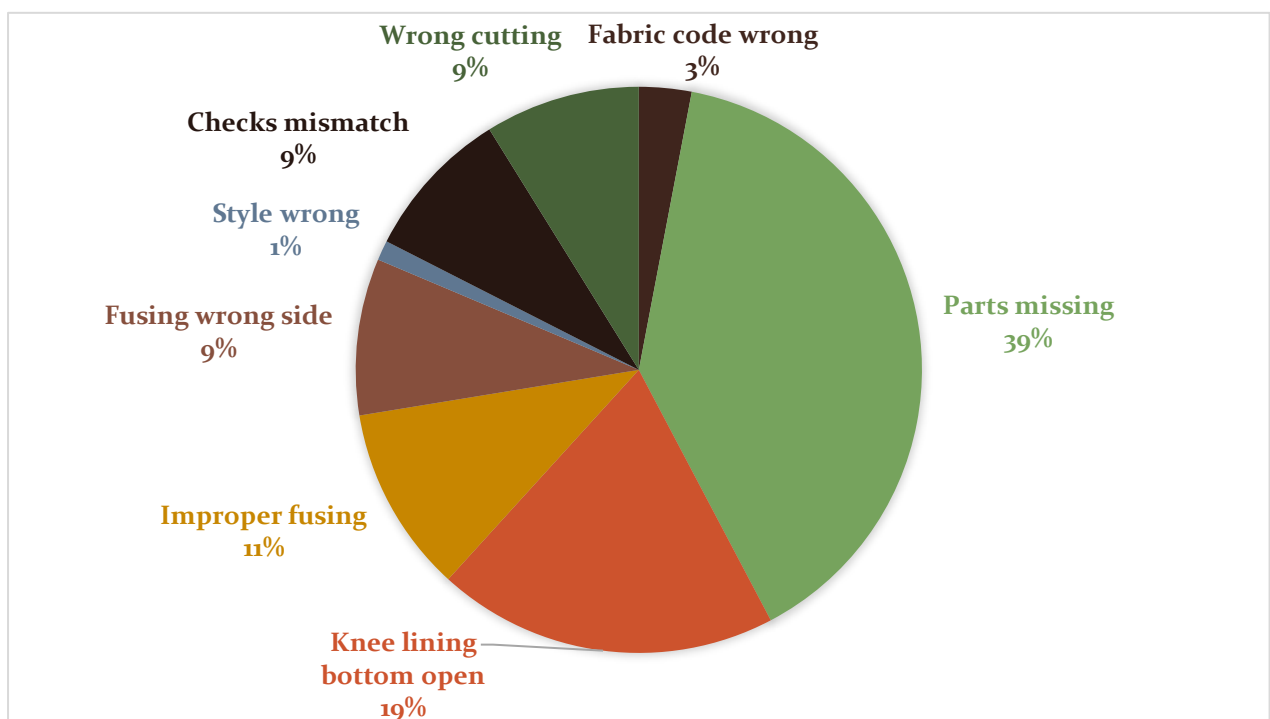
The quality reports were compiled to the top 8 defects.

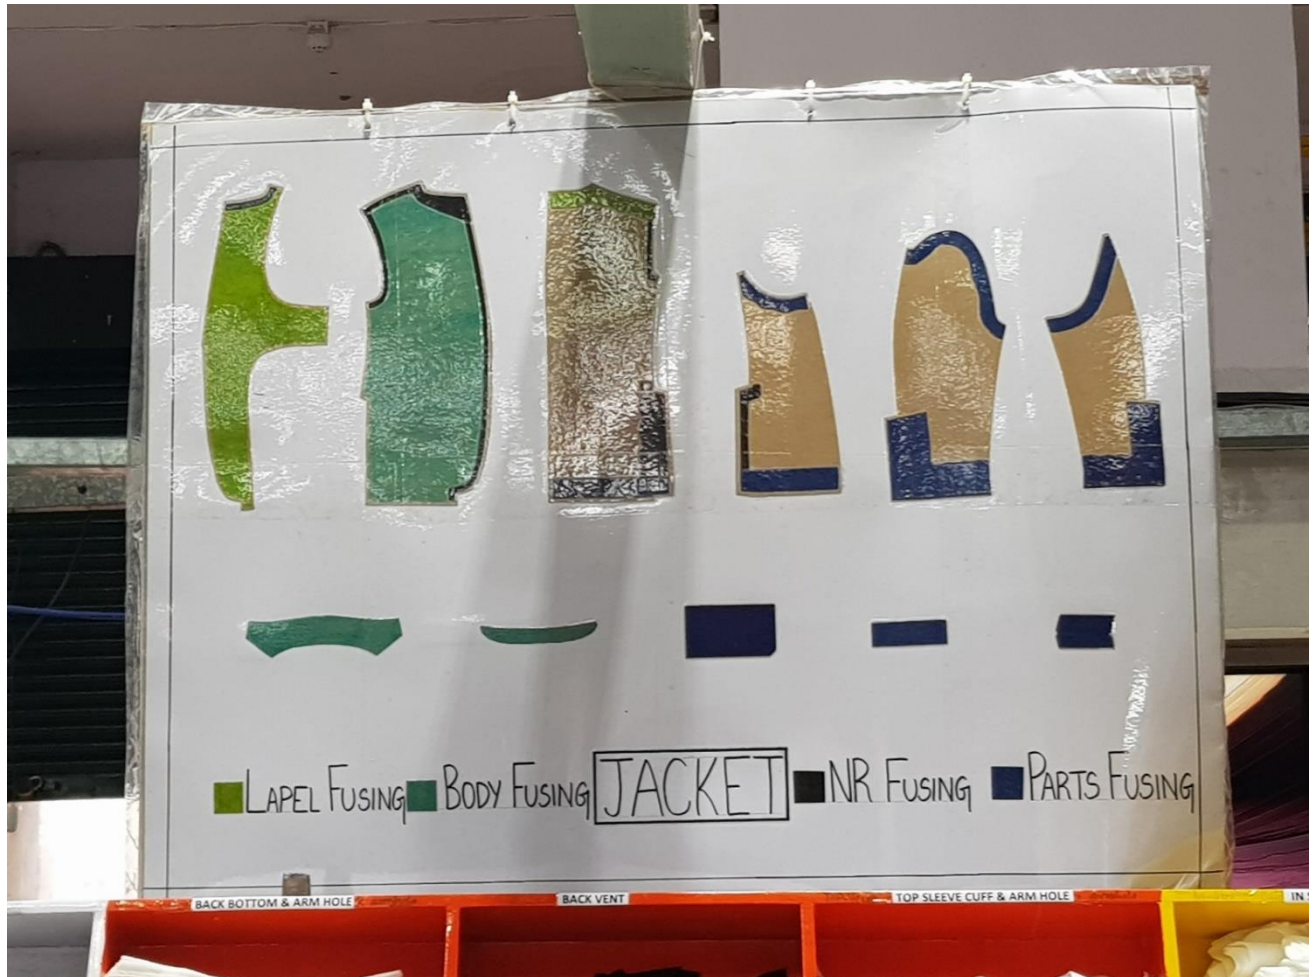
Fig: Training Board for Fusing Operators

A board consisting of various fusible parts of a jacket and the placement of the fusing along with its type was displayed above every fusing machine. The display board was used to train new recruits and provided a reference to the operators.
