# METALLOSIS AND OSTEOLYSIS

Metal, Polyethylene and Ceramic Implants

**GROUP 11:**

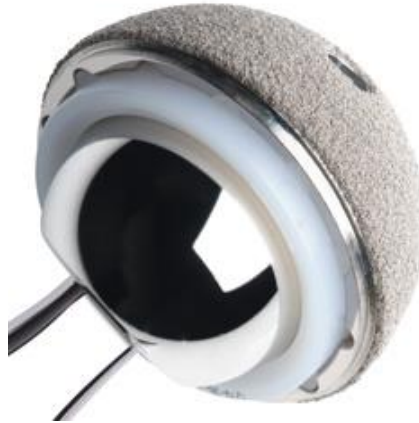
*Figure 13: polyethylene implants*

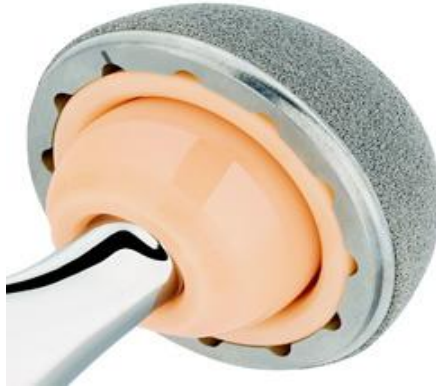
Ceramic bearings are available in 2 configurations: a ceramic femoral head (ball) with a polyethylene liner, or a ceramic femoral head (ball) with a ceramic liner. No one material is right for every patient. Only your surgeon can determine what's right for you.

*Figure 15: ceramic implants*

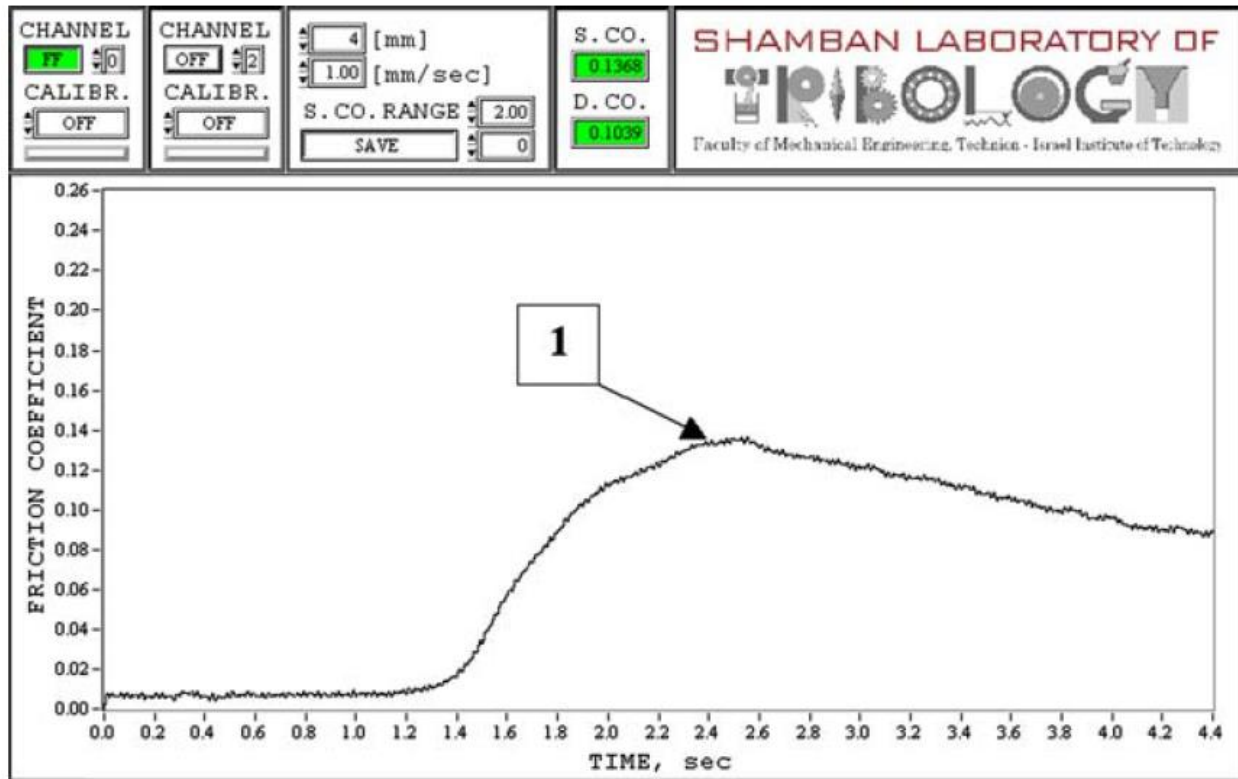
*Figure 16: Changes in friction coefficient of lubrication with change of time*

The case shown in the figure corresponds to saline lubricant, 10 N load, sliding speed of 1 mm/s, dwell time of 5 s, and temperature of 24 deg C.

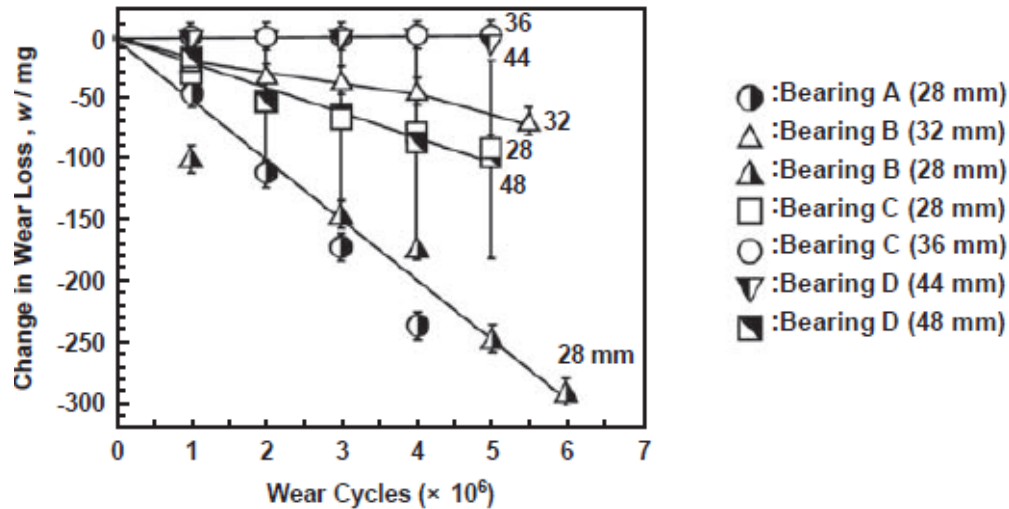
The results obtained were very interesting. The first set of experiments were conducted on the metal-on-metal bearings. It was noticed that the increase in head size lead to decrease in the wear rate of both the head and the cup. Only the Bearing D (48 mm) showed an exception to this rule. This result can be seen from the graph 1 plotted for wear cycles against the wear rate for bearings of different sizes. The negative values on the y-axis signify a decrease in weight of material, thus a greater negative value signifying greater wear in the part.

Figure 21: Wear cycles vs Wear rate

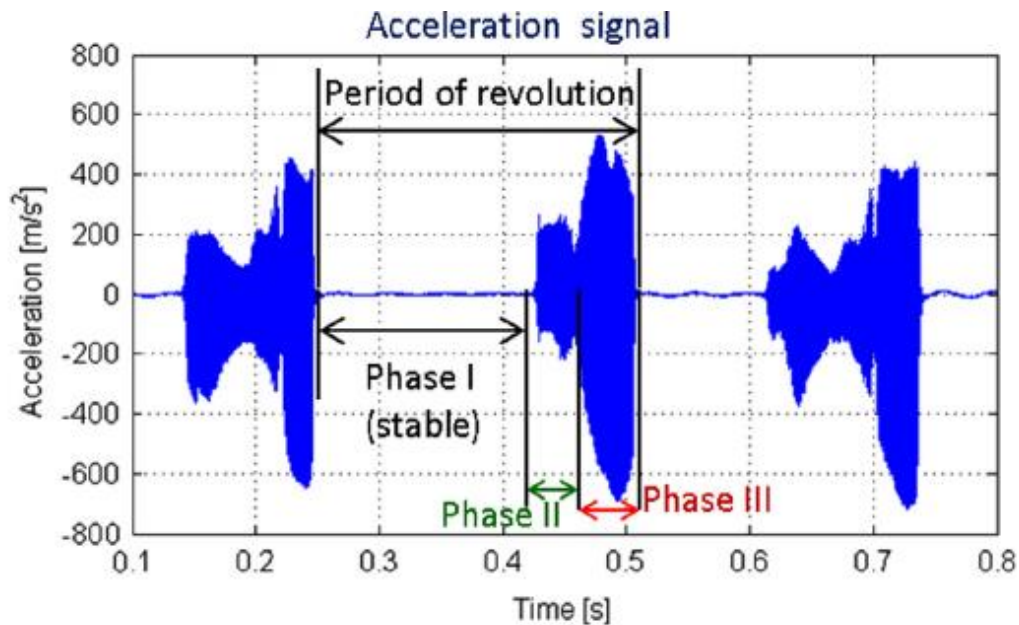
The following is a standard curve used to analyze the frequencies. It shows the complete loading cycle used for evaluation. The cycle is divided into three phases. The first phase has no major acceleration disturbance. In phase II there is a higher level of disturbance and the highest level of acceleration can be found in the phase III.

Figure 27: PSD diagram for frequency analysis

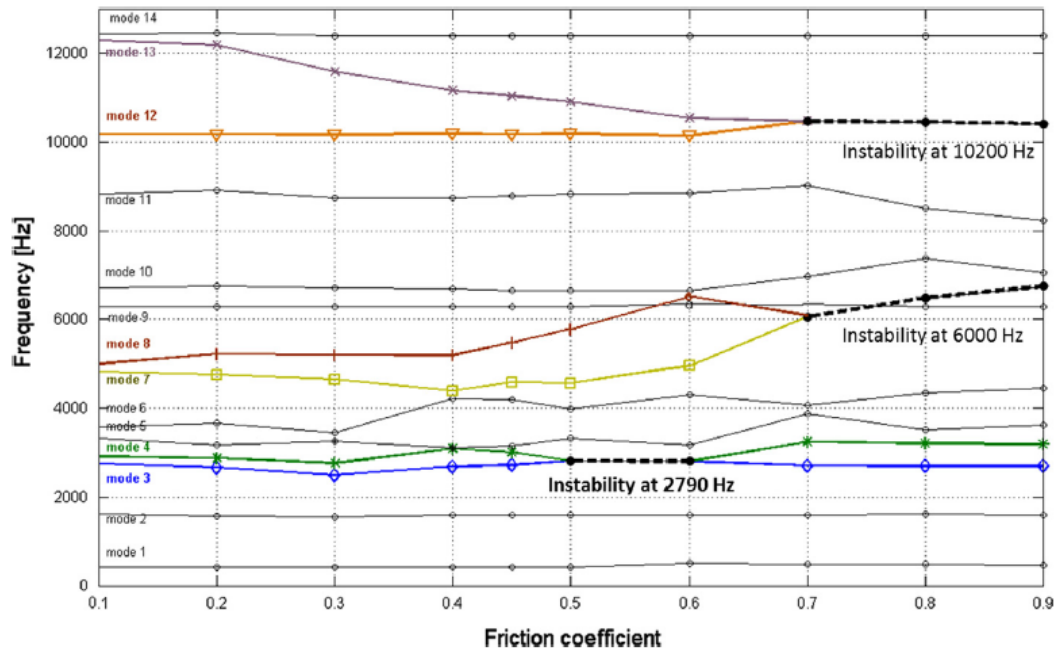
Finally the most important result was obtained by evaluation of the relation between the frictional coefficient and the frequencies which are used to pin point the exact points at which the squeaking occurs. On the graph shown below, the intersection of any two lines leads to what is termed as instability points. As can be seen in the graph, increase in the frictions coefficient leads to greater occurrences of instability points. Also no instability occurs at friction coefficient values below 0.5.

Figure 28: Frictional coefficient vs Frequency
