Summary

Given a set of stairs of archaeological interest, our model aims to look at the pattern of erosion to determine the total number of footsteps those stairs have endured over the centuries. We present a linear model that accounts for the amount of weathering the steps have endured from environmental factors. The model uses a linear relation between the number of steps taken on the stairs and the amount of wear measured by approximating the eroded area as a quarter-ellipsoid. We assume the stairs are made out of granite, with a Mohs hardness rating of 6.2, and we assume the archaeologists have a rough estimate of the age of the stairs. From this information, our model can calculate how much of the existing erosion was caused by nature and how much was caused by human activity. We then use a parameter for the amount of erosion per thousand footsteps to approximate an average for the total number of steps that a stair has experienced. Though our model is unable to determine if the stairs were used primarily for going up or down, we can infer if multiple people used it simultaneously given the number of troughs in the erosion pattern and the total width of each step. Repairs or

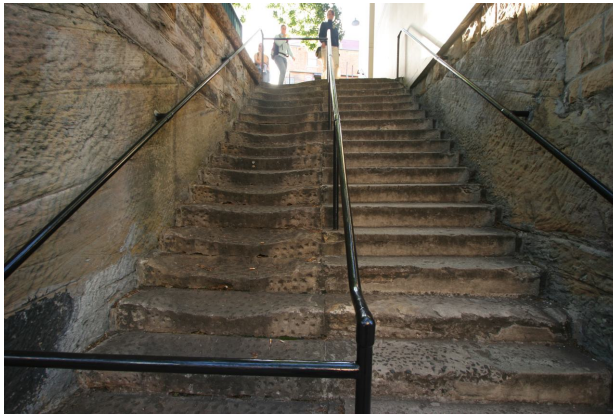
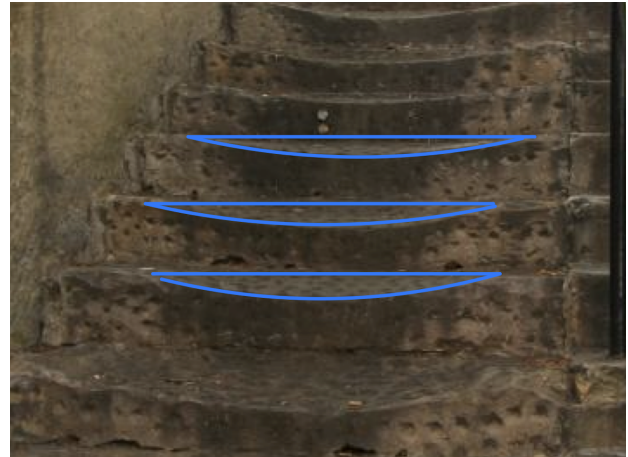
(a) Staircase showing erosion from prolonged foot traffic and erosion.

(b) Close-up of bow erosion pattern on individual steps.

Figure 1: Bowing erosion pattern on a historical staircase [7].

Stairs are one of the oldest architectural features in human history. As is the case for any structure, stairs face wear and degradation over time, both naturally and from human activity. As shown in **Figure 1**, we can observe this decay in the shape of a bow (see **Figure 1b**). Given a set of measurements from a set of stairs, our goal is to estimate the average amount of foot traffic the stairs have received over a certain number of years. To do this, we developed a mathematical model that incorporates the building material of the stair, the observed amount of stair lost, human foot traffic, and environmental degradation.

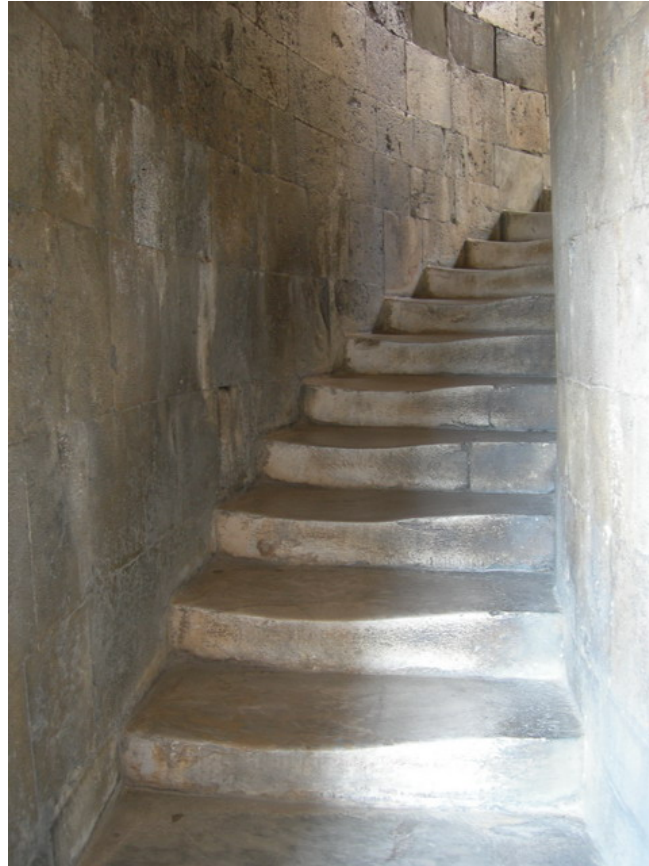
Figure 4: Stairs in the Leaning Tower of Pisa [6].

The stairs leading to the top of the Leaning Tower of Pisa in Pisa, Italy are a prime example of long-term staircase erosion (see **Figure 4**). Note the consistent eroded area on the left side of each step. Construction of the tower began in 1173 and was completed with the addition of the bell chamber in 1372, although the topmost floor was completed in 1319 [2]. We can reasonably assume then that the stairs closer to ground level have been used more than the ones at the top, given the amount of time it took to complete the tower. Thus, a rough estimate for the age of the marble stairs is anywhere from 653 to 852 years old, with different sections of the staircase falling in different parts of this age range. For simplicity's sake, we use the extrema of this range to provide a lower and upper bound on the stairs' usage. We start by estimating the dimensions of each step of the staircase. The two main spiral staircases (one of which is pictured in **Figure 4**) that run the height of the tower are narrow and

only one person can travel on them at a time, single-file [2]. In modern-day, building codes typically mandate a minimum of 36 inches of stair width per person traveling on the staircase, or 0.91 meters, though most single-file staircases are 44 inches wide, or 1.12 meters [3]. Since spiral stairs are usually tighter and modern building regulations didn't apply in the 12th century, we will assume these stairs are 1 meter wide. We will also assume typical riser height and tread depth here at 7 inches and 12 inches, or 0.1778 m and 0.3048 m respectively. Using these values and **Figure 4**, we can estimate the dimensions of the eroded area as follows:
