Freightliner LLC New Vehicle and Aftermarket Parts Limited Warranties warrant that Freightliner LLC products will be free from defects in material and workmanship that occur under normal use within the applicable warranty period, subject to certain limitations and exclusions as specified in the Warranty Manual.

Clutch Wear-Out	Section 83.02.01 Damage Code: 130-001080590

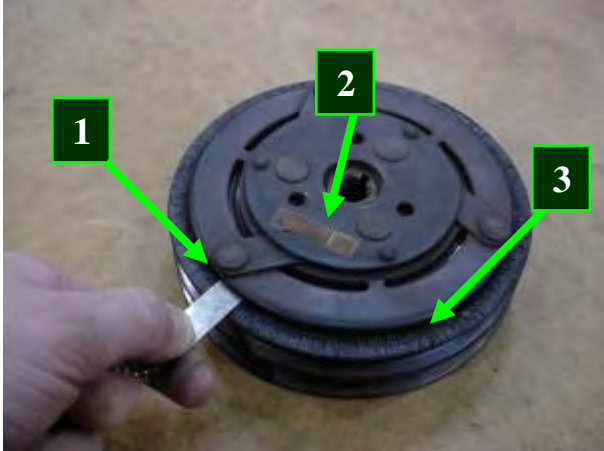
<p>Figure 1. A 0.045" feeler gage inserted between the pulley and the armature indicates clutch wear-out (Ref. 1). Notice signs of heat, indicating slipping and friction, such as: burned and shrunk label (Ref. 2) and coil material melting and expelled across pulley surface (Ref 3).</p>	<p>Vehicle Symptoms: Clutch wear-out is indicated by any of the following:</p> <ul style="list-style-type: none"> • Poor A/C performance. • Abnormal under-hood noise. <p>Post-removal Observations: Clutch wear-out is indicated by all of the following:</p> <ul style="list-style-type: none"> • Clutch pulley gap larger than .045" • Signs of excessive heat: <ul style="list-style-type: none"> ○ Blueing ○ Burned or shrunk label ○ Burned or cracked rubber <p>Note: If compressor clutch exhibits signs of excessive slipping (ie. excessive heat & premature wear-out), supply voltage should be checked. A normally operating electrical system should never supply less than 12V to the clutch, but poor grounding or other electrical faults could cause this low voltage condition.</p> <p>Warranty Coverage: A clutch with evidence of clutch wear-out is warrantable if all of the following apply:</p> <ul style="list-style-type: none"> • A/C system free of leaks. • A/C compressor and other components function correctly <p>A clutch with evidence of clutch wear-out is non-warrantable if any of the following apply:</p> <ul style="list-style-type: none"> • A/C system leaks. • A/C compressor has failed. • A/C clutch coil circuit receives low voltage <p>Note: Clutch may be claimed as progressive damage if attached to a claim with correct PFI.</p>

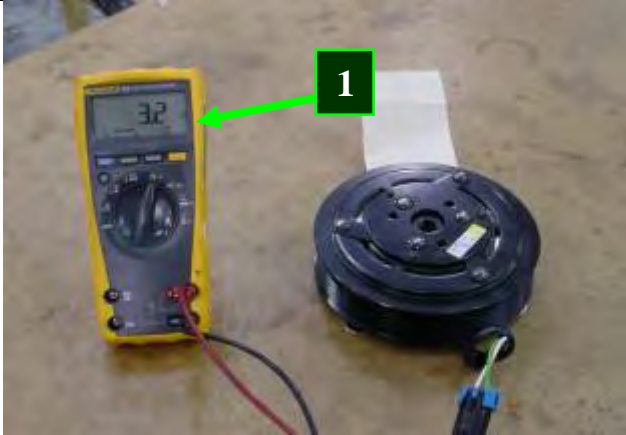
Shorted / Open Clutch Coil Circuit	Section 83.02.02 Damage Code: 130-001A09315 (Open) 130-001A09317 (Short)

<p>Figure 2. A clutch coil hooked up to a multimeter. The clutch reads a correct resistance of 3.2Ω (Ref. 1).</p>	<p>Vehicle Symptoms: Shorted or open circuit is indicated by the following:</p> <ul style="list-style-type: none"> • Non-functioning A/C system. <p>Post-removal Observations: Shorted or open circuit is indicated by any of the following:</p> <ul style="list-style-type: none"> • Multimeter measurement shows no continuity in coil circuit. • Multimeter shows resistance lower than 2Ω. <p>Warranty Coverage: A clutch with evidence of a shorted or open circuit is warrantable unless any of the following apply:</p> <ul style="list-style-type: none"> • Coil wire is damaged. • Coil is cracked, burned or otherwise damaged.

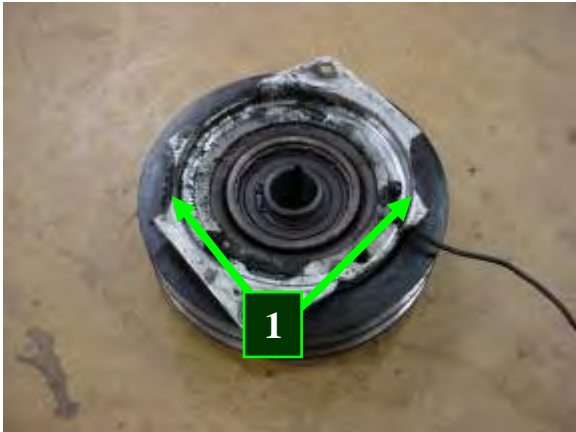
Incorrect Clutch Mounting	Section 83.02.03 Damage Code: 130-001080500
<div data-bbox="235 344 808 772">

</div> <p>Figure 3. The coil mounting bracket is broken (Ref. 1), indicating movement.</p> <div data-bbox="235 884 808 1318">

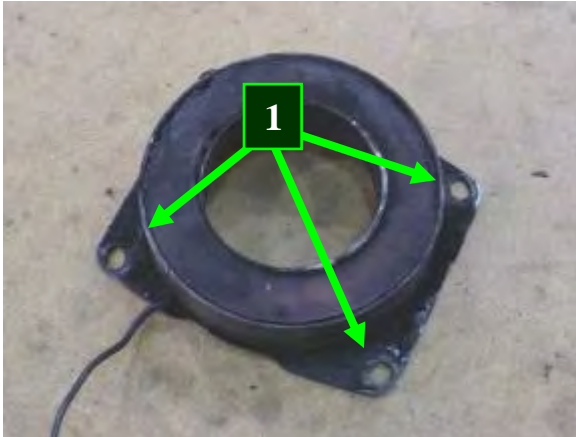
</div> <p>Figure 4. The mounting holes have been enlarged to a size greater than normal (Ref. 1).</p>	<p>Vehicle Symptoms: Incorrect clutch mounting is indicated by any of the following:</p> <ul style="list-style-type: none"> • Underperforming A/C system. • Under-hood noise and vibration. <p>Post-removal Observations: Incorrect clutch mounting is indicated by any of the following:</p> <ul style="list-style-type: none"> • Missing or loose coil mounting bolts. • Enlarged or broken coil mounting holes. <p>Warranty Coverage: A clutch with evidence of incorrect clutch mounting is warrantable if any of the following apply:</p> <ul style="list-style-type: none"> • Part is covered under new vehicle warranty. • Clutch was pre-installed on compressor. <p>A clutch with evidence of incorrect clutch mounting is non-warrantable if the following applies:</p> <ul style="list-style-type: none"> • Clutch was purchased separately.

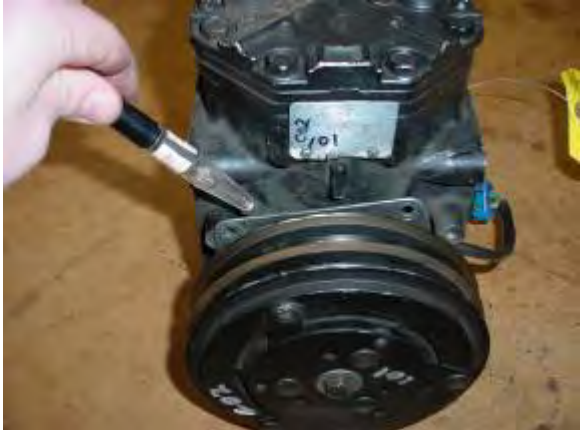
Front Seal Leak	Section 83.02.04 Damage Code: 130-001551609

<p>Figure 5. When the system is (re)charged with refrigerant, a leak detector will respond when placed behind the clutch from multiple angles if a front shaft seal leak is present.</p>

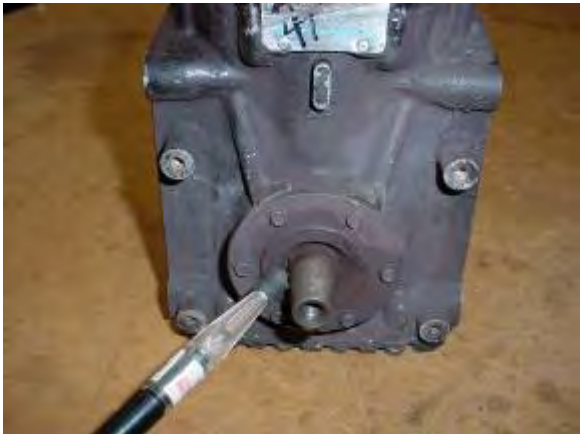
<p>Figure 6. The same test with clutch removed.</p>	<p>Vehicle Symptoms: A front seal leak is indicated by any of the following:</p> <ul style="list-style-type: none"> • Non-functioning A/C system. • Underperforming A/C system. <p>Observations: A front seal leak is indicated by all of the following:</p> <ul style="list-style-type: none"> • Leak detected at front shaft seal area by electronic leak detection. • Clean Oil • Front shaft does not shake or wobble (i.e. not a bearing failure). • Note: Oily residue under front shaft seal area will be present to some degree. <p>Warranty Coverage: A compressor with evidence of a front shaft seal leak is warrantable unless the following applies:</p> <ul style="list-style-type: none"> • Another leak is present in the system. • Internal system blockage was found. • Condenser air flow was restricted.

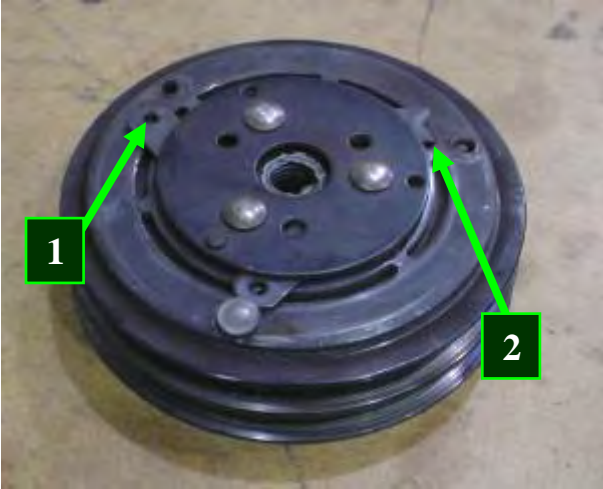
Clutch Pulley Failure

Section 83.02.05
	Damage Code: 130-001435130
	Vehicle Symptoms: Clutch pulley failure is indicated by all of the following: <ul style="list-style-type: none">• Non-functioning A/C system.• Abnormal under-hood noise. Post-removal Observations: Clutch pulley failure is indicated by the following: <ul style="list-style-type: none">• Fractured or broken clutch pulley. Warranty Coverage: A clutch with evidence of clutch pulley failure is warrantable unless any of the following apply: <ul style="list-style-type: none">• Associated A/C compressor failure• Part was abused.

Figure 7. A failed pulley may exhibit missing rivets (Ref. 1) and broken leaf springs (Ref. 2).

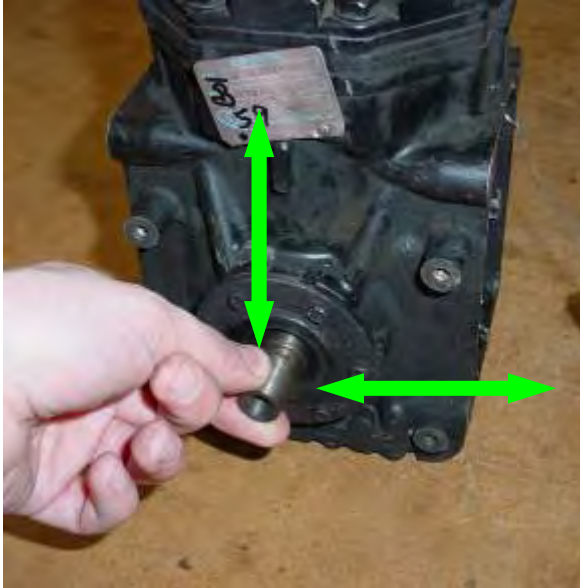
Bearing Failure	Section 83.02.06 Damage Code: 130-001050345 130-001050950

<p>Figure 8. A bearing failure will allow the front shaft to move relative to the compressor body. The shaft may have to be rotated.</p>

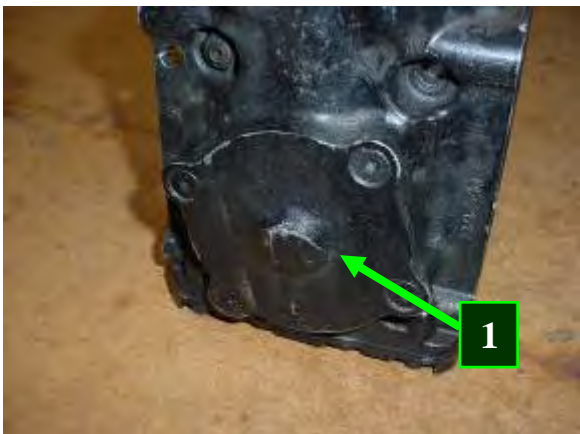
<p>Figure 9. A back bearing failure may result in a deformation of the back bearing plate (Ref. 1).</p>	<p>Vehicle Symptoms: Bearing failure is indicated by any of the following:</p> <ul style="list-style-type: none"> • Underperforming or non functioning A/C system. • Abnormal under-hood noise. <p>Observations: Bearing failure is indicated by all of the following:</p> <ul style="list-style-type: none"> • Front shaft has play when moved, • Pulley and coil rubbing marks, <p>And any of the following:</p> <ul style="list-style-type: none"> • If back bearing failed, rear bearing plate is deformed. • Dark oil. • Leak at front shaft seal. • Shaft does not turn freely <p>Warranty Coverage: A compressor with evidence of bearing failure is warrantable unless any of the following apply:</p> <ul style="list-style-type: none"> • Part was abused or damaged during service.

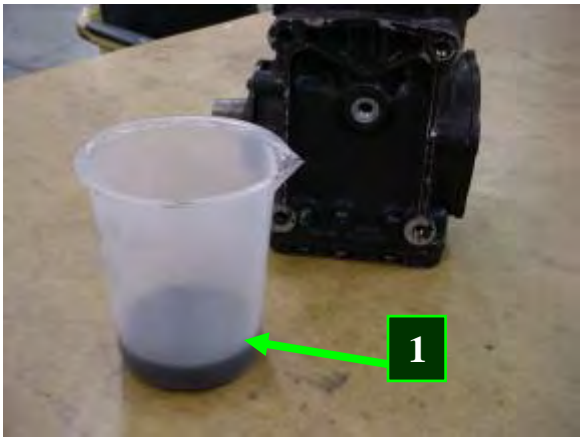
Internal Failure	Section 83.02.07 Damage Code: 130-001A09345 130-001A09590

<p>Figure 10. An internal failure will result in dark oil (Ref. 1) Please return oil to compressor after checking volume and color.</p>	<p>Vehicle Symptoms: Internal failure is indicated by all of the following:</p> <ul style="list-style-type: none"> • Non-functional or underperforming A/C system. • Possible abnormal under-hood noise. <p>Post-removal Observations: Internal failure is indicated by all of the following:</p> <ul style="list-style-type: none"> • Dark oil and/or metallic sludge. • Shaft may not turn freely. • Possible leak at front shaft seal. • Clutch may exhibit signs of excessive heat. • Possible lack of compression and suction when shaft is turned. • Rattling from loose parts within the compressor. • Compressor casing may be cracked <p>Warranty Coverage: A compressor with evidence of internal failure is warrantable unless any of the following apply:</p> <ul style="list-style-type: none"> • A leak exists elsewhere in the system. • System was contaminated by previous failure or repair. <p>Note: Clutch may be claimed as progressive damage if attached to a claim with correct PFI.</p>

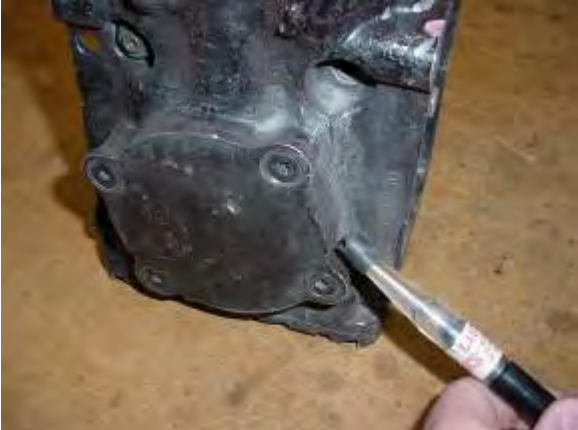
Incorrect Diagnostic Procedure	
Section 83.02.08	
Damage Code: 130-001423609

<p>Observations:</p> <p>Incorrect diagnostic procedure is indicated by the following:</p> <ul style="list-style-type: none">• Back bearing plate seal compromised. <p>Charging the compressor sump with high-pressure nitrogen will damage seals and other components. The compressor sump is not designed to handle the pressures from nitrogen testing.</p>
	<p>Warranty Coverage:</p> <ul style="list-style-type: none">• A compressor with evidence of incorrect diagnostic procedure is non-warrantable.

Figure 11. The seal between the back plate and compressor housing will leak if subjected to high pressures associated with high-pressure nitrogen.
