Freightliner LLC New Vehicle and Aftermarket Parts Limited Warranties warrant that Freightliner LLC products will be free from defects in material and workmanship that occur under normal use within the applicable warranty period, subject to certain limitations and exclusions as specified in the Warranty Manual.

It is assumed the technician or analyst reading this guide has familiarized themselves with all group 83 troubleshooting and service instructions in the vehicle Workshop Manual and has read all group 83 service bulletins pertaining to the vehicle.

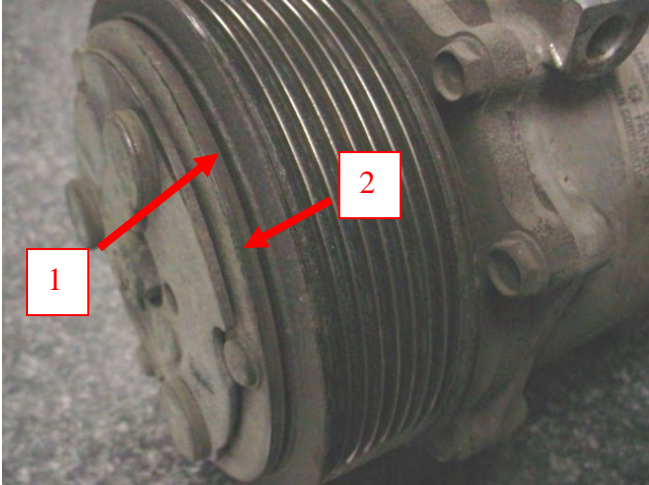
<p><b>Vehicle Symptoms:</b> Worn-out clutch is indicated by all of the following:</p> <ul style="list-style-type: none"> <li>• Clutch armature plate does not pull-in in all areas of the clutch.</li> <li>• Clutch gap is greater than .039 inch in areas where it does not pull-in (Fig. 1).</li> <li>• Clutch may have slipped and shows signs of overheating.</li> <li>• If the clutch slipped and overheated, it may have caused the compressor front shaft seal to leak.</li> </ul>

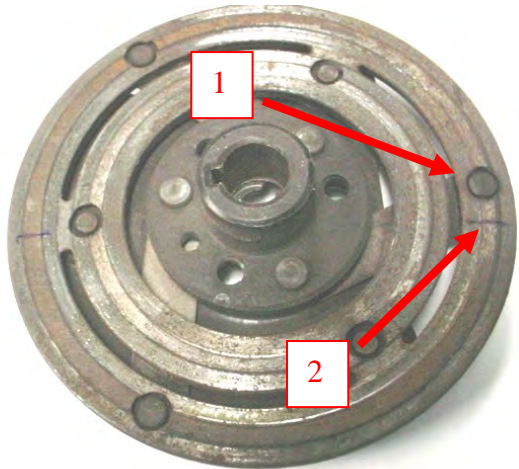
<p><b>Post-removal Observations:</b> Worn-out clutch is indicated by the following:</p> <ul style="list-style-type: none"> <li>• Excessive armature plate wear may be used to indicate excessive gap.</li> <li>• Wear down to any one rivet is an indication of worn-out clutch (Fig. 2).</li> </ul>
<p><b>Figure 2.</b> Back-side of armature plate of worn-out clutch with wear on edge of one rivet (Ref. 1) and ridge indicated by ink mark (Ref. 2) across ridge created by clutch wear.</p>	<p><b>Warranty Coverage:</b> A compressor/clutch assembly with evidence of worn-out clutch is <b>warrantable</b> if the following applies:</p> <ul style="list-style-type: none"> <li>• Clutch gap is greater than .031 inch.</li> <li>• Compressor rotation is still smooth (no internal binding or failure).</li> </ul> <p>A compressor/clutch assembly with evidence of worn-out clutch is <b>non-warrantable</b> if any of the following apply:</p> <ul style="list-style-type: none"> <li>• Failure of another system component caused the worn-out clutch.*</li> </ul> <p>* Note: May be warrantable as secondary damage.</p>

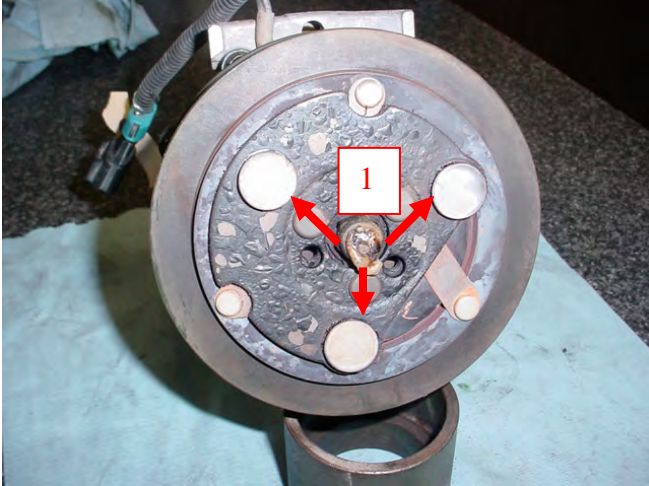
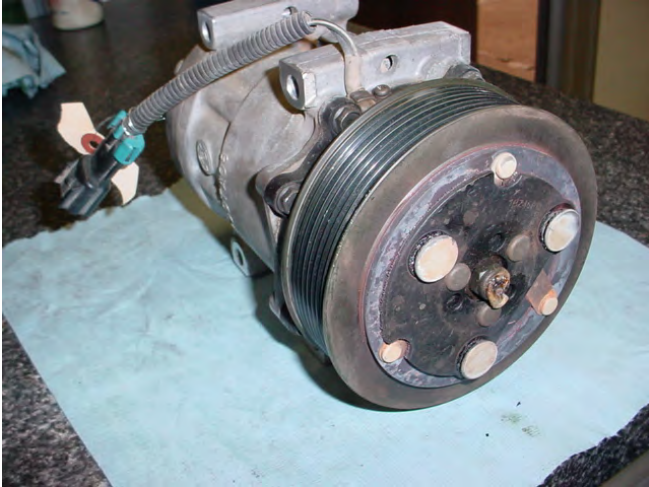
<p><b>Figures 3 and 4.</b> Clutch armature plate with paint bubbled and peeled and rubber isolators (Ref. 1) melted after compressor lock-up from loss of refrigerant.</p>

<p><b>Vehicle Symptoms:</b> Loss of refrigerant is indicated by any of the following:</p> <ul style="list-style-type: none"> <li>• Gradual loss of AC performance</li> <li>• Compressor lock-up.</li> <li>• Clutch slippage</li> <li>• Drive belt failure</li> </ul> <p><b>Post-removal Observations:</b> Loss of refrigerant is indicated by all of the following:</p> <ul style="list-style-type: none"> <li>• No lubricant in compressor.</li> <li>• Little or no refrigerant in system.</li> <li>• Leak in system and/or compressor.*</li> </ul> <p>* Note: Due to the size of the system and number of connections, the probability of a leak somewhere other than in the compressor is high. Therefore the entire system should be leak-checked using the methods recommended in the vehicle's workshop manual.</p> <p><b>Warranty Coverage:</b> A compressor/clutch assembly with evidence of loss of refrigerant is <b>warrantable</b> if <u>only</u> the compressor leaks.</p> <p>A compressor/clutch assembly with evidence of loss of refrigerant is <b>non-warrantable</b> if there is a leak elsewhere in the system. **</p> <p>** Note: May be warrantable as secondary damage.</p>

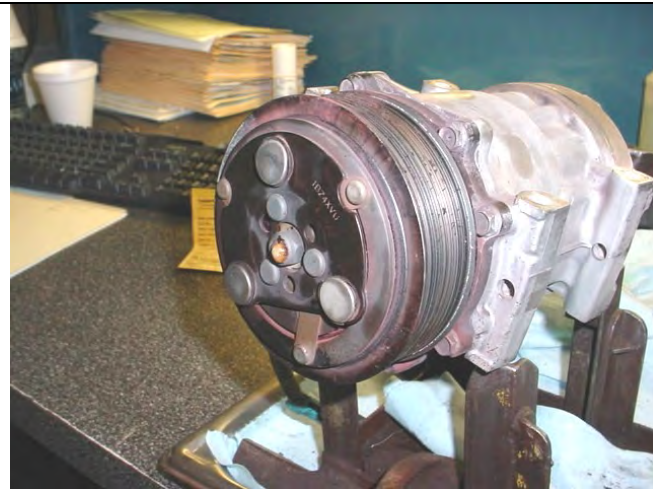
**Figure 5.** Clutch overheated from slipping.

- Clutch damaged due to slipping (see fig. 5).
- Compressor label darkened and shrunk from heat (see fig. 6).
- Oil remaining in compressor is black (see fig. 7).
- System blockage, over-charge, or contaminated system.

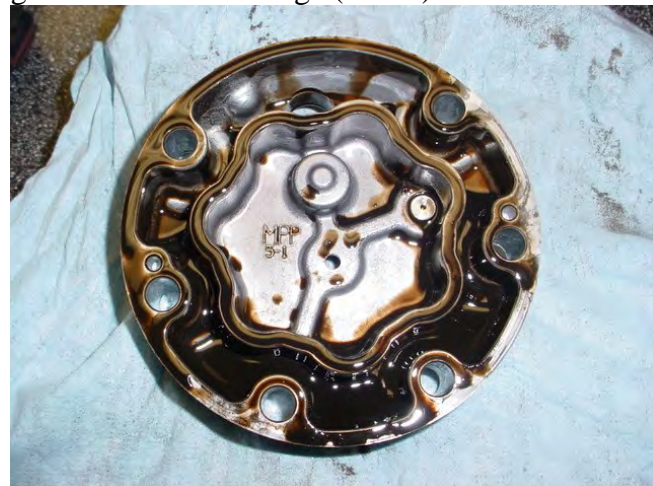
**Figure 7.** Black oil in compressor.\***Section 15.01.03****Damage Code: 130-001A09345 (if warrantable)****Vehicle Symptoms:**

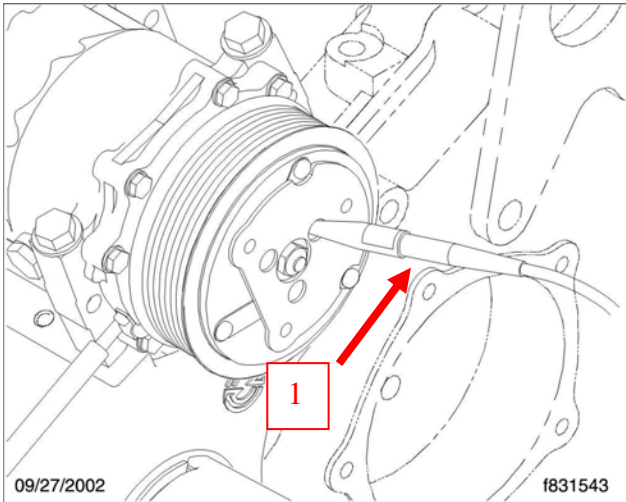
<p><b>Figure 8.</b> Using detector probe to check for leaks at the compressor front shaft seal. Leak detector probe (Ref. 1).*</p> <p>*Note: See vehicle workshop manual for proper leak detection methods. Use of incorrect leak detection methods will lead to incorrect diagnosis and a possible rejected claim.</p> <p>**Note: The compressor assembly may be warrantable as subsequent damage of a warrantable repair.</p>	<p><b>Vehicle Symptoms:</b> Compressor leak is indicated by any of the following:</p> <ul style="list-style-type: none"> <li>• Gradual loss of AC performance.</li> <li>• Increased compressor cycling.</li> </ul> <p><b>Warranty Coverage:</b> A compressor/clutch assembly with a compressor leak is <b>warrantable</b> if one of the following apply:</p> <ul style="list-style-type: none"> <li>• The compressor exhibits a leak*, and the compressor clutch shows no sign of excessive heat.</li> </ul> <p>(OR)</p> <ul style="list-style-type: none"> <li>• The compressor exhibits a leak*, and the clutch shows signs of excessive heat, and there are no leaks elsewhere in the system.</li> </ul> <p>A compressor/clutch assembly that leaks is <b>non-warrantable</b> if all of the following apply:</p> <ul style="list-style-type: none"> <li>• The clutch shows signs of excessive heat.</li> <li>• There is a leak elsewhere in the system. **</li> </ul>

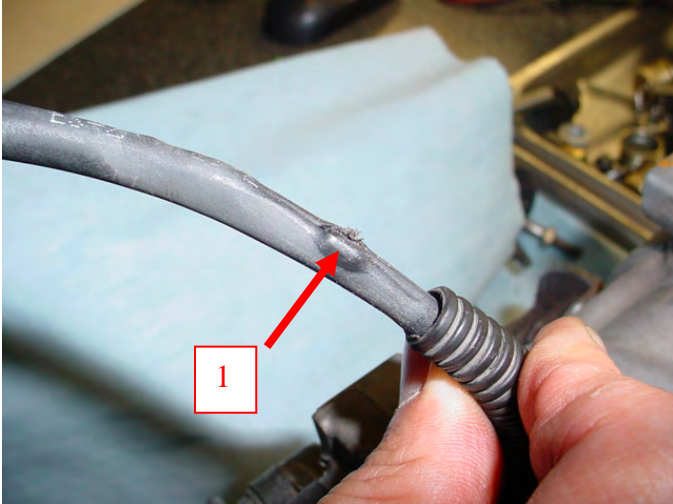
<p><b>Figure 9.</b> Diode in power lead has failed open (Ref. 1). Swell in heat shrink is from over-heated diode.</p>	<p><b>Damage Code: 130-001A09317 (if warrantable)</b></p> <p><b>Vehicle Symptoms:</b> Diode failure is indicated by any of the following:</p> <ul style="list-style-type: none"> <li>• Unexplained grounding codes.</li> <li>• Failure of clutch relays.</li> <li>• Blown fuse on clutch circuit.</li> </ul> <p><b>Observations:</b> Diode failure is indicated by any/all of the following:</p> <ul style="list-style-type: none"> <li>• Heat damaged diode.</li> <li>• Reverse voltage spike when clutch power is disengaged (use of an oscilloscope would be required to observe this reverse voltage).</li> <li>• Spark on positive lead when power is taken away from clutch by breaking the circuit (this spark may not be visible in a well lit area, though it may be audible). Use of a 12V power supply and a connector with visible contacts may be required to observe this spark. <b>Warning: DO NOT reverse the supply voltage to the clutch; this will damage the diode.</b></li> <li>• Flexing the cable in the area of the diode may cause an intermittent short.</li> </ul> <p><b>Warranty Coverage:</b> A compressor/clutch assembly with evidence of diode failure is <b>warrantable</b> unless an unwarrantable condition exists as stated below.</p> <p>A compressor/clutch assembly with evidence of diode failure is <b>non-warrantable</b> if any of the following apply:</p> <ul style="list-style-type: none"> <li>• The compressor clutch lead was damaged by handling during field installation or in service.</li> <li>• Power to the clutch was reversed.</li> </ul>

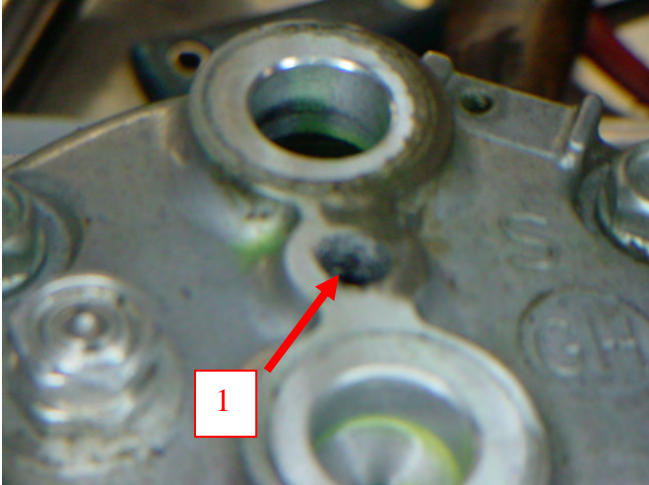
<p><b>Figure 10.</b> Threads stripped at hose connector bolt (Ref. 1).</p>	<b>Vehicle Symptoms:</b> Incorrect Installation is indicated by any of the following observations: <ul style="list-style-type: none"> <li>• Stripped threads in hose connections.</li> <li>• Broken bolts in mounts or hose connections.</li> <li>• Broken or worn mounts.</li> <li>• Severed or worn-through power lead.</li> <li>• Too-long of bolt used in hose connection.</li> </ul>

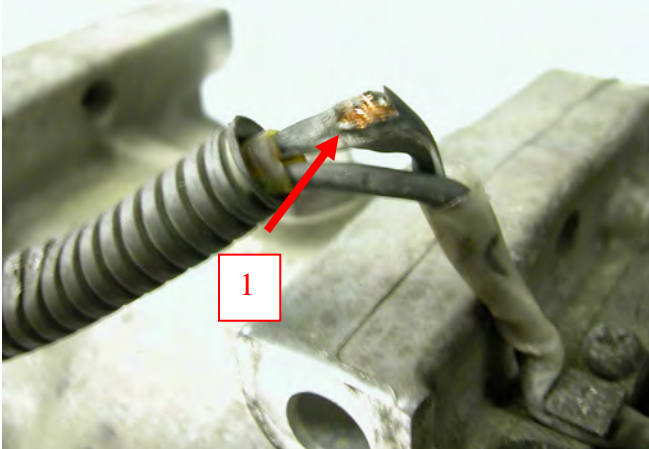
<p><b>Figure 11.</b> Severed or worn through power lead (Ref. 1).</p>	<b>Warranty Coverage:</b> A compressor/clutch assembly with evidence of incorrect installation is <b>warrantable only</b> if the condition occurs within the initial operating period. (Refer to the Initial Operating Period in section 1.5 of the Warranty Manual for details.)

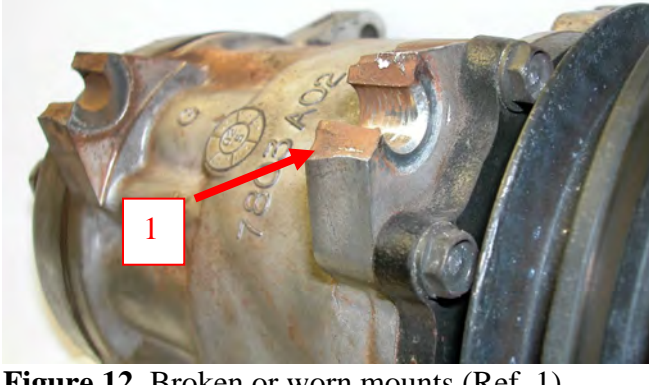
<p><b>Figure 12.</b> Broken or worn mounts (Ref. 1).</p>	A compressor/clutch assembly with evidence of incorrect installation is <b>non-warrantable</b> under any conditions other than that stated above.

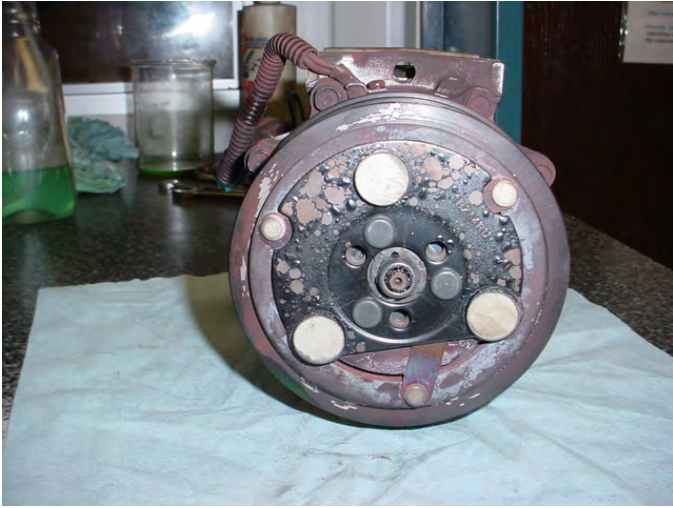
<p><b>Vehicle Symptoms:</b> Excessive torque required to turn compressor is indicated by any of the following:</p> <ul style="list-style-type: none"> <li>• Clutch slippage.</li> <li>• Belt noise.</li> </ul> <p><b>Post-removal Observations:</b> Excessive torque required to turn compressor is indicated by all of the following:</p> <ul style="list-style-type: none"> <li>• Presence of clean oil in compressor.*</li> <li>• Difficulty turning compressor shaft.</li> </ul> <p>**</p>
<p><b>Figure 13.</b> Heat damage from clutch slippage.</p>

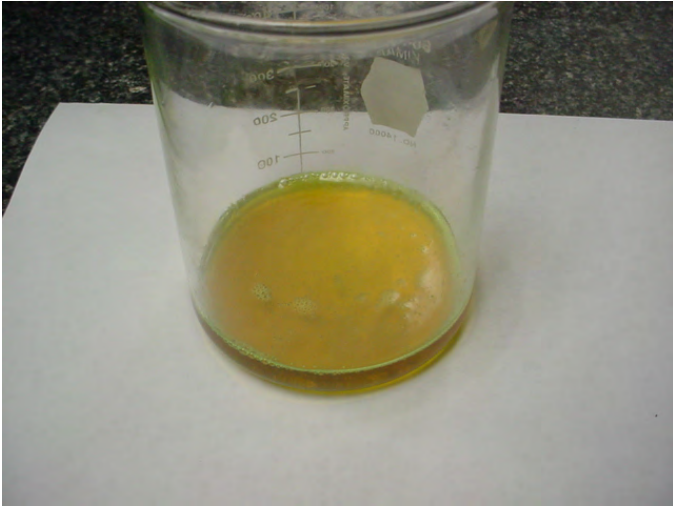
<p><b>Figure 14.</b> Clean oil with dye in it.</p>	<p><b>Warranty Coverage:</b> A compressor/clutch assembly which requires excessive torque to turn is <b>warrantable</b> <u>only</u> if all of the following apply:</p> <ul style="list-style-type: none"> <li>• Compressor in service for less than 5000 miles.</li> <li>• Compressor oil clean.</li> <li>• Full refrigerant charge recovered.</li> <li>• Shaft does not turn smoothly**</li> </ul> <p>*Always remember to return the oil sample to the compressor after inspection.</p> <p>**If shaft is encumbered by a failed clutch bearing it may be necessary to remove the armature plate before attempting to rotate the compressor shaft.</p>
