AT 257
Aug 9, 2012
G. De los
R. FT.

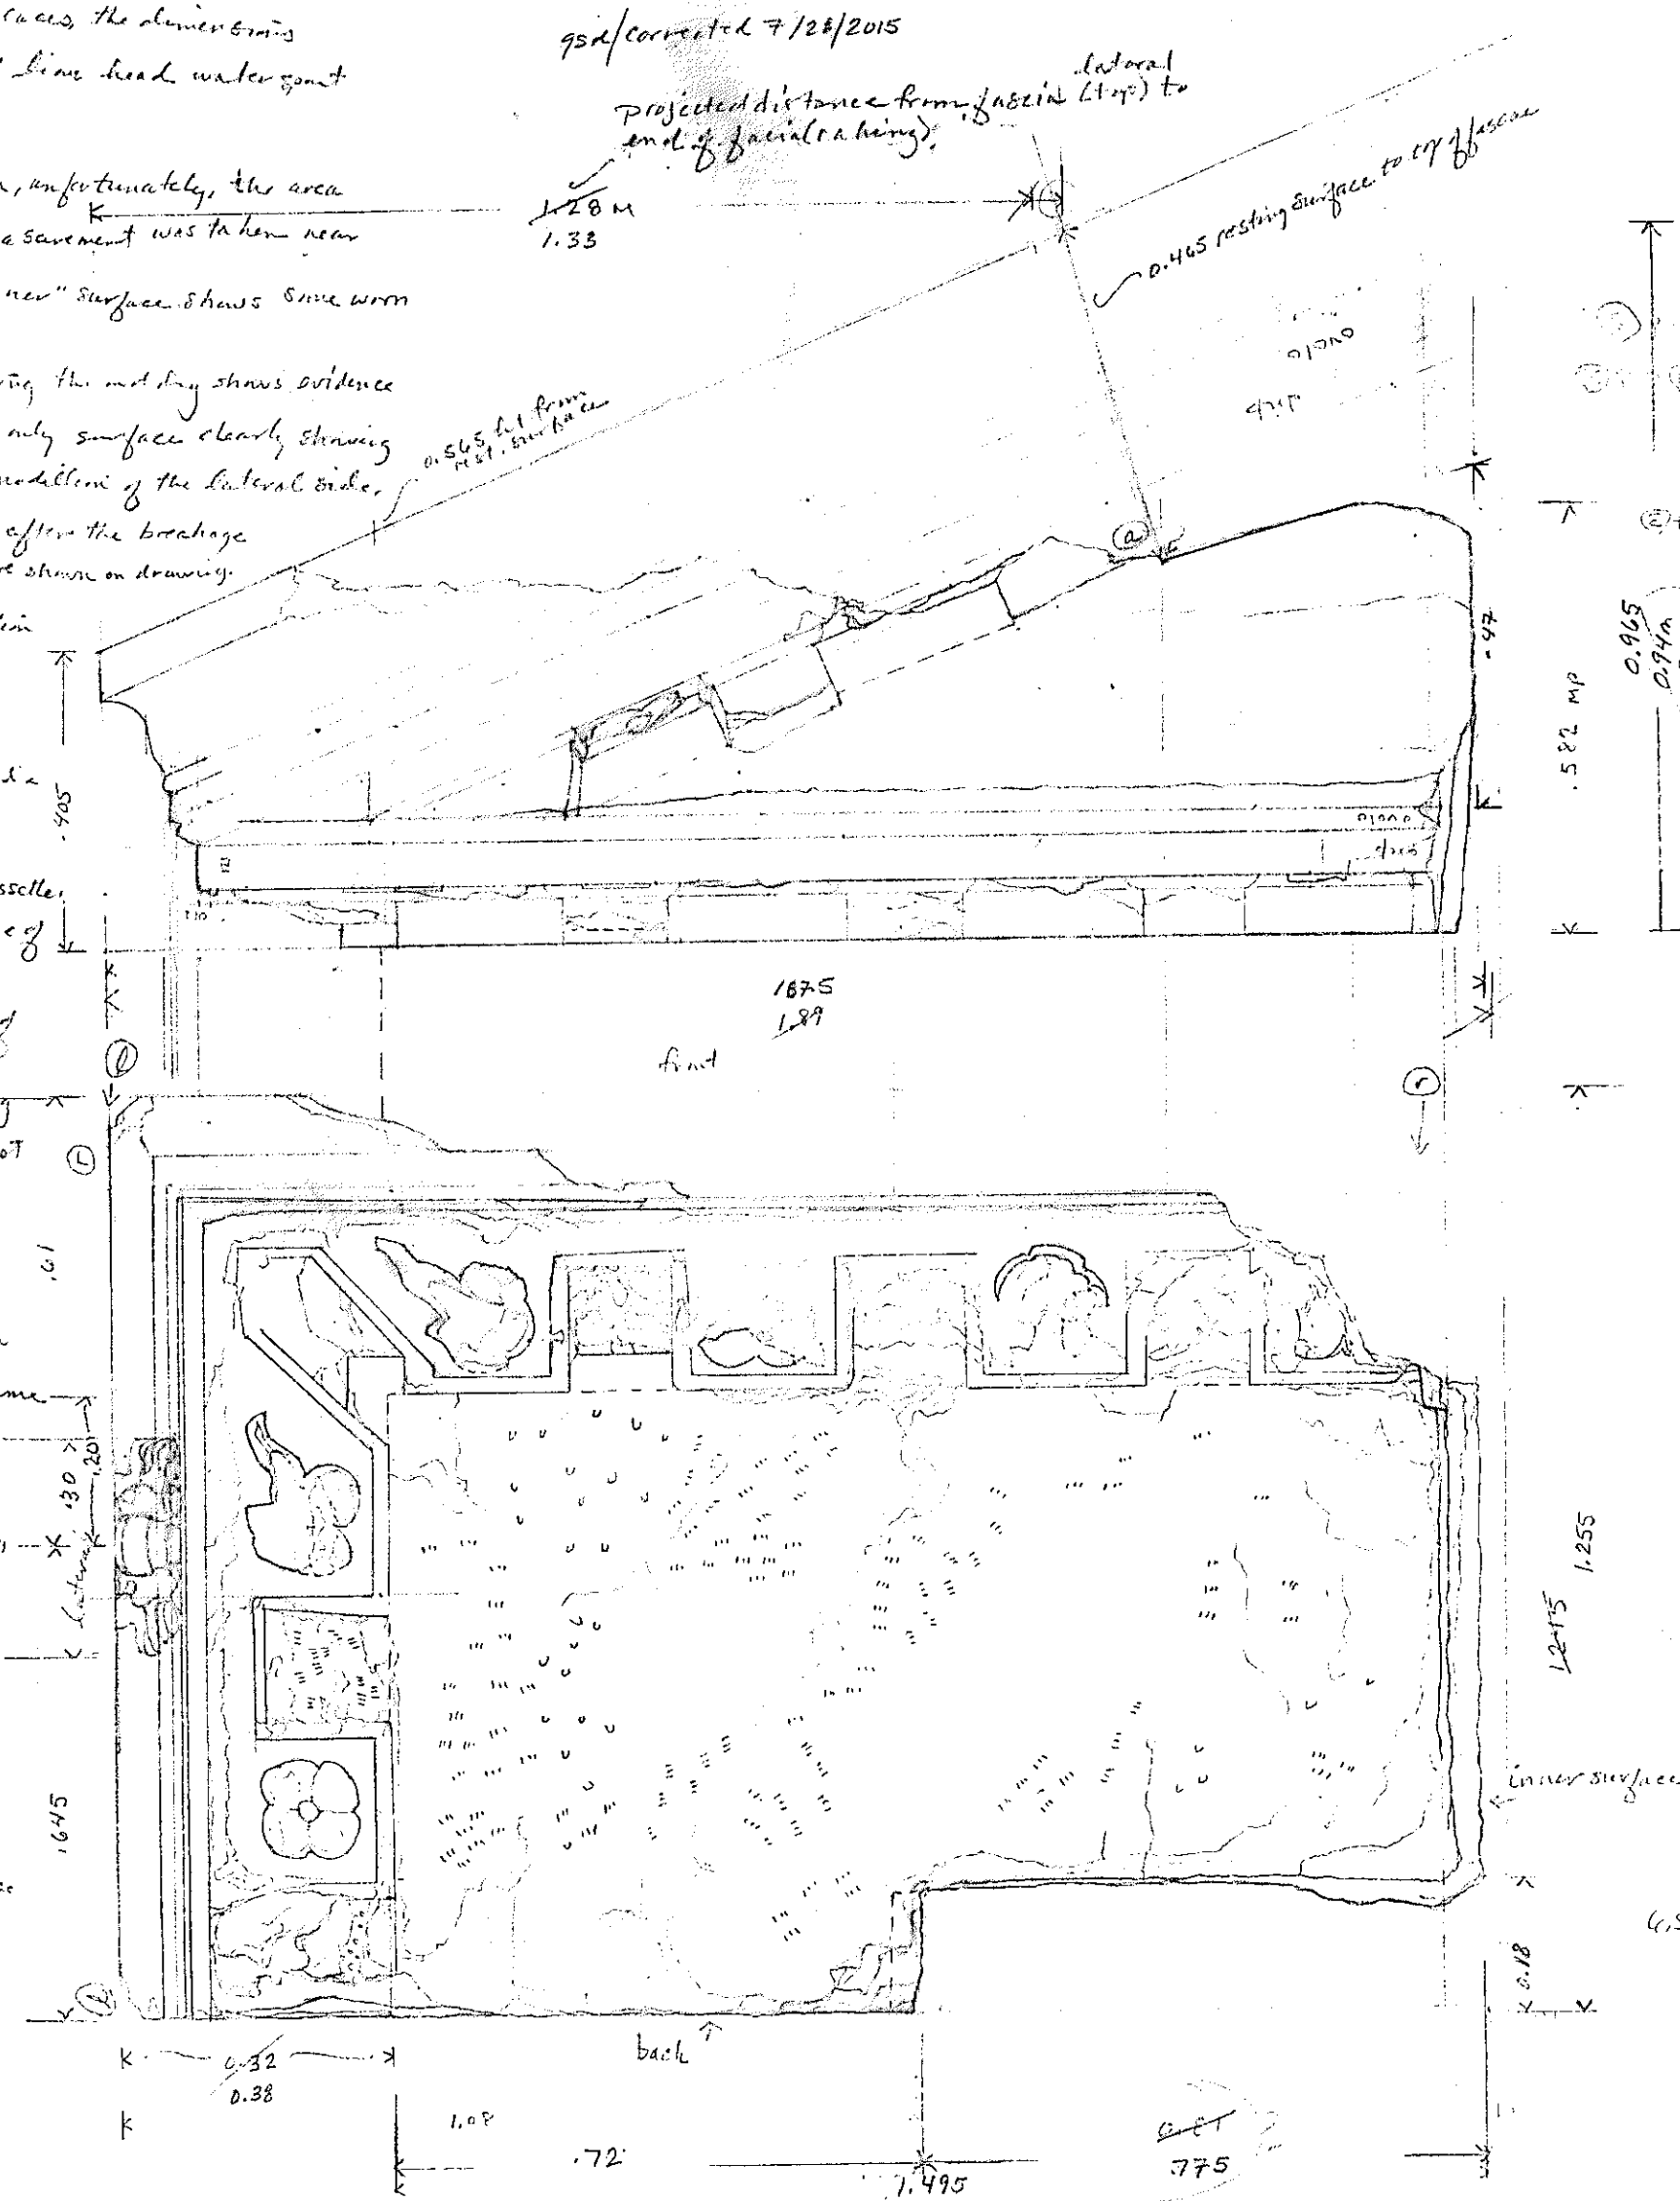
What remains of this block is stands and the under resting surface and lateral portion of molding is preserved. Although the decoration is badly broken in places the dimensions for medallions and cassettes are still determinable. The corner medallions and linear head water spout are typical for this block.

The height of this block (.582 m) is the same height as a typical lateral geison, unfortunately, the area on the sloping surface of the roof, no longer has the acroterion base. This height measurement was taken near the front of the block along the side labelled "inner" on this drawing. This "inner" surface shows some worn hammer work & point chisel tool marks.

The surface labelled "back" is more weather worn and although the edge adjoining the molding shows evidence of acroteriosis (as a very slight projection) none of the tool marks remain. The only surface clearly showing tool marks is the underside resting surface. There are a few marks on the middle medallion of the lateral side. The block in this condition is broken and it is possible that these marks were made after the breakage happened. Rounded marks on the left lateral medallion may also be later. These marks are shown in drawing.

For the most part, the medallions and cassettes are poorly preserved. No medallion remains intact and all lack the border. All cassettes contain a floral motif. The left front cassette appears to be a stemmed flower with 3 large petals. A clear example of this can be found in block AT 442.

Originally, four cassettes graced the front of this pediment geison; now only three and a portion of the fourth remain. Second from the left, a disk of flower with portions of 2 petals remain. The breakage in this cassette is deeper (in some places) than the base of the cassette. Its true design is unknown. The third cassette, along the front, contains the outer edge of one petal and portions of 2 other petals. There is room for possibly 5 petals. The far right cassette has only very small portions of 2 petals. There is room from the end of this cassette to the end of the block for a terminating oval in this cassette, but at the end the cassette has an obviously and intentionally curved edge which extends along the "inner" surface .03 m. The pediment flow geison which would match this block must have terminating ovals on the medallions.

Only the left medallion on this front side contains the 2 parallel lines typical of most medallions.

The lateral side contains 2 medallions and 2 cassettes. The right cassette is the same as the left front cassette; a stemmed 3-petaled flower. It is preserved in much the same condition as the left front cassette; the stem is preserved in the end but all relief for the petals is broken. The left lateral cassette is the best preserved of all cassettes and shows 4 rounded petals. The center is a raised button. Portions of 3 petals are broken but the outline is clearly there.

The left lateral medallion is broken and although the block is wide enough to accommodate a terminating oval here, it appears that the block is curved at an angle and the area nearest the medallion becomes too narrow (.12 m) to comfortably fit an oval in this space. Likely, the adjoining block would have a cassette with a terminating oval.

The resting line is only preserved at the lateral end. The pediment contains a cassette with a rough, carved flower of 3 rounded petals - the 4th & 5th petals don't exist because this flower is too up to the pediment wall. The medallions also roughly carved. Both are finished with ovals.

The upper surface shows some tool marks and is preserved along the outer edge above the molding as well as the area above, which would correlate with the front pediment geison's acroterion base.
