STRUCTURAL CONSEQUENCES OF GROUT DETERIORATION IN THE GROUTED SHEAR STUD (GSS) CONNECTION

Keywords: Grouted Shear Stud connection; Large scale testing; Artificial damage simulation; Steel bridge substructures; Seismic design

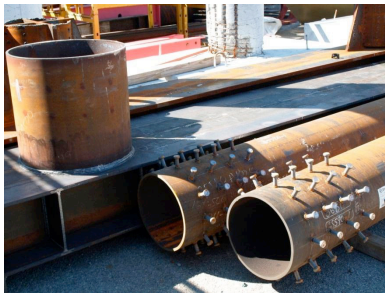
Fig. 1. (a) Constituents of the GSS connection; (b) Experimental setup for Tests 1 and 2.

The Grouted Shear Stud (GSS) connection is a steel bridge column-to-cap beam connection with potential use in seismic design. The components of the GSS connection include a round steel pile column, a steel pipe stub of larger diameter, and a steel cap beam as shown in Fig. 1(a). The pipe stub is shop welded to the cap beam. The cap beam-stub assembly is then lowered onto the erected piles to make a socket type connection. The annular region between the pile and larger diameter pipe stub is then filled with high strength grout to complete the connection. In contrast to conventional column-to-cap beam directly welded connections, the GSS connection relocates the plastic hinge to the steel column section thereby mobilizing its full capacity and ductility before failure. Complete discussion of the GSS connection may be found in Fulmer et al. (2015, 2016). This paper summarizes two large scale tests of two-column steel bent specimens that incorporate the GSS connection. The objective of these tests was to determine if damage to the GSS connection due to long-term exposure to extreme cold climatic conditions could potentially reduce the seismic

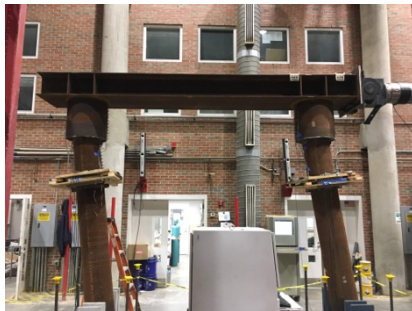
Fig 3. (a) The maximum drift achieved by Test 2 was 11% at a ductility of 5; (b) A comparison of the force-displacement hysteresis of two tests; (1 in = 25.4 mm, 1 kip = 4.45 kN).

Test 1 achieved a drift of 9% while Test 2 achieved 11% drift as shown in Fig. 3(a). A comparison of the cyclic force-displacement hysteresis curves for the two tests is shown in Fig. 3(b). Tests 1 and 2 showed similar structural behavior. During the elastic cycles, Test 2 specimen had a slightly reduced stiffness compared to Test 1 specimen as shown in Fig. 4(a). This was expected since the grout in Test 2 had a lower elastic modulus. However, this reduction is only slightly noticeable in the complete force-displacement hysteresis curve. In the early inelastic cycles ($\mu 1$ and $\mu 2$), the curvature demand in the plastic hinge region for Test 1 columns was higher than that of Test 2. This resulted in a slightly larger energy dissipation by Test 1 specimen compared to Test 2 as shown in Fig. 4(b). During $\mu 3$ cycles, shown in Fig. 4(c), Test 1 specimen started losing its load carrying capacity as the plastic hinge was fully developed. The section just below the plastic hinge pinched and therefore reduced the section modulus. Moreover, high strain demands caused the steel material to yield and thereby reduced the wall thickness. During $\mu 4$ cycles, shown in Fig. 4(d), both Test 1 and Test 2 started to show similar behavior once again. Some differences here included a slightly higher load carrying capacity and a reduced reloading stiffness of Test 2 specimen. Loosely speaking, Test 2 specimen was more flexible and ductile than Test 1 specimen.
