Underground Miscellaneous

Site: 475 Brooktondale Rd Brooktondale, NY

We appreciate the opportunity to provide this report for our work completed on June 29, 2023.

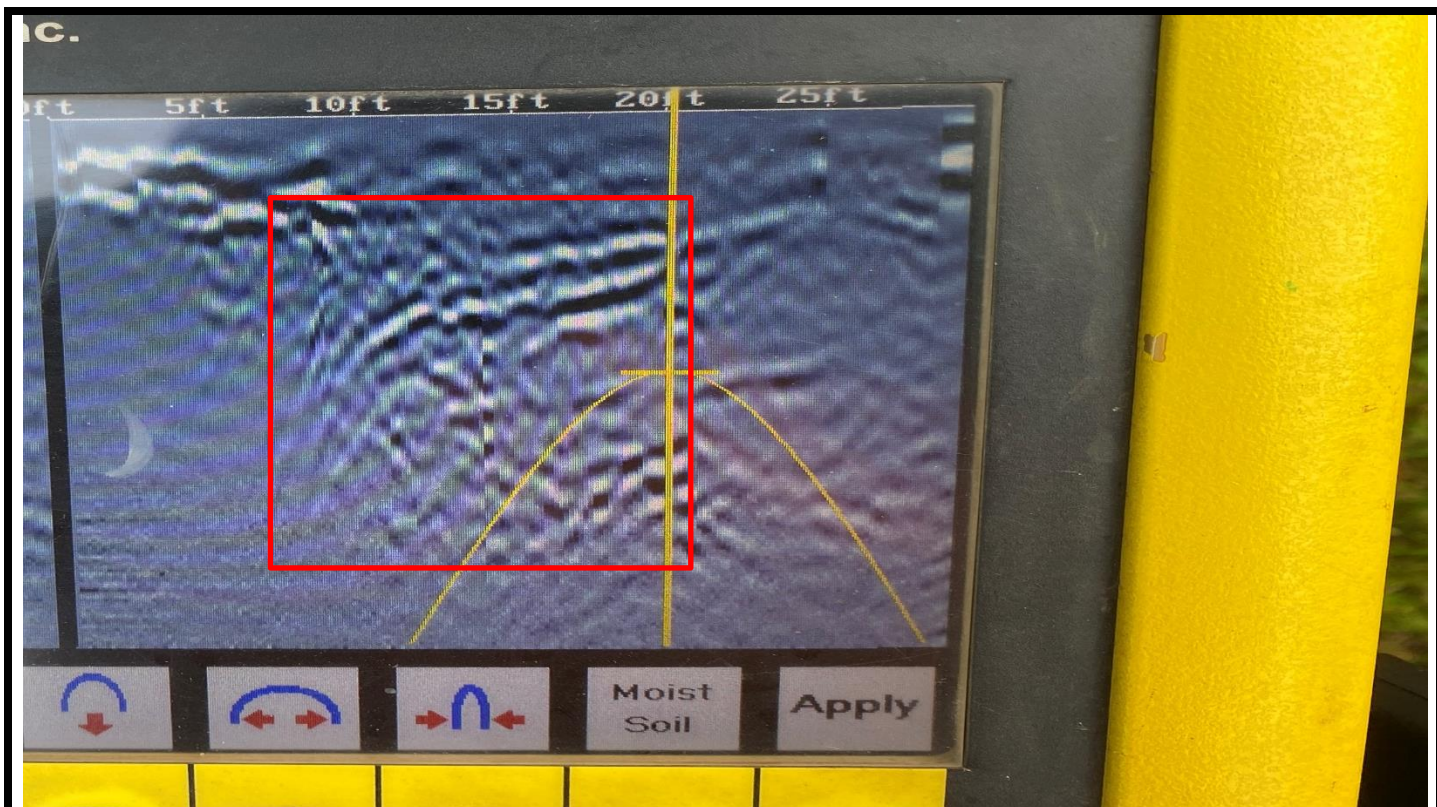
Typical GPR imagery throughout site in grass-This reaction may be detecting a reaction to an old creek bed. Images below were marked off this data.

Potential anomalies were able to be produced with GPR that may indicate the old creek bed that was desired to be found. Measurements from old deed descriptions were taken and lined up very closely with what was found with GPR. When scanning for the old barn foundation on the SW corner of the property, no reactions were detected with the GPR that would indicate such. The highest priority was the creek bed and it is believed it was found.

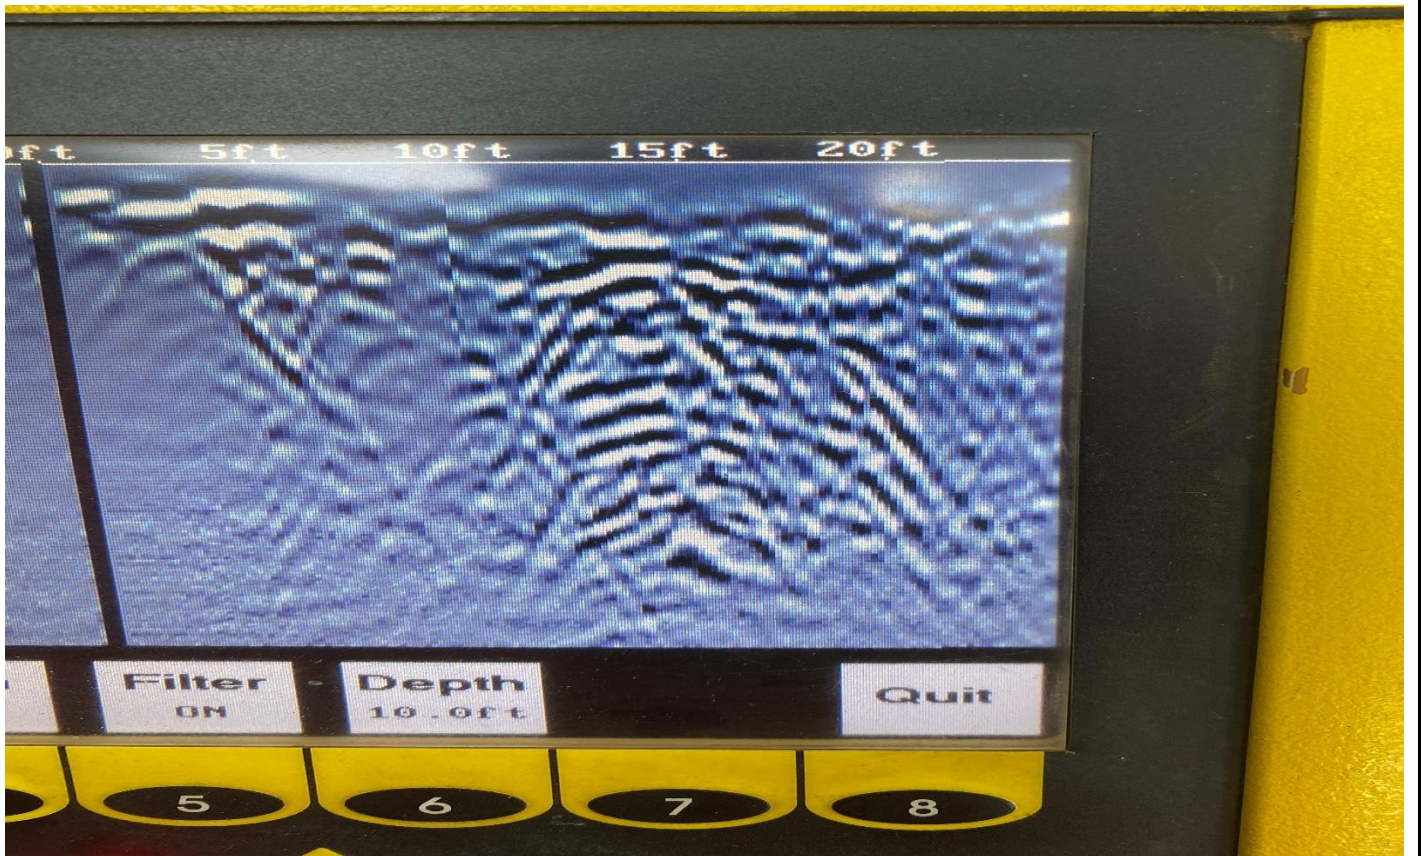
Imagery going into street, last favorable image of potential reaction to old creek bed.

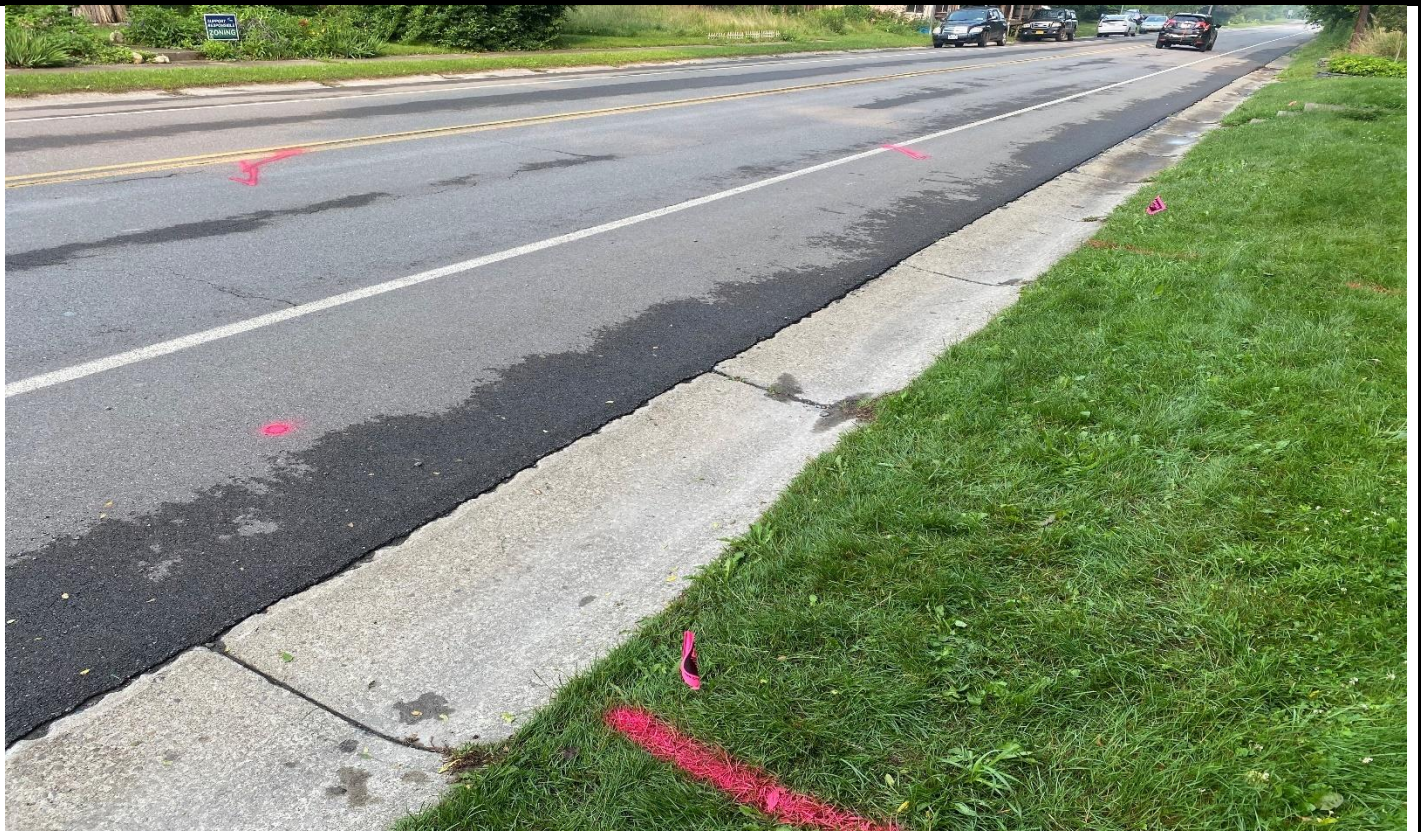
Suspected area of creek bed laid out going across street where old location is known.
