# ASSISTANCE OF BIOPORE TECHNOLOGY AS A RAINWATER INFILTRATION METHOD TO REDUCE SURFACE RUNOFF AND FLOODING IN RT.10, SUNGAI DUREN VILLAGE, MUARO JAMBI REGENCY

*[Title: Assistance of biopore technology as a rainwater infiltration method to reduce water runoff and flooding in Rt.10, sungai duren village, muaro jambi regency]* Community Service (PPM) activity takes place in RT.10, Sungai Duren, Muaro Jambi Regency. This area is prone to flooding and is densely populated. When it rains for an extended period flooding frequently occur. Therefore, team took the initiative to raise awareness about flood disaster mitigation by reducing water runoff, helping to prevent floods. The Community Service Team consists of five lecturers from UNJA from various disciplines and five students, each contributing according to their expertise. The method employed involves raising awareness about biopore technology, which increases the soil's ability to absorb rainwater. This PPM activity is expected to help address the flooding problem in the partner area. Geographically, the PPM partner area is 3 km away from the Batang Hari River, so it is not part of a floodplain. Base on topography, the partner are

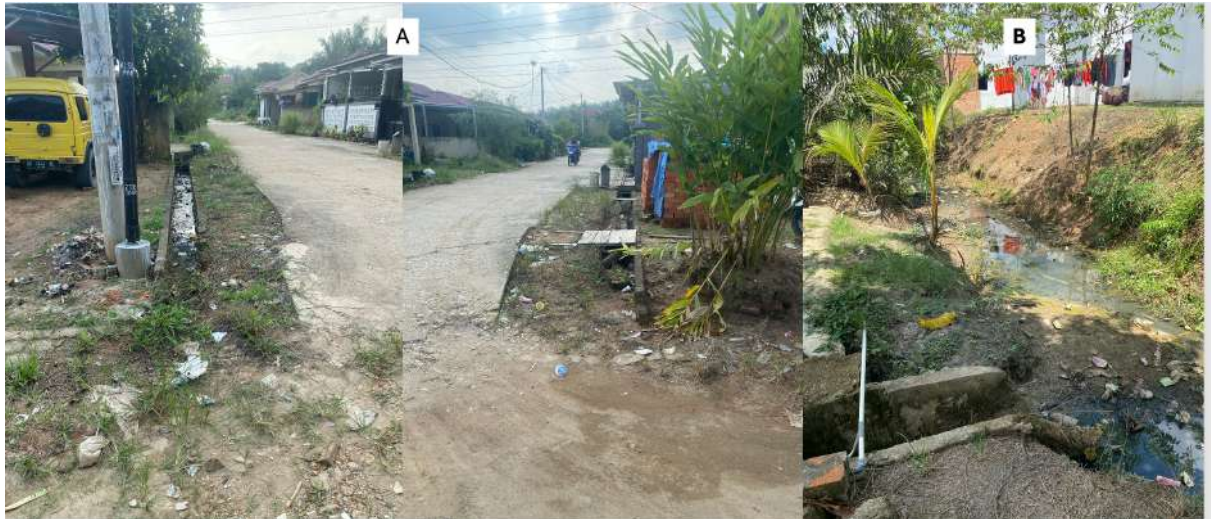
Figure 3. A. Disconnected household drainage system that flows onto the ground and concrete-paved road; B. Artificial canal functioning as the main wastewater drainage channel, but has become silted.

The drainage systems in the residential area are not interconnected, causing some household

wastewater to flow directly onto the concrete-paved ground and streets. Additionally, although there is a canal in the PPM partner area that functions as the main drainage channel, it has become silted due to a buildup of sediment and household waste carried in during floods. Community participation in maintaining environmental cleanliness is minimal, with no efforts to clean the canal or homeowner initiatives to repair their own drainage systems. The silting of the canal has resulted in increased surface water runoff, causing floods to occur more rapidly. The drainage systems and artificial canal can be seen in Figure 3.

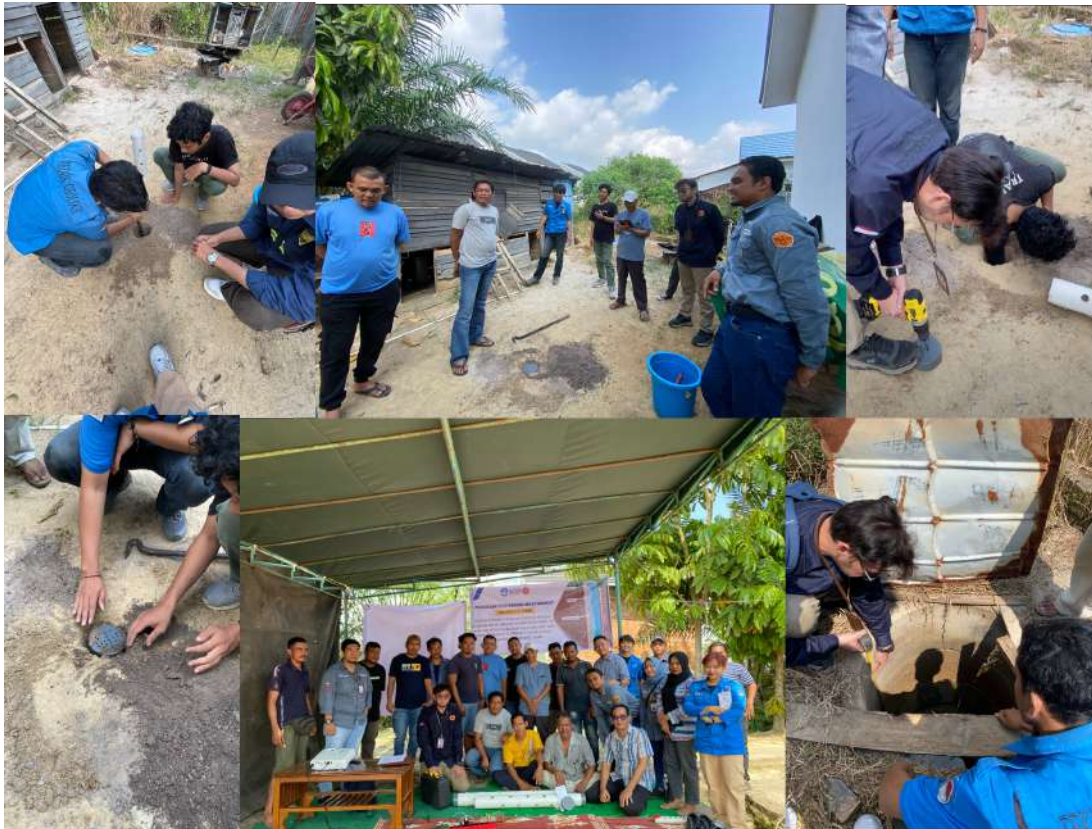
Figure 6. The second session of the assistance activity for creating biopore infiltration holes and measuring the groundwater table at the dug well conducted in the yard of the RT.10 Head's house in Sungai Duren Village, Muaro Jambi Regency

Geological Engineering program and the Head of the PPM Team from the Department of Earth Engineering, University of Jambi. After the awareness session and discussion, the assistance activities for creating biopore infiltration holes were conducted, guided by the team of lecturers and students from the Department of Earth Engineering. The biopore technology assistance activities of the PPM can be seen in Figure 6.

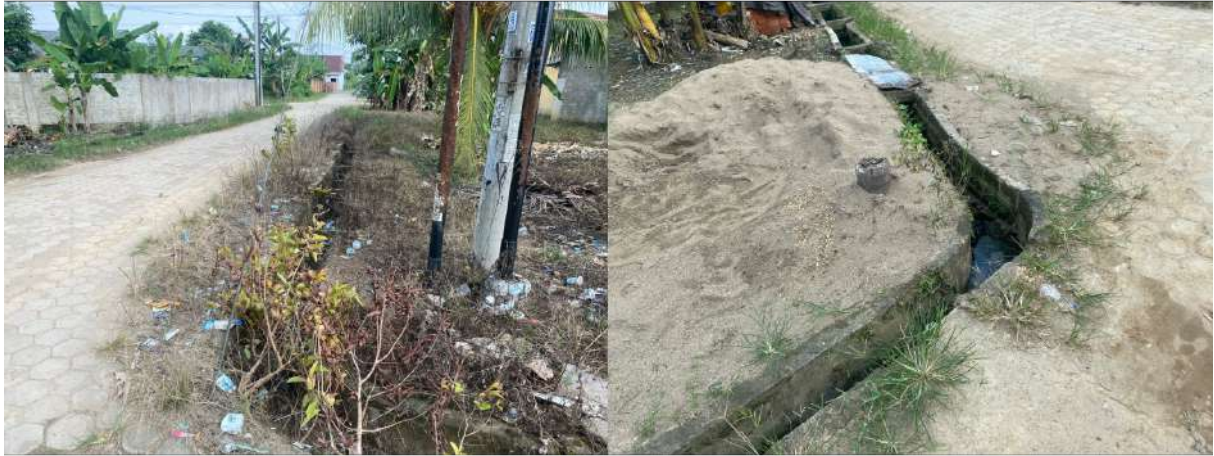
Figure 8. Changes in community attitudes toward the importance of environmental cleanliness. Image A shows the condition before the socialization on July 20, 2024, and Image B shows the condition during monitoring and evaluation on September 9, 2024

Based on direct observations made on September 9, 2024, approximately 50 days after the socialization activities were conducted, the overall cleanliness level of the environment has started to improve. Community service activities have been undertaken by the PPM partner; however, due to heavy rainfall, a significant amount of plastic waste has been washed back into the area. Fortunately, this litter is only

present in a few spots, and overall, the partner area has become much cleaner. This situation can actually be managed by maintaining cleanliness in each household's surroundings, rather than waiting for community cleanup efforts. An illustration of the change in community attitudes toward environmental cleanliness can be seen in Figure 8.

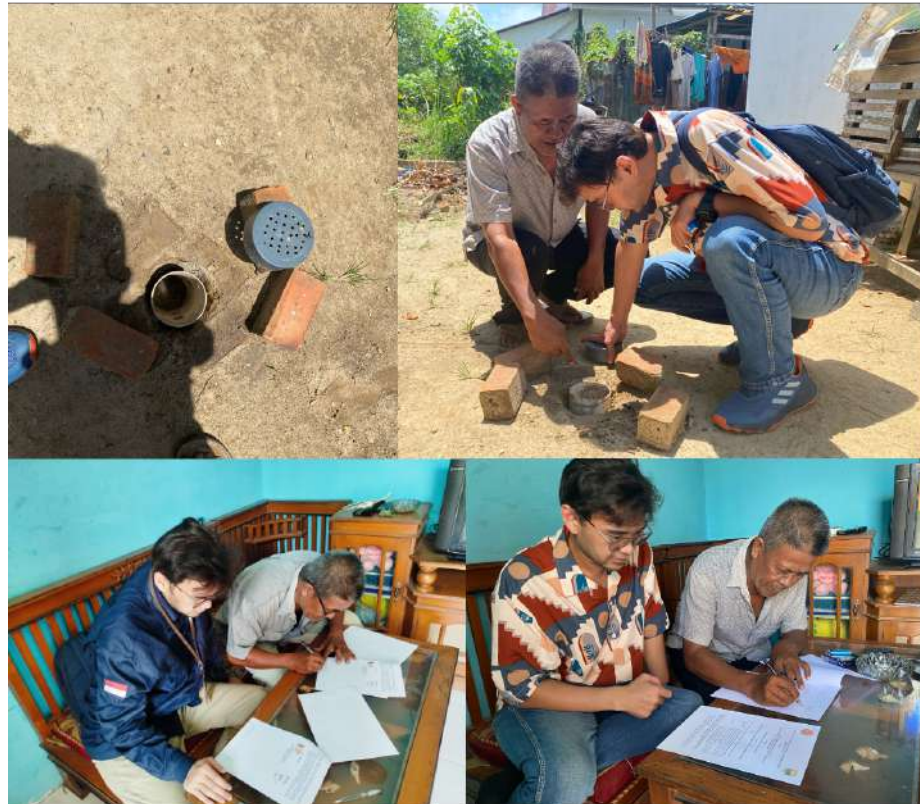
Figure 9. Monitoring and evaluation of the performance of biopore infiltration holes and the signing of the Implementation Arrangement
