Monthly Report: Chevron Richmond Community Air Monitoring Program

Report Number: RCAMP_MO_20
Date: November 2014

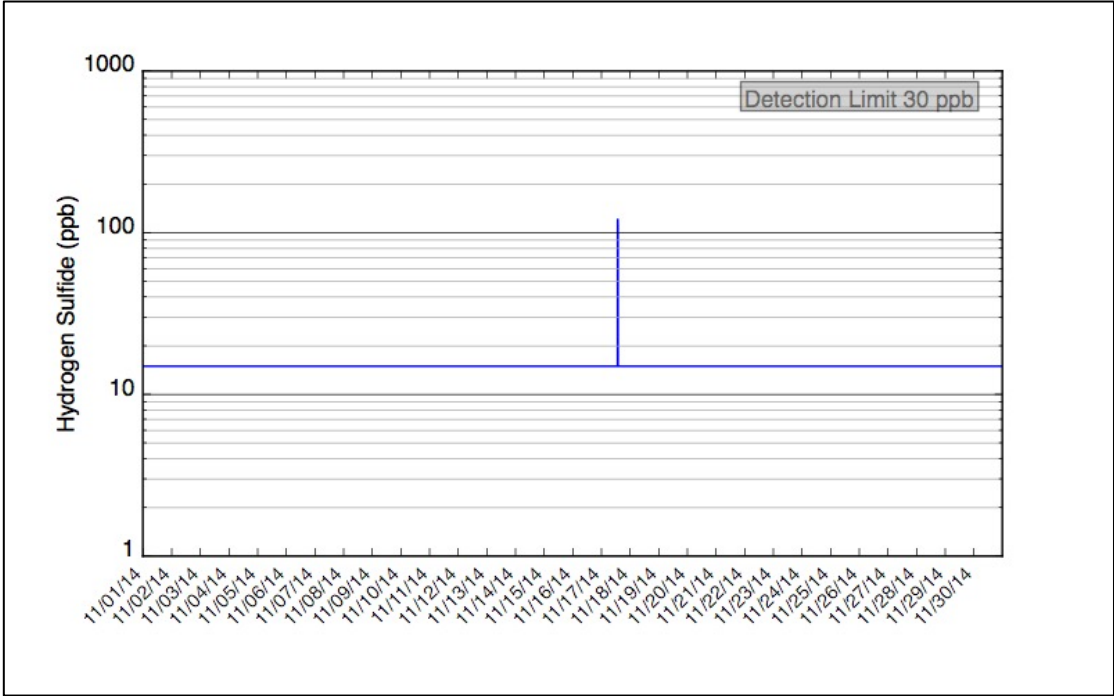
Figure 3.4: Point Richmond Hydrogen Sulfide Monitored by TDL

Figure 3.4 shows that the maximum concentration of 121 ppb was detected on November 17, 2014 at 2:05 PM. Toxicity levels established by the State of California are listed in tables 3.1 above.
