Monthly Report: Chevron Richmond Community Air Monitoring Program

Report Number: RCAMP_MO_14
Date: May 2014

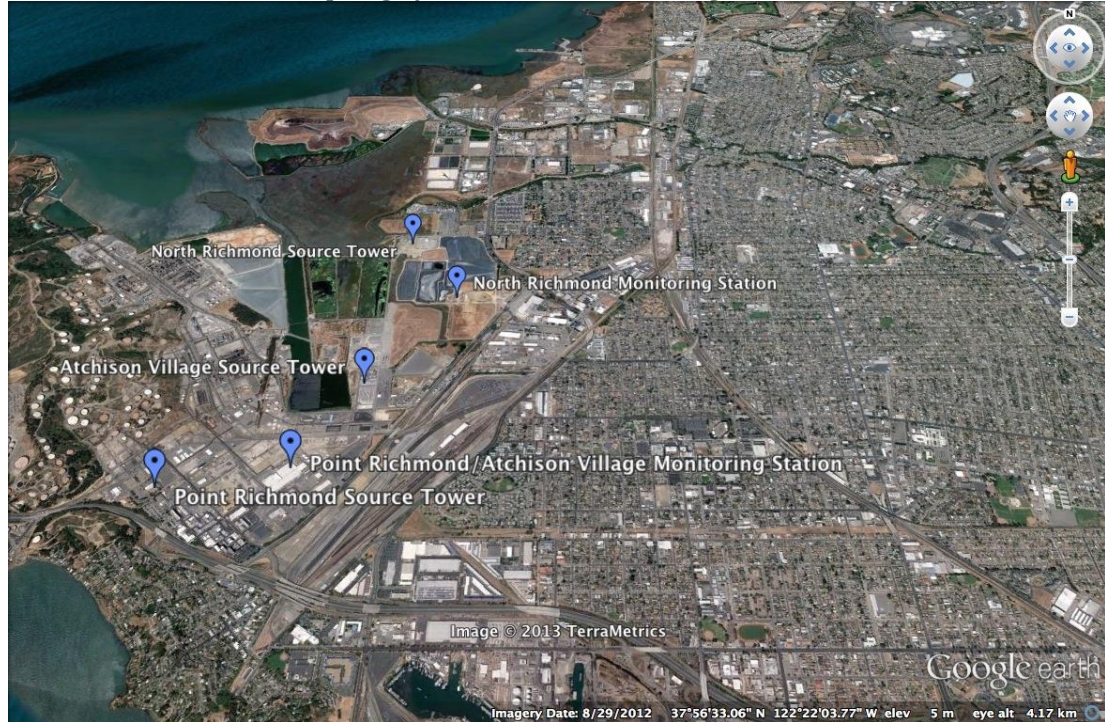
The location of the sampling systems is shown in Figure C.1 below:

Table 2.1 lists the target compounds monitored during the month of May 2014, at the fence line monitoring systems near the refinery perimeter and adjacent to Point Richmond, Atchison Village and North Richmond. Each site has an open path Ultra Violet (Open Path UV) air monitoring system and an open path tunable diode laser (TDL) air monitoring system, see Appendix C for an equipment location map.
