# Monthly Report: Chevron Richmond Community Air Monitoring Program

## Fence Line Air Monitoring Stations

Report Number: RCAMP\_MO\_9

Date: December 2013

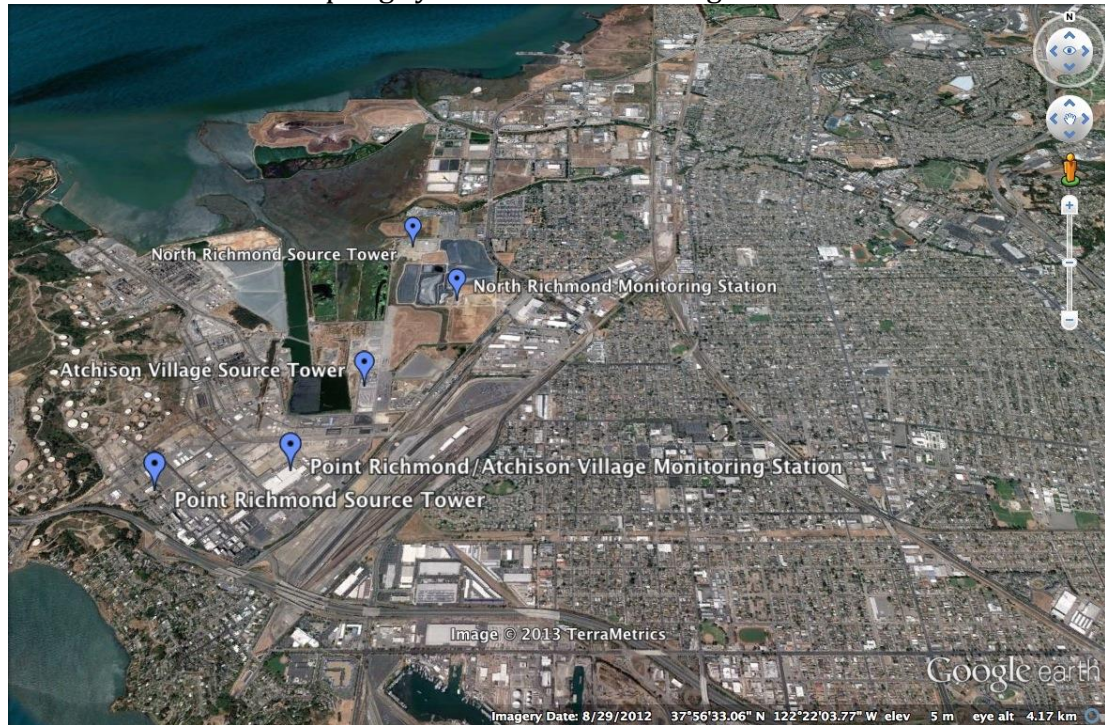
The location of the sampling systems is shown in Figure C.1 below:

Table 2.1 lists the target compounds monitored during the month of December 2013, at the fence line monitoring systems near the refinery perimeter and adjacent to Point Richmond, Atchison Village and North Richmond. Each site has an open path Ultra Violet (Open Path UV) air monitoring system and an open path tunable diode laser (TDL) air monitoring system, see Appendix C for an equipment location map.
