Monthly Report: Chevron Richmond Community Air Monitoring Program

Report Number: RCAMP_MO_10
Date: January 2014

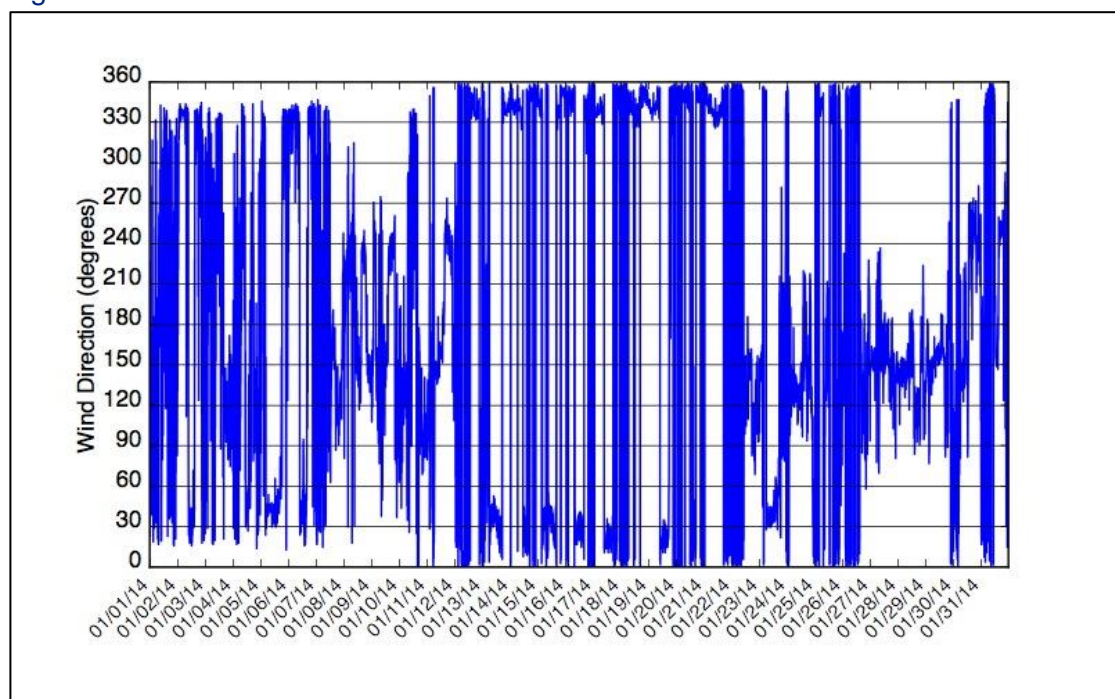
Figure 3.5: Point Richmond Wind Direction
