# INSTALLATION SHEET

## V WINDOW BN (CLIPS T/B) CLR

Customer: JOHN-06  
Location: 14218 MEADOW  
Quantity: 1  
Project #: 10076518-A-MBW

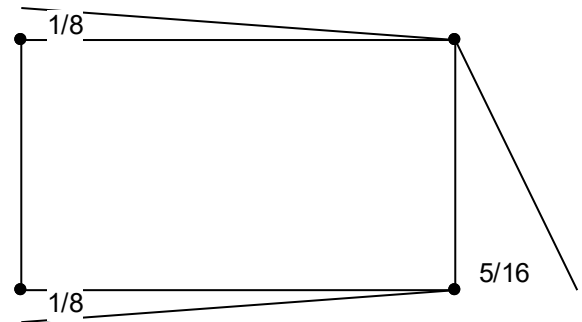
### OUT OF PLUMB / LEVEL CONDITIONS

Showing Centerline Void
