INSTALLATION SHEET

V WINDOW BN (CLIPS T/B) CLR

Customer: HIGHLAND - 10
Location: 210 SONRISA
Quantity: 1
Project #: 30027837-MBW

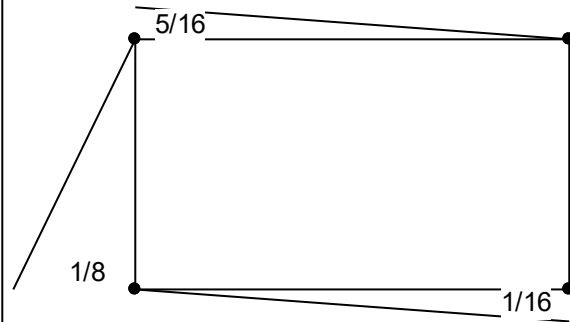
OUT OF PLUMB / LEVEL CONDITIONS

Showing Centerline Void
