INSTALLATION SHEET

Project Name: R PANEL BN (OT/OL) CLR

Project #: 10075822-B-MBP2

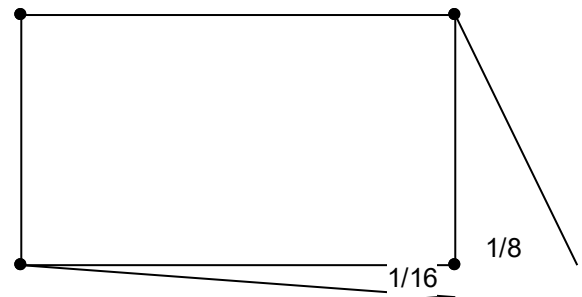
OUT OF PLUMB / LEVEL CONDITIONS

Showing Centerline Void
