INSTALLATION SHEET

Project Name: V80 IL DR NS BN CLR AGI3

Project #: 10074021-I-B2

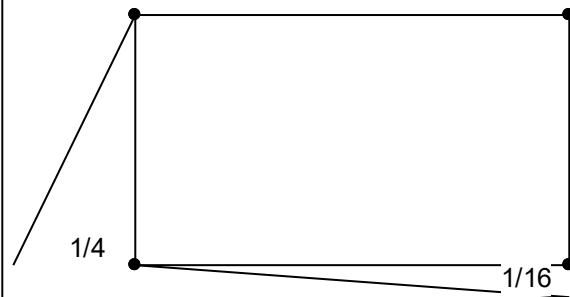
OUT OF PLUMB / LEVEL CONDITIONS

Showing Centerline Void
