# Darwin III: Lessons Learned

Team 11 Post-Flight Analysis for the 2022 EuRoC

17 October 2022

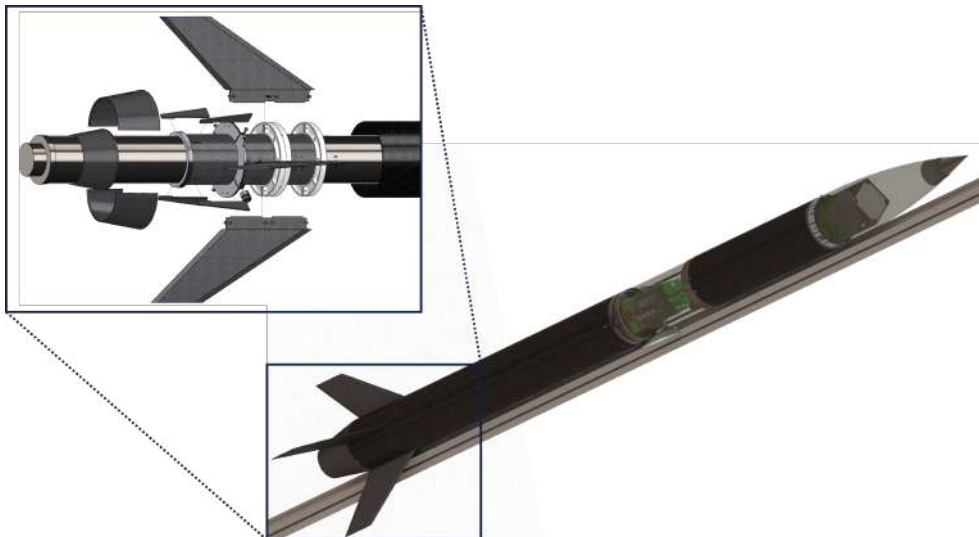
Figure 1.1: Computer Aided Design (CAD) model of the Darwin III Launch Vehicle with Fin-Can Detail.

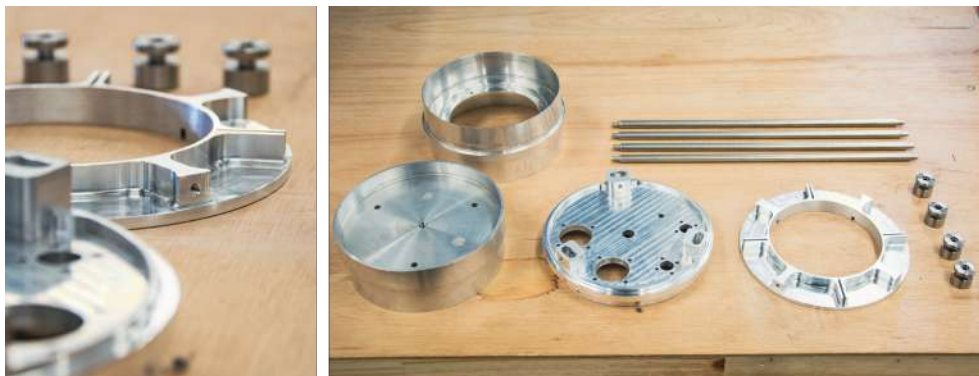
Figure 1.2: Wholly student-designed CNC Machined Bulkheads and Structural rods which support the Carbon Fiber airframe. Machined at the University of Edinburgh Mechanical Engineering Machine Shop in Sanderson Building.

The 8mm thick Stainless Steel Force Rods supporting the **Avionics Bay** were found contorted upon themselves, having ripped their housing blocks from the Motor and Recovery Bulkheads respectively. This is evidence of the immense shear loading experienced on impact, sufficient to shear off over 3cm<sup>2</sup> of 7075-T6 Aluminium.

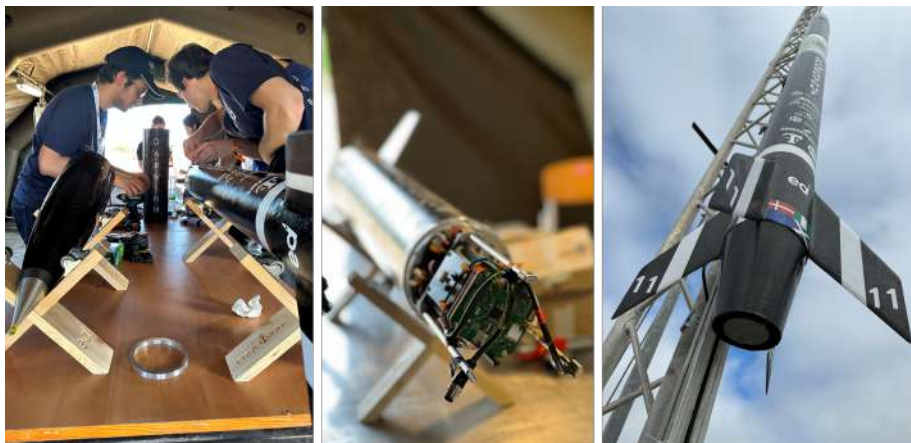
Figure 1.6: Final assembly of the 4 Main Segments in the Integration Tent

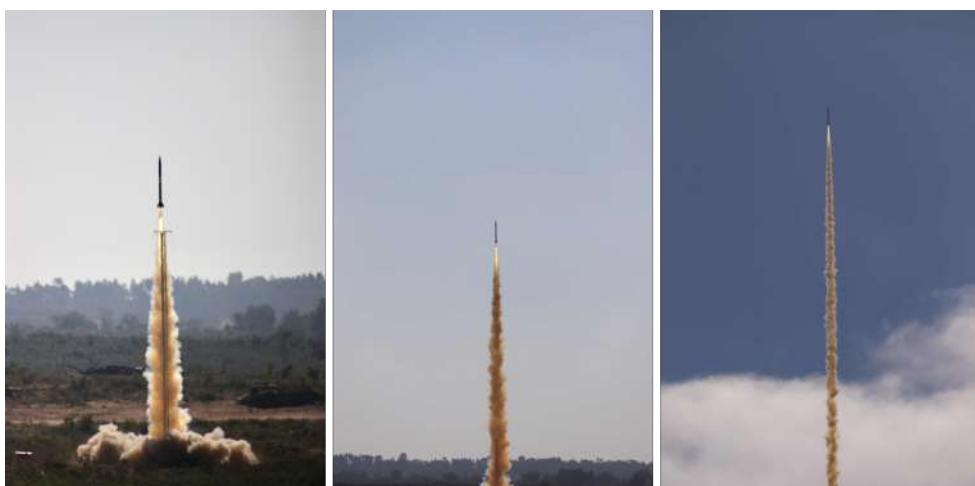
Figure 1.8: Liftoff and the long boosting phase captured by the official ESA photographer. The plume consists mostly of water vapour and some CO<sub>2</sub>. The Team is currently developing a "green" bi-liquid engine with 95% combustion efficiency and a significantly cleaner exhaust

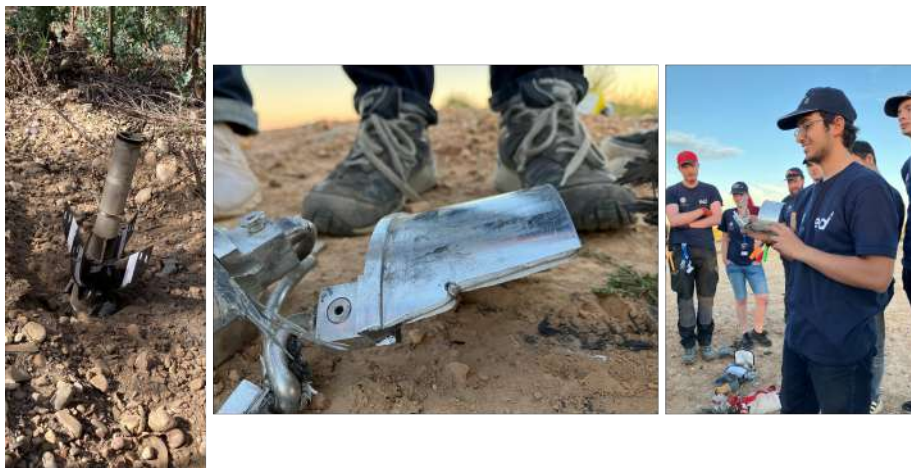
Visual confirmation of drogue or main parachute ejection was not given, and the vehicle was assumed ballistic. No damage to life, limb or property was recorded and no fires were reported. Two recovery teams were dispatched immediately after the closing of the launch window to the last GPS coordinates received, which were necessarily in close proximity to the launch site due to the early flight-stage in which they were received. The recovery crews were not immediately successful but were later directed towards a point at 39.386377N, -8.275252W by a local fire brigade, where Darwin III was immediately identified in a "lawn dart" position in the shade of some large trees.

Figure 1.10: The Landing Site of DIII and images from the Team Debriefing

The vehicle failed to deploy its nosecone at apogee, thus entering a high velocity dive quickly reaching its terminal velocity of 251m/s. Darwin continued its descent following a ballistic trajectory, finally impacting the ground and penetrating approximately 600mm into the Portuguese soil, a dry mixture of gravel, sand and mid-sized sharp rocks, releasing 724'000 joules of energy in 8 thousands of a second.

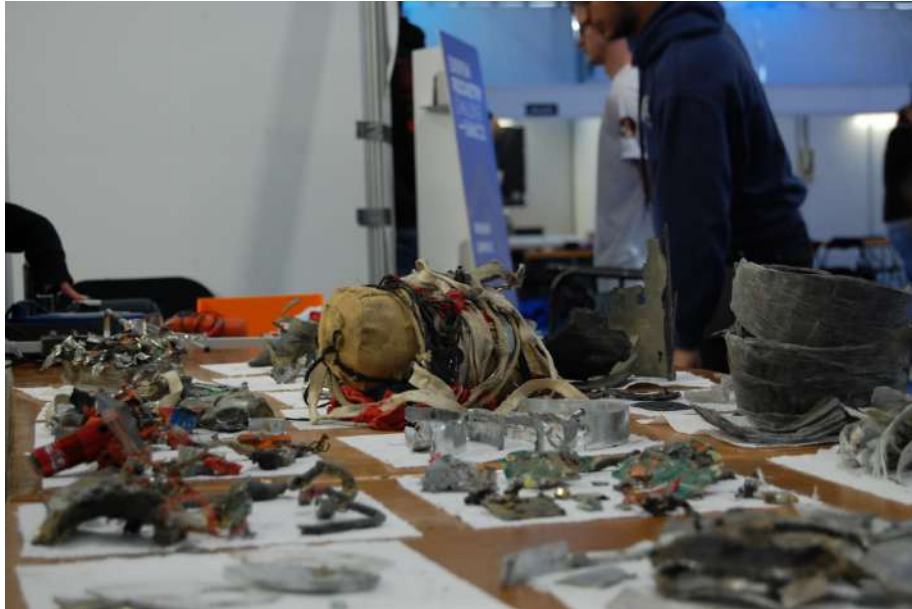
80% of the vehicle disintegrated on impact, with failure modes ranging from brittle explosion, to plastic

deformation, composite delamination and buckling. The aft end of the lower body, including the fins and the thrust structure, was recovered nearly intact, except for evidence of violent impact on the fins most likely attributable to the forest canopy. There is little evidence of delamination caused by aero-thermal heating, and few fatigue cracks imputable to fin flutter. Every system of the vehicle has been recovered and catalogued, but the vehicle is cannot be reflown in its current state.

Figure 1.11: The Remains of Darwin III, exhibited to the Jury for the Post-Flight Review. The root cause identified by the Team and confirmed as highly likely by the Technical Experts.

The **Motor Casing** plastically deformed on impact, splaying outwards and tearing open, with the Forward Closure becoming one with the Motor Bulkhead and the Motor Retention Hardware. The Motor Tube features evidence of extreme delamination following the winding angle pattern.

The **Avionics** was flattened amongst the bulkheads and most Surface Mounted Devices (SMD) such as passive components and power regulators were ripped off the boards by the force of impact. The team is happy to report that a FLASH chip was salvaged from the COTS Quantum Flight Computer in good conditions. Data recovery attempts will be made in a controlled laboratory environment upon the return to Edinburgh.

The **Recovery system components** were in a range of conditions. The compliant parachutes only present some small perforations, while the recovery hardware such as the SRAD mechanism and the COTS Tender

Descenders and Raptor systems were severely damaged.

The **Payload** was flattened between its two heavy bulkheads, with the avionics encapsulated within the steel and aluminium sheets. No data storage devices were salvaged, with all 3 SD cards having been found in a fractured state. The Payload and the Nosecone and Nosecone Tip were found at the bottom of the hole created by the vehicle, suggesting lack of separation at Apogee.
