# **A Report on the Causes and Effects of Landslides in Dhunche, High Mountain Himalaya, Nepal**

**Tanya Pascual MA, FRGS**

This report is an abridged version of a dissertation that was submitted in partial fulfilment of the requirements for the degree of MA Environment and Development of the School of Oriental and African Studies (University of London)

February 2001

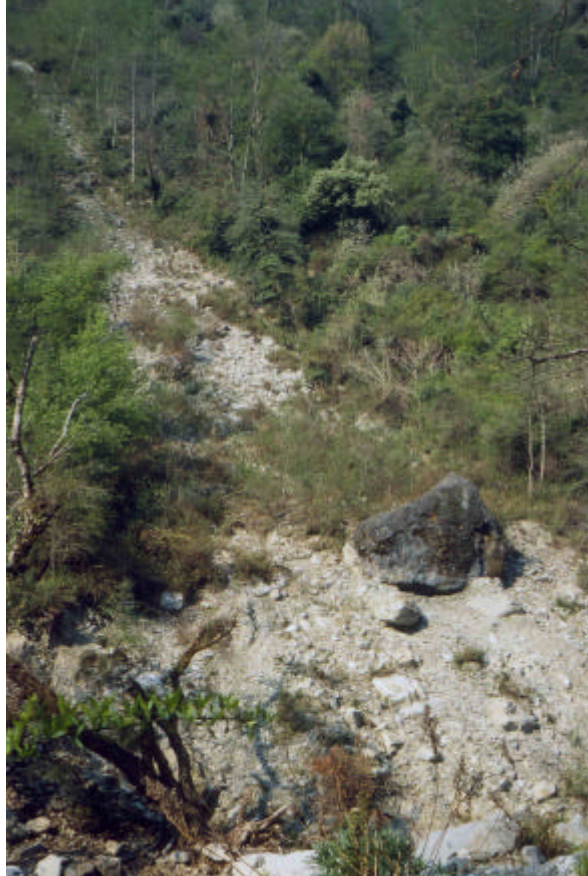
Plate 1: Landslide 1 Rock Slide by Trisuli Khola River

Location: Set in the forest area at end of the village on the trekking route to Gosainkunda. Just above the south side of the Trisuli Khola river, and the village water mill (although not damaged).

Cause and Effect: According to information gathered by villagers living and working in the immediate area, the slide was triggered during a particularly intense precipitation, which caused flooding. The hill slope form above the footpath is steep set in forested area and below it concaves until it reaches the rivers edge (south side) where shrub vegetation is growing amongst the boulders. At this point the river (which runs perpendicular to the slide) runs down stream/slope to meet the Trisuli and is full of huge boulders and rocks. The footpath, which cuts across the slide, has been cleared, although it is still relatively unsafe with course loose sandy soil and rocks and represents a sloping ledge. A new heavy precipitation torrent could destabilise the slide further.

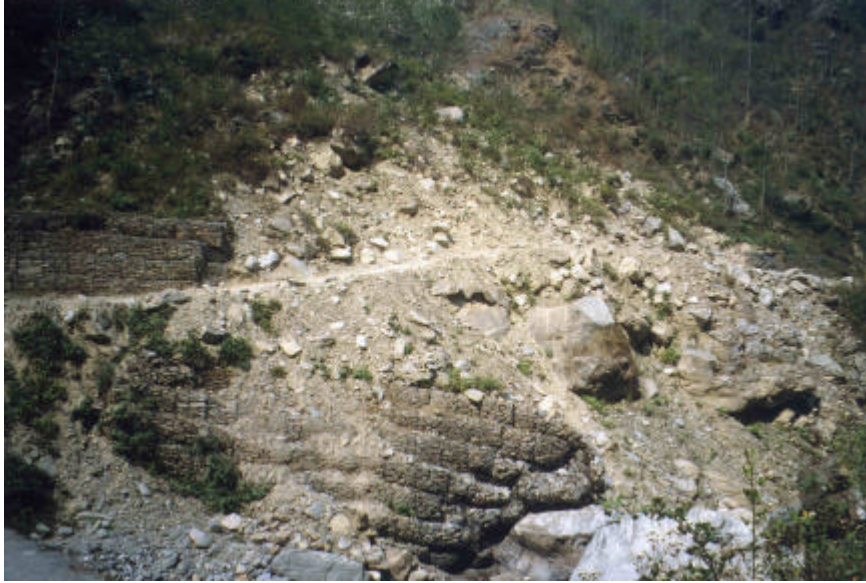
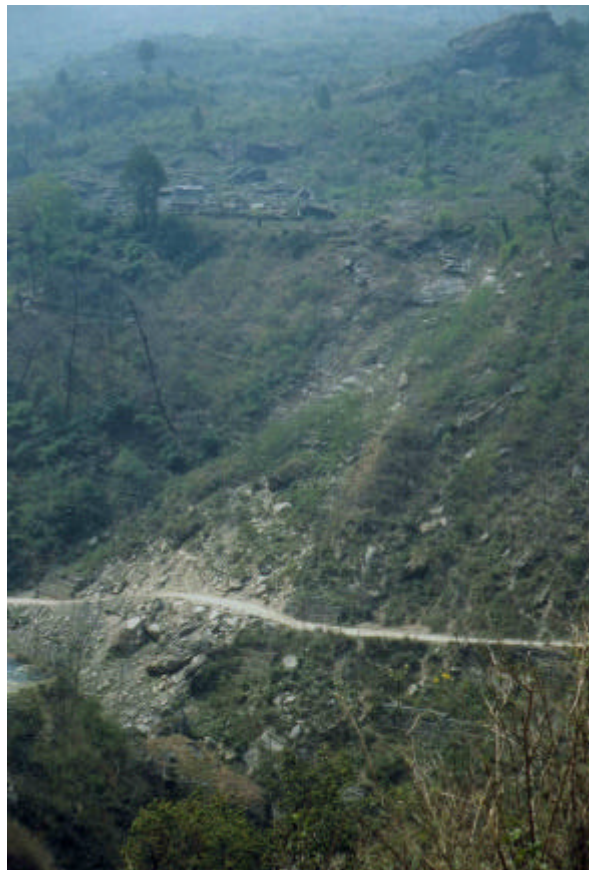
Plates 2-3:  
Landslide 2  
Rock Slide Near  
the Trisuli Khola  
Bridge

Cause and Effect: According to information supplied by the villagers of Dhunche, this landslide occurred during a high precipitation. The road had been blocked and it is clear that the road support is badly damaged (Plate 2). Above the fall is farm and shrub area. The outline of a much earlier and larger slide can be seen above the scarp of the present one, which is now covered in shrub.

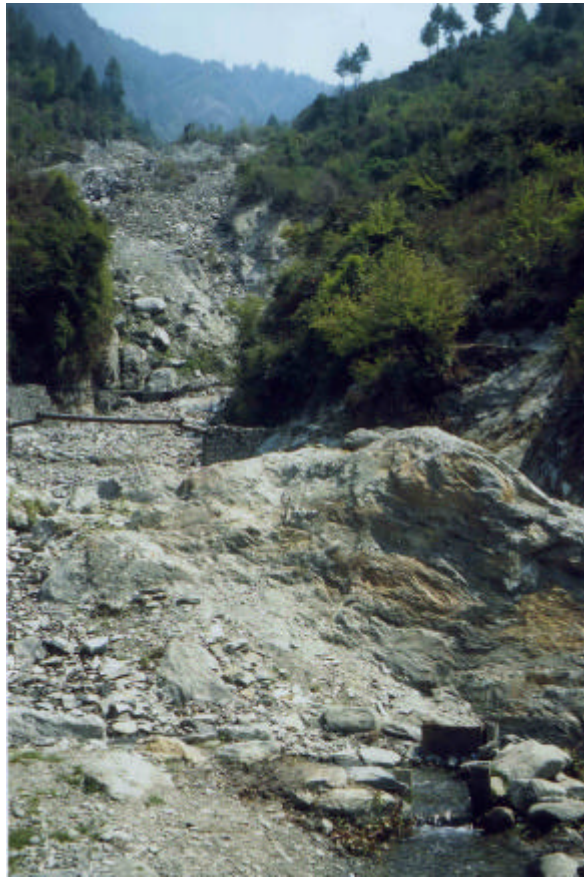
Plate 4: Landslide 3 Rock Slide at Thulo Bharku Village

Cause and Effect: Information regarding this slide came from a Tamang family farming on a small piece of land by the Trisuli Khola river (near the water mill) in Dhunche but who actually lived in Thulo Bharkhu. This particular slide occurred during a particularly intense precipitation, which had flooded the river and consequently swept away the water mill. According to the Tamang farmer, this had happened three times. The slide leads down to a bend in the road where there is still evidence in the form of

loose rocks, sand and water tracks, that the landslide/flood crossed the road following a downhill stream. The stream is gradually creating a gully. Further uphill, where the newly re-built mill is, the area is laden with piles of large loose rocks.

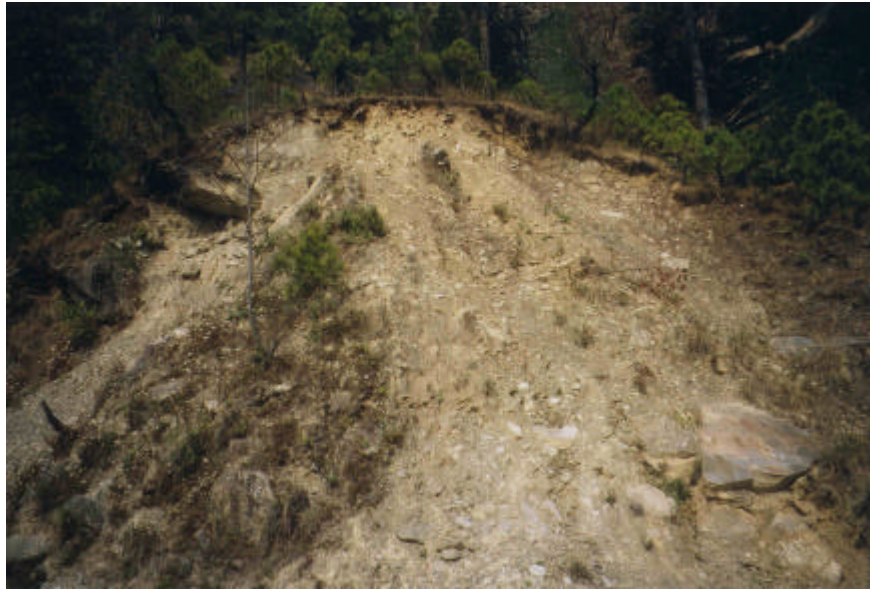
Plate 5:  
Landslide 4  
Road to Dhunche (1)

Cause and Effect: According to information supplied by villagers interviewed in Dhunche. This is one of three slides, which occurred at the same time during the monsoon season. This is the largest of the three with mainly sand, small loose rocks and stones. There is evidence of a continued trail of loose soil and stones on the opposite side of the road where the slide has continued down the slope towards the river. However, the connectivity with the river would not be so great due to the great height between the road and the river. In addition the downward slope was covered with shrub and trees.

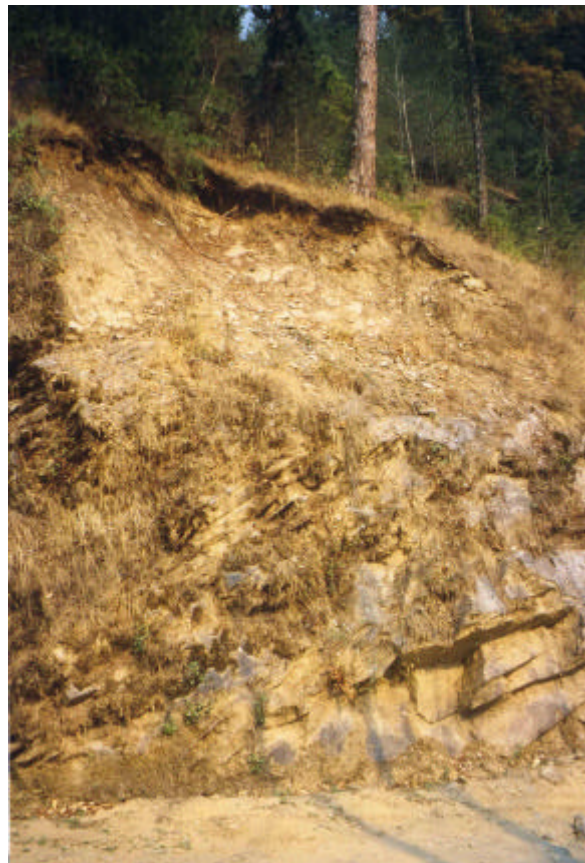
Plate 6:  
Landslide 5  
Road to Dhunche (2)

Cause and Effect: The second of the three slides as described above but smaller than the first.

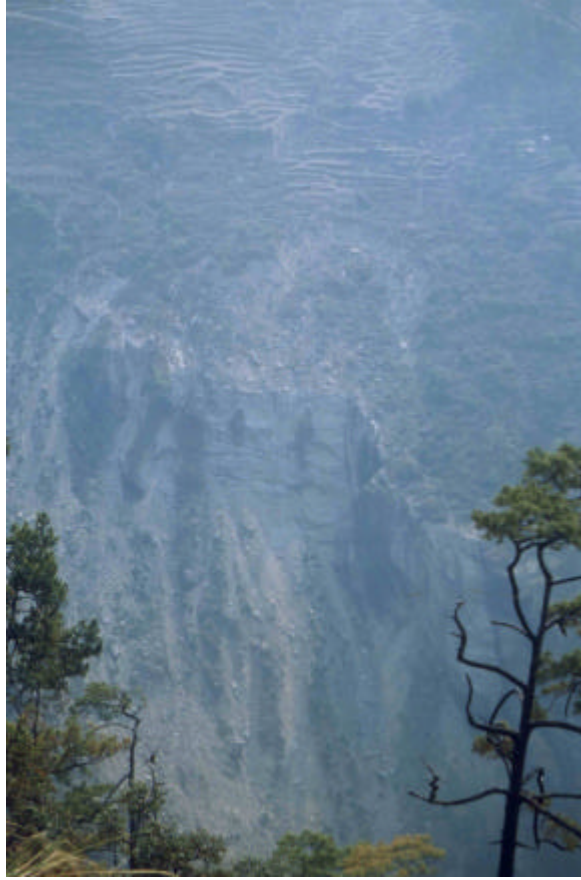
Plate 11: Landslide 11 Below Dhunche Village

Cause and Effect: This is a huge what can be described from a distance as an earth slump but could also be described as a debris slide. Few people of the village could give much information about its age or even existence. A journalist gave an approximate age of 25 years but some stated it was much older. The main point in agreement was that it was still continuing. This has a high connectivity with the river even though there is a great distance between the two, the steep drop lands directly in the river, close to the main Trisuli river. In Plate 11 there is evidence of the land having been previously cultivated and terraced. This then raises the question to one of the points from the environmental degradation theory that terraced land causes landslides. However it is argued in the literature that landslides can be triggered by unmanaged land and this could be an example.

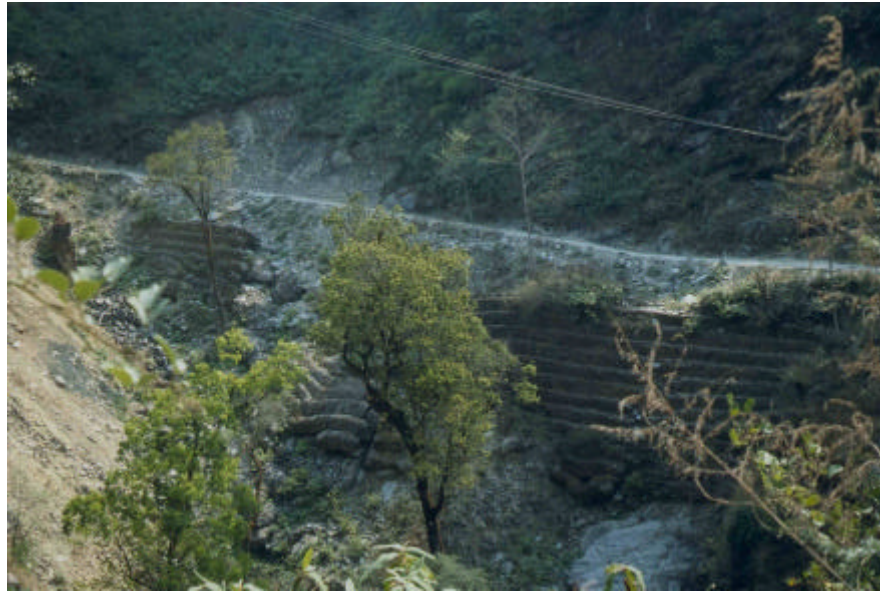
Plate 12:  
Deteriorating Road  
Supports

However in its relatively short life it is visibly deteriorating (Plate 12). The supports are cracking and collapsing and landslides are occurring along the upper and lower sides. This strongly implies poor engineering and the use of cheap materials.
