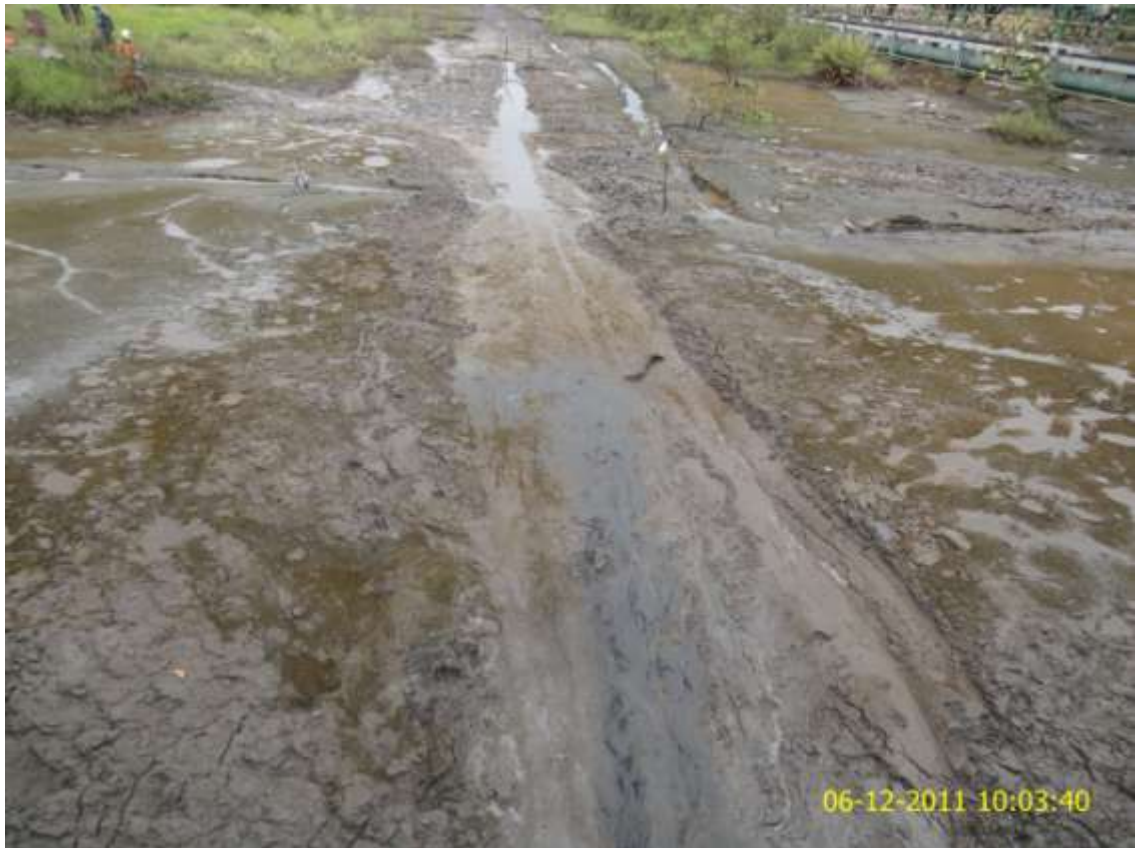
Overview: Part of spill impact on Awoba Well8T flowline at Bille. Picture was taken during Joint Investigation of 6<sup>th</sup> December, 2011.

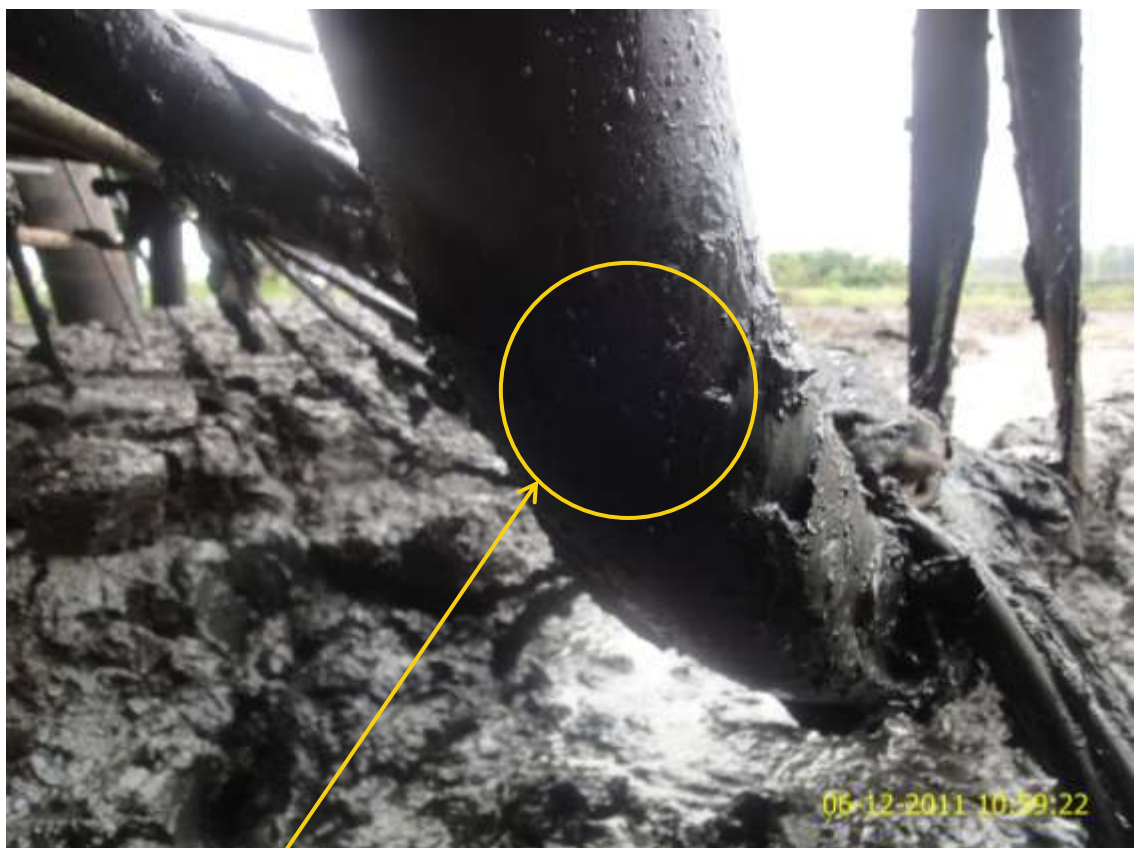
Close-up: Approximate location of pinhole due to corrosion on Awoba Well8T flowline riser at Bille. Picture was taken during Joint Investigation of 6<sup>th</sup> December, 2011.
