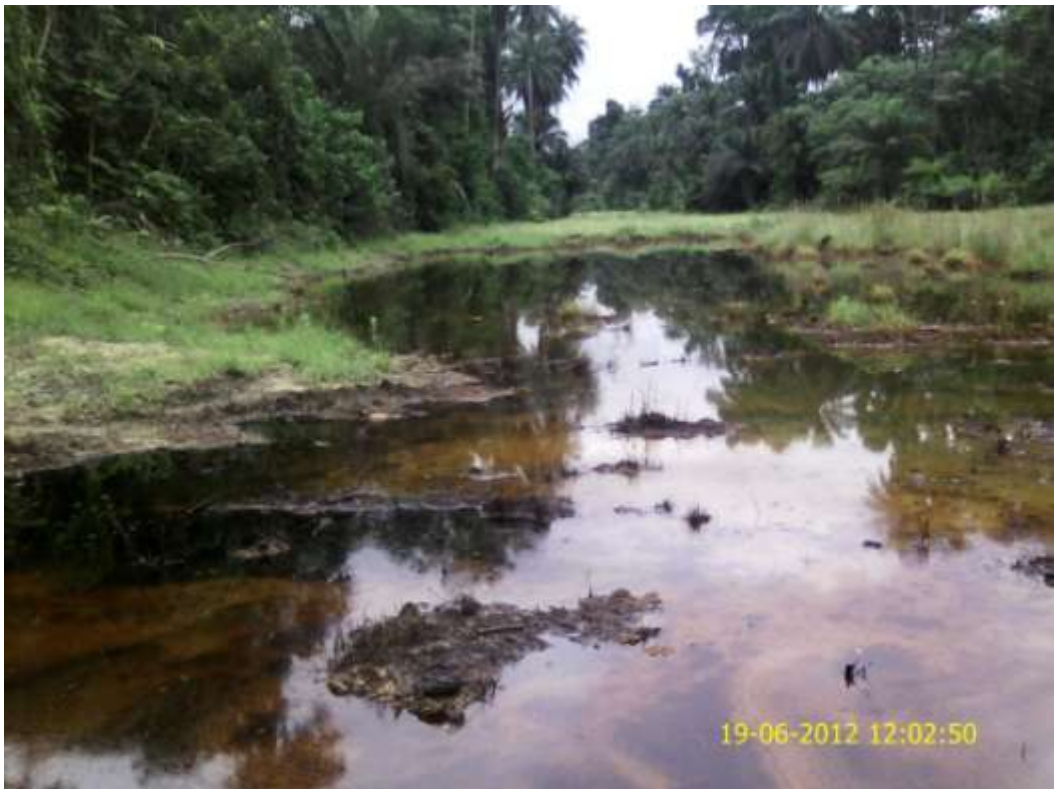
Overview: Part of spill impact on 14" Okordia-Rumuekpe pipeline right of way at Ikarama. Picture was taken during Joint Investigation of 19<sup>th</sup> June 2012.

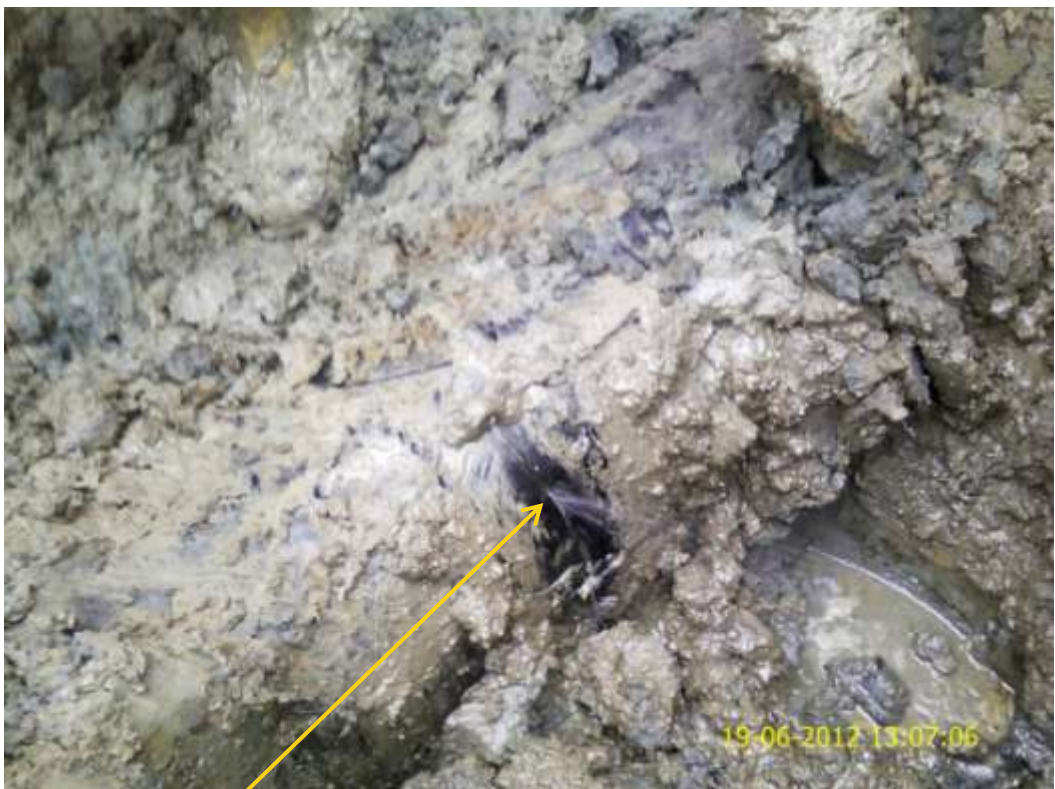
Close up: Hacksaw cut on 14" Okordia-Rumuekpe pipeline at Ikarama. Picture was taken during Joint Investigation of 19<sup>th</sup> June 2012.
