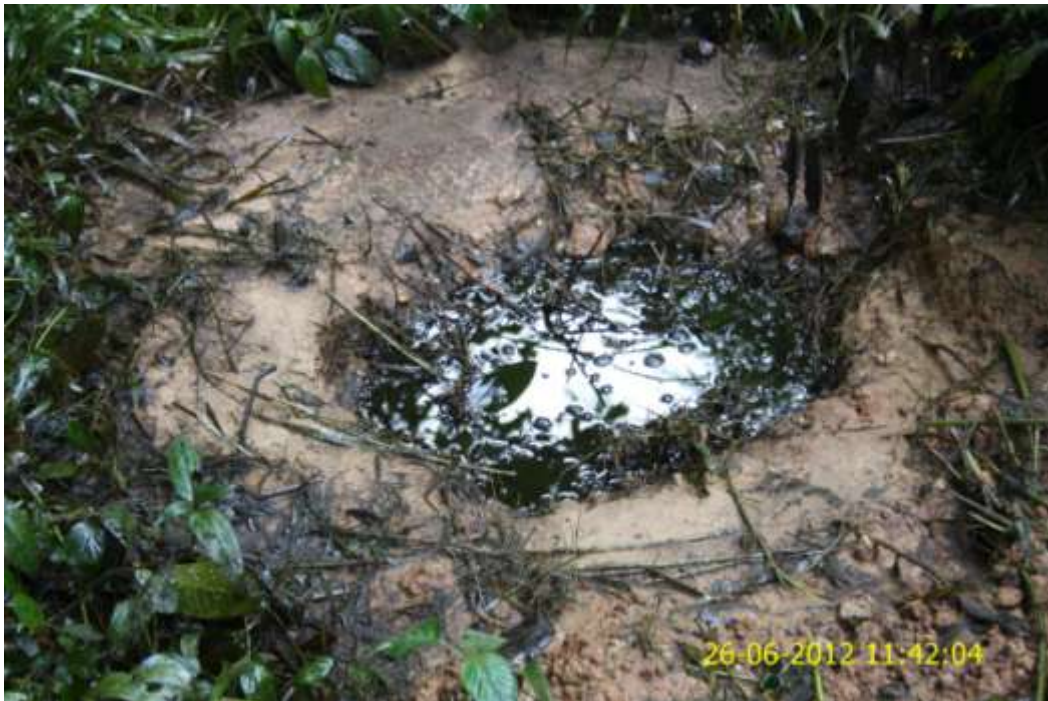
Overview: Part of spill impact on 24" Npoku-Bomu trunkline right of way at Botem.
Picture was taken during Joint Investigation of 26th June 2012.

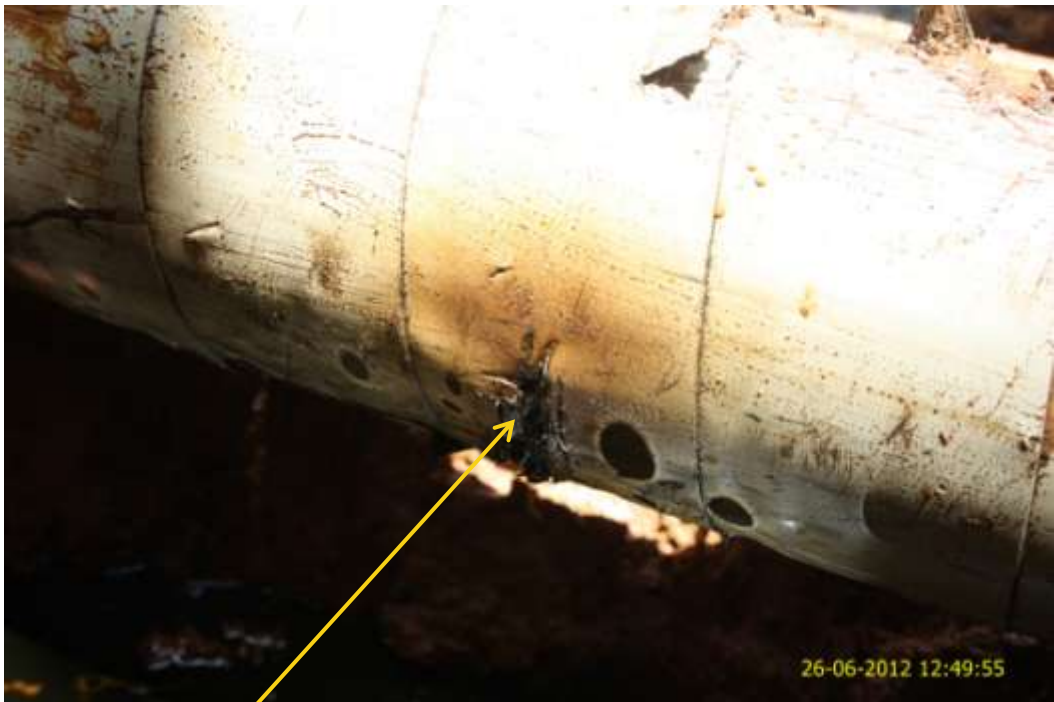
Close up: Hacksaw cut at 7 o'clock on Oweh Well8L/11L flowline at Otor-Oweh.
Picture was taken during Joint Investigation of 26th June 2012.

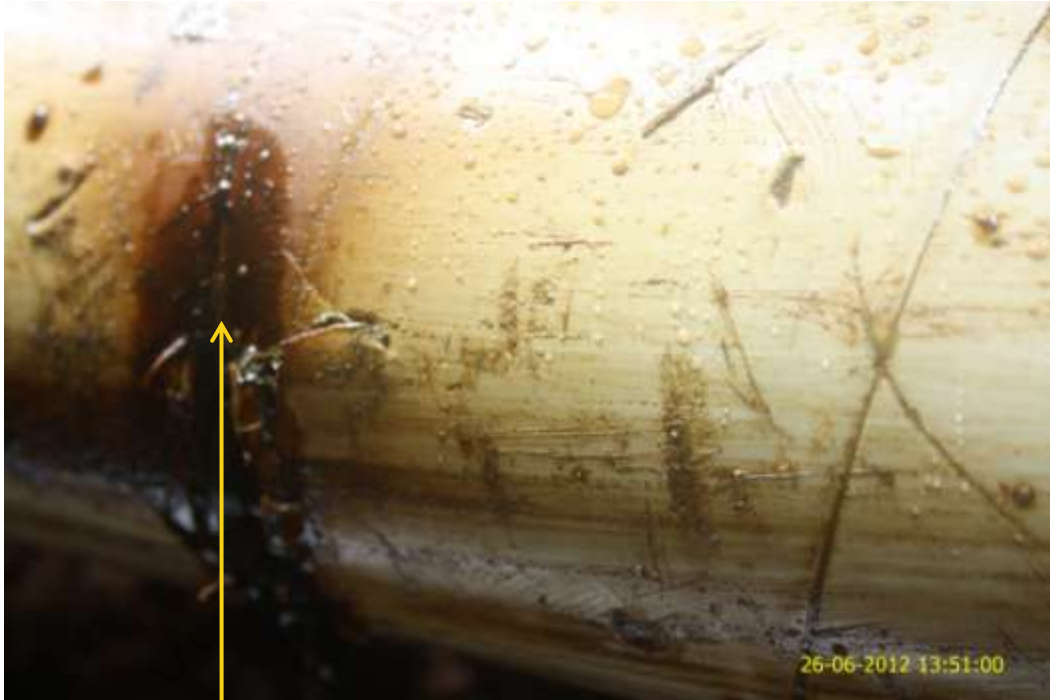
Close up: Hacksaw cut at 3 o'clock on Oweh Well8L/11L flowline at Otor-Oweh.
Picture was taken during Joint Investigation of 26th June 2012.
