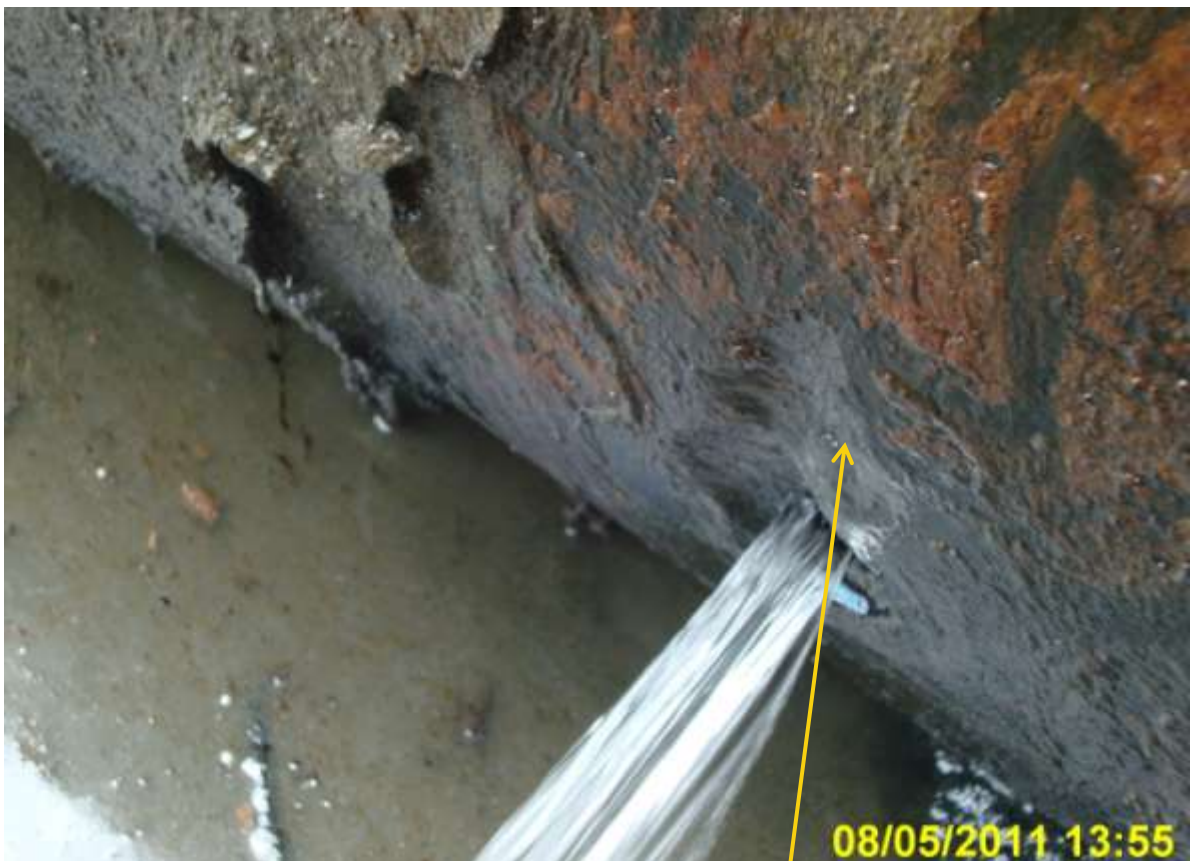
Close-up: Evidence of grinding and drilled hole on 24" Alakiri-Bonny Pipeline at Kalibiama. Picture was taken during JIV of 8th May 2011
