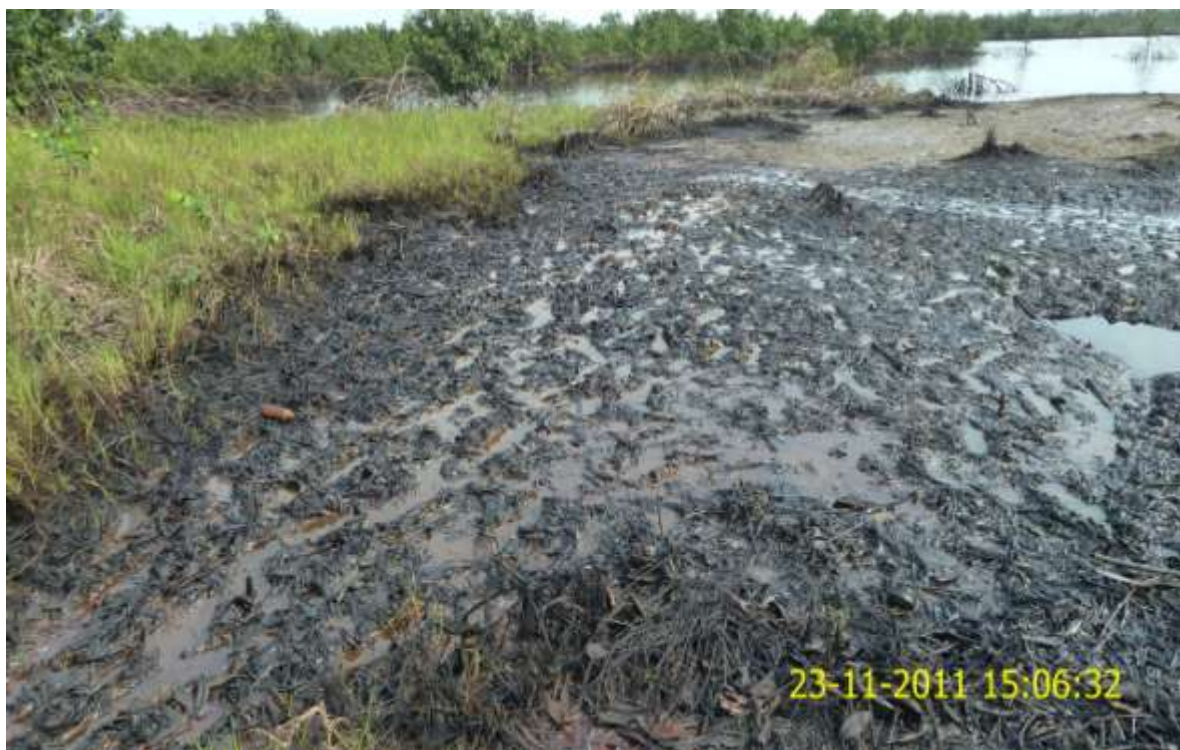
Overview: Part of spill impact on 12" Cawthorne Channel pipeline right of way at Ilomaturu.  
Picture was taken during Joint Investigation of 23<sup>rd</sup> November, 2011.

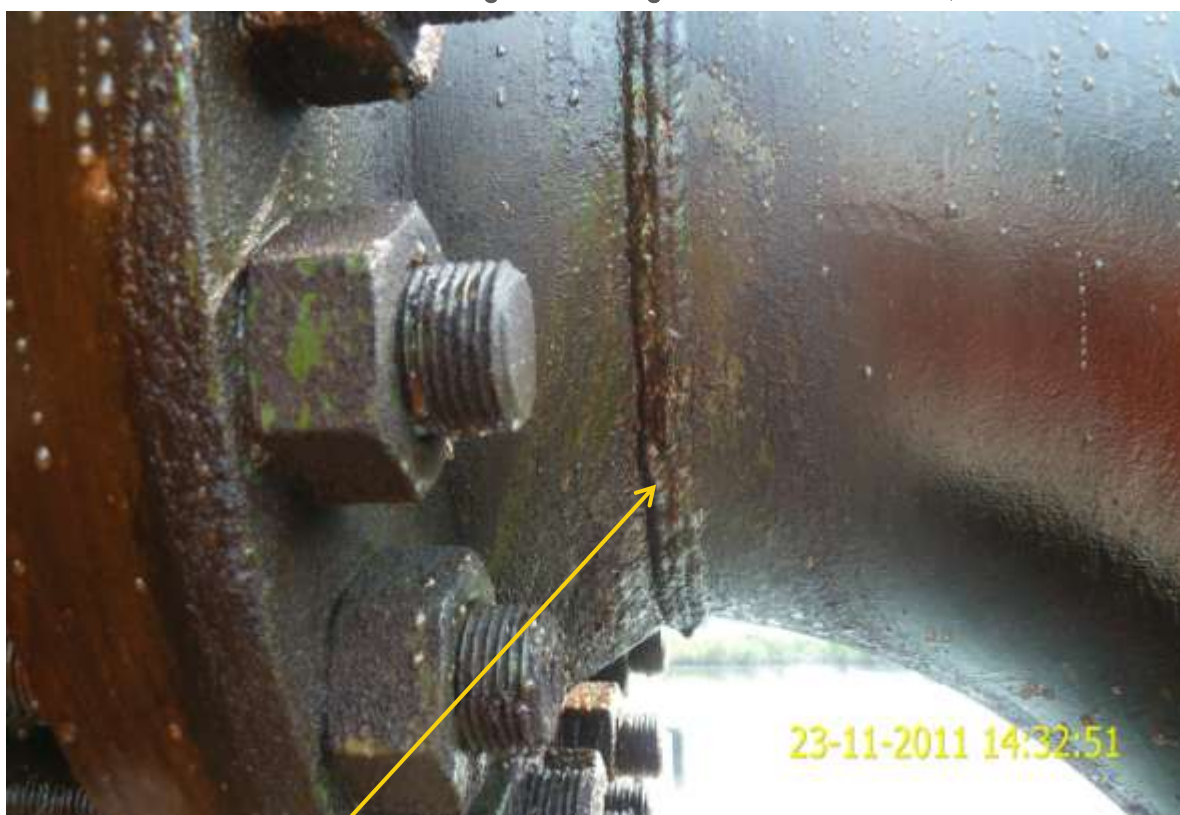
Close-up: Spill due to failed weld on 12" Cawthorne Channel pipeline riser at Ilomaturu.  
Picture was taken during Joint Investigation of 23<sup>rd</sup> November, 2011.
