Overview: Extent of the spill incident impact on Kolocreek Well 3T flow line at Otosiga. Pictures taken during Joint Investigation of 1st March, 2011.

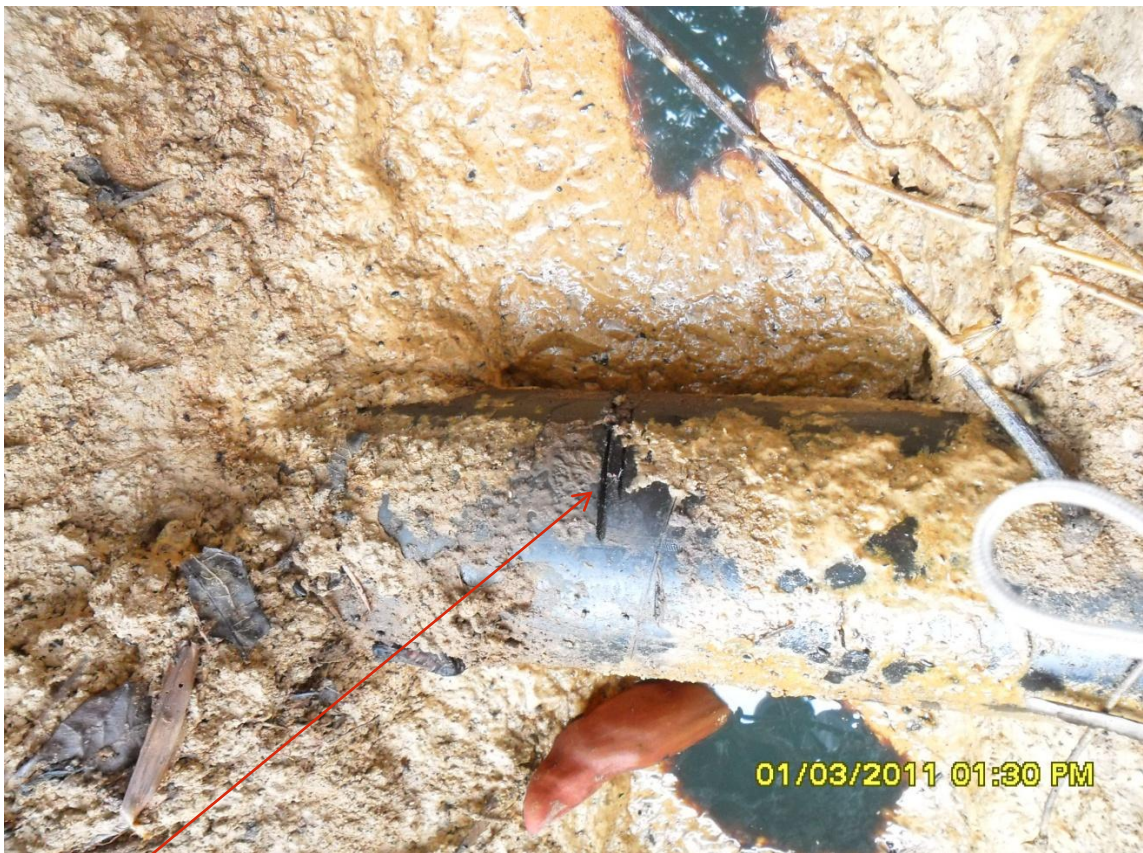
Close-up: Spill due to hacksaw cut on Kolocreek Well 3T flow line at Otosiga. Picture taken during Joint Investigation of 1st March, 2011.
